The Yogyakarta Earthquake of May 27, 2006

**Amr S. Elnashai
Sung Jig Kim
Gun Jin Yun
Djoni Sidarta**

Mid-America Earthquake Center

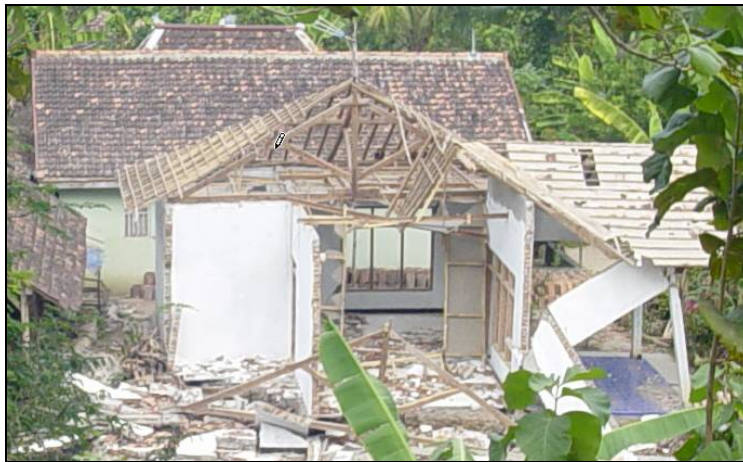
Figure 5.1 Heavily damaged residential building

The main causes of damage to this type of housing are discontinuity of load path and brittle characteristics of materials. Due to poor anchoring of roof-to-wall and wall-to-foundation, there are no continuous load paths to transfer the inertia force from the building to the foundation. In many cases, sliding of the timber roof off the masonry wall was observed. The frequently used brick masonry is brittle and has low compressive strength of 2 ~ 6 MPa. Since clay bricks are produced in large numbers and at a low cost without any standard, its quality is very much dependent on the local conditions and circumstances. The rubble stone used for strip foundations also has very low strength of less than 3 MPa. Low moisture content in mortar mixes due to pervasive use of acrylic

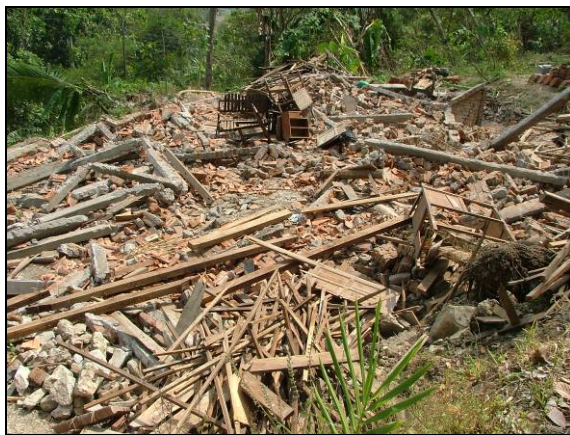
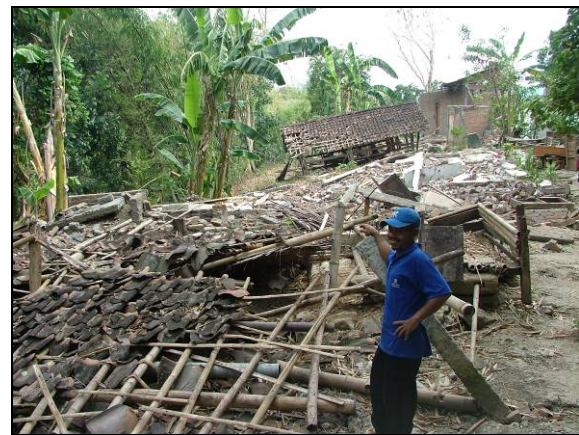
Figure 5.2 Housings on the hillside of mountain at Nglepen – Sengir (Sumberharjo village), north of Opak fault ($S7^{\circ} 49.02'$ - $E110^{\circ} 30.371'$ and altitude of 422 m)

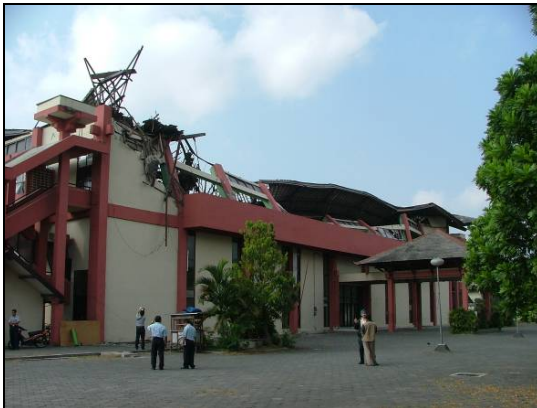
(a) Overview of GOR Sport Stadium

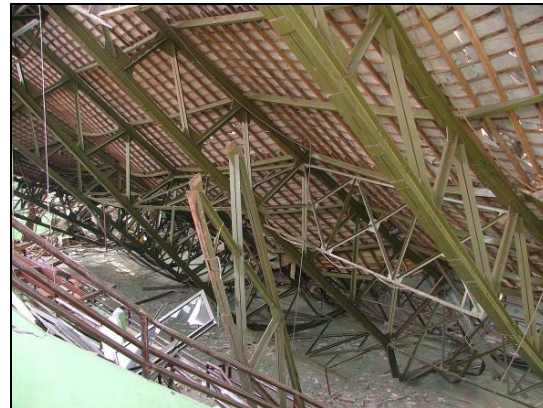
Figure 5.3 (b), local buckling, tearing and separation of partial truss members were observed. Figure 5.4 and Figure 5.5 show that flexural hinges of the columns are visible either at the joint with slab or at the connection with beams. The failure of the flexural hinges was caused by insufficient spacing of ties, insufficient splice length, use of smooth bars, and poor quality of concrete. Severe non-structural damage in the infill walls was also observed.

(b) Collapse of roof truss system

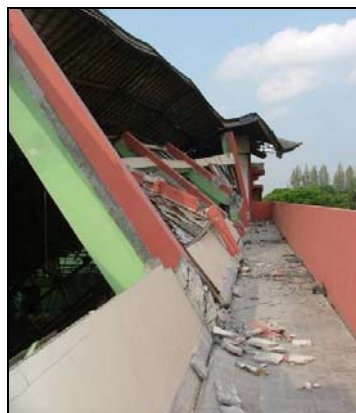
(a) Column failures

As explained previously, the observed failure mechanism is that the damaged columns of the second story were mostly bent inwards. This may be due to the vertical ground motion leading to very high vertical forces applied on the heavy roof resulting in the inwards failure of all perimeter columns. According to back-calculations with dimensions of severely damaged column sections and the roof system measured on site, a range of vertical ground accelerations could be obtained with consideration of material variability. The material strengths were considered as 17.1 to 27.6 MPa for concrete compressive strength (f'_c) and 310.0 to 520.0 MPa for reinforcement yield strength (F_y). Figure 5.5 shows the calculated lower and upper limits of moment capacity of columns and the required vertical ground accelerations to reach the moment capacity. For example, the calculated vertical ground accelerations were 0.183g for the lower limit of flexural resistance (589 kN-m) and 0.30g for the upper limit of flexural resistance of 977 kN-m.

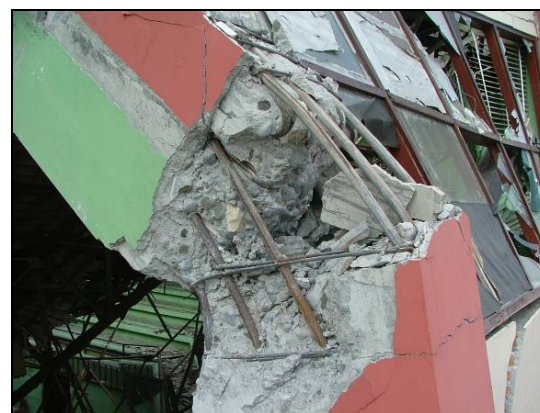
(b) Close view of flexural damages at column

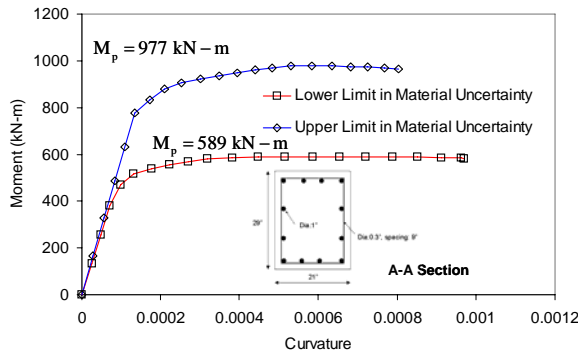
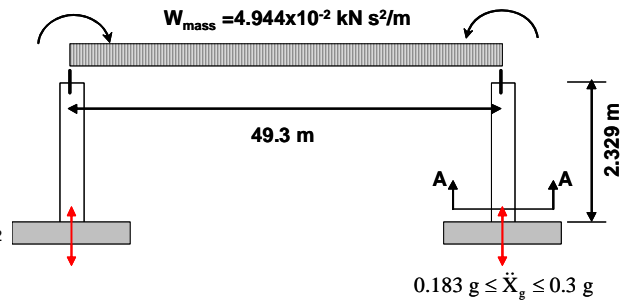
(a) Moment-curvature curve of column section (b) Flexural damages at the column
Figure 5.5 Verification of column damage, GOR Sport Stadium

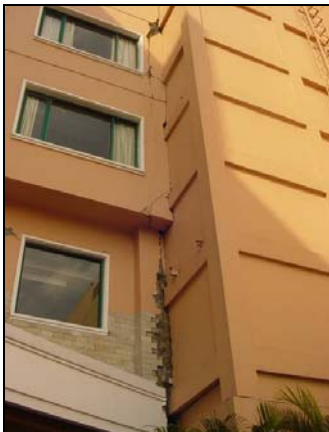
Another commercial building inspected by the MAE Center Team was the IBIS hotel in Yogyakarta City, shown in Figure 5.6. This hotel suffered moderate damage mostly concentrated in the ground floor, such as shear cracks in columns and damage to infill walls, stairs and partitions.

(a) Pounding at expansion joint

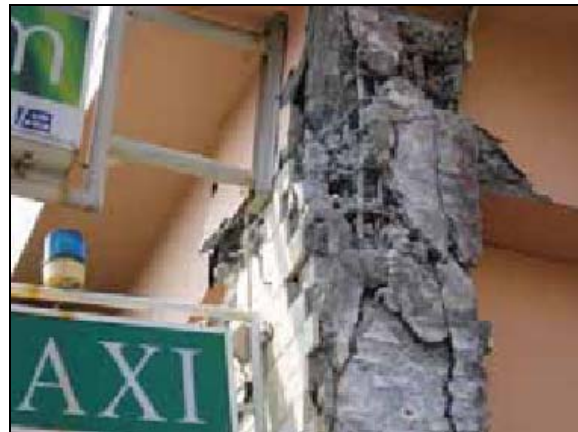
(b) Shear failure in beam-column connection

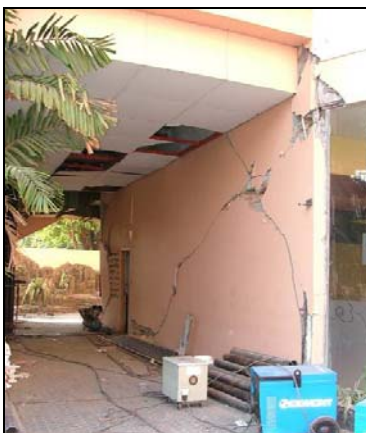
(c) Diagonal cracking of infill wall

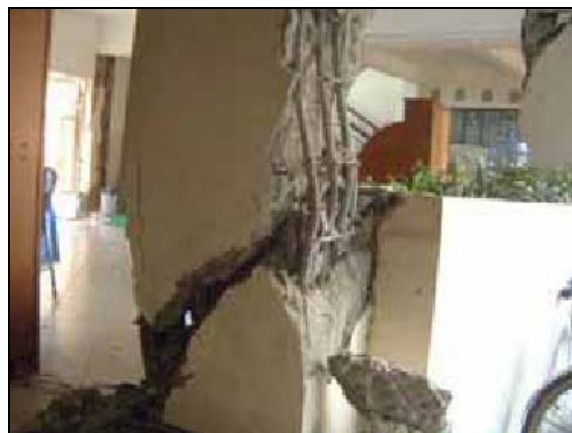
(d) Shear failure of column

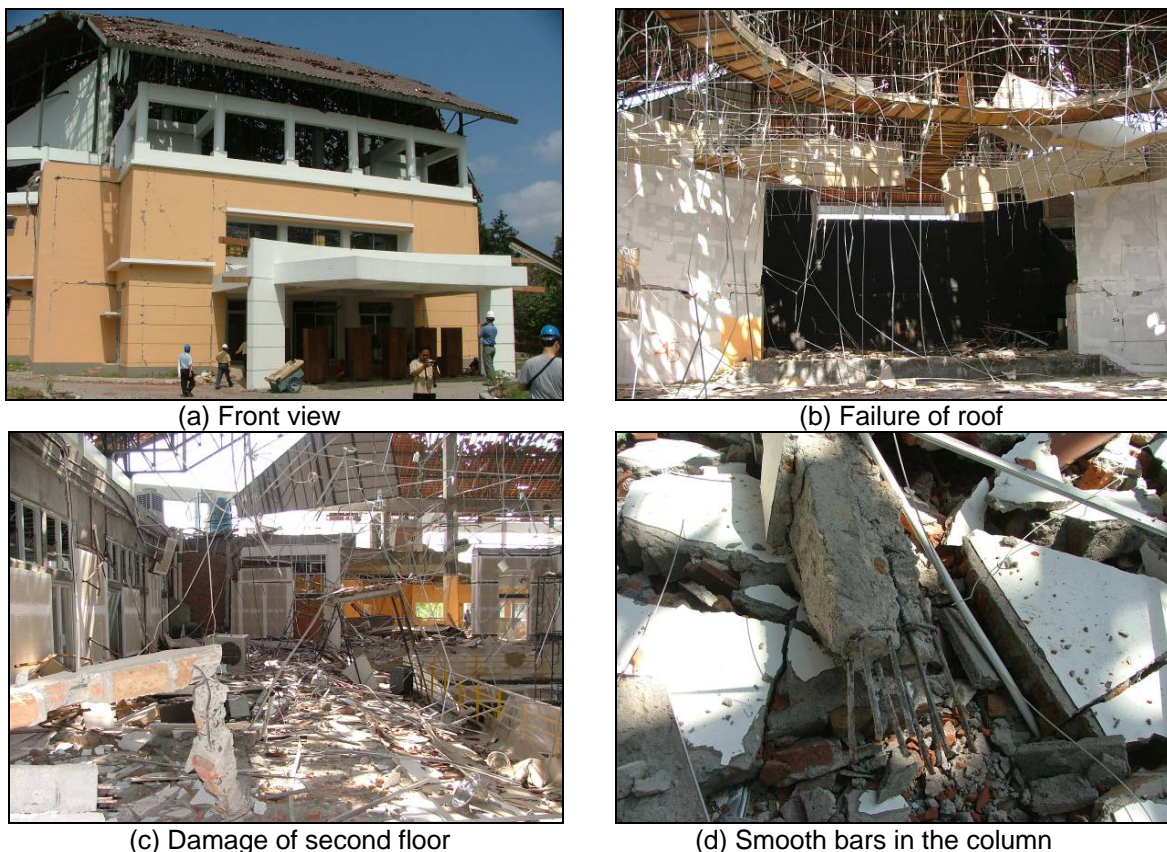
Figure 5.7 Damage of Multipurpose Building, UIN (S7° 47.162' -E110° 23.574')

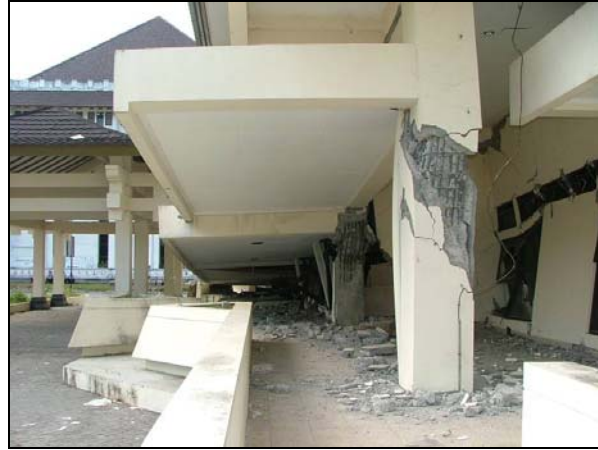
(b) Exterior right column

Figure 5.10 Failure of exterior columns in IAI

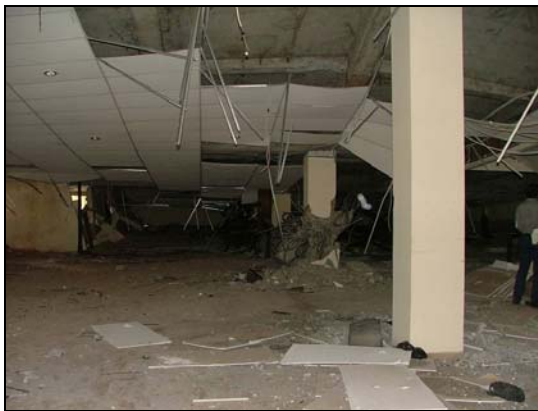
(a) Failure of interior columns

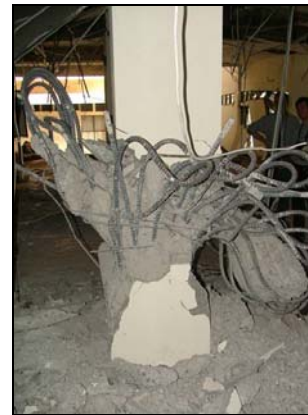
(b) Closeup of failed column, left

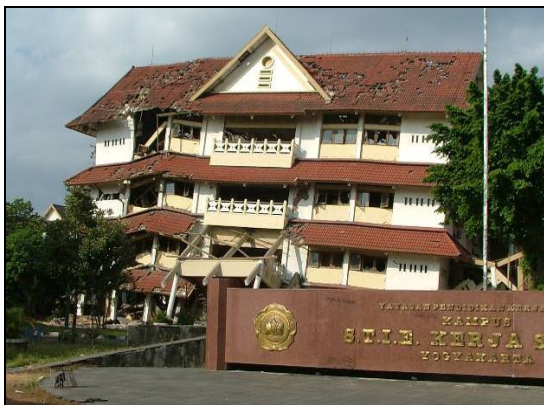
Another educational institution inspected by the MAE Center Team was the University of Economic Science (STIE – Sekolah Tinggi Ilmu Ekonomi Kerja Sama). There were two almost identical buildings on same site, while the damage levels were very different. Figure 5.12 shows that the first storey of the left building collapsed by soft storey while the right building sustained heavy roof damage.

(a) Heavy damage by soft story at left site

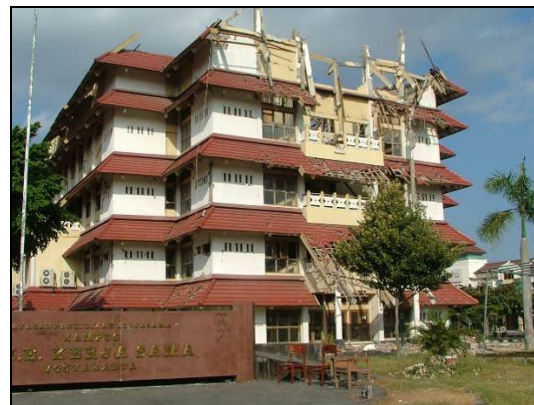
(b) Survival with minor damage at right site

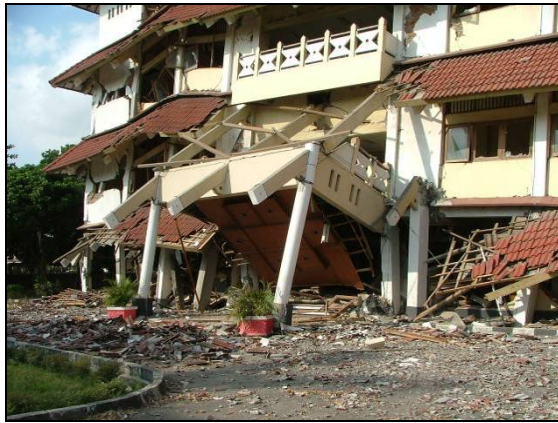
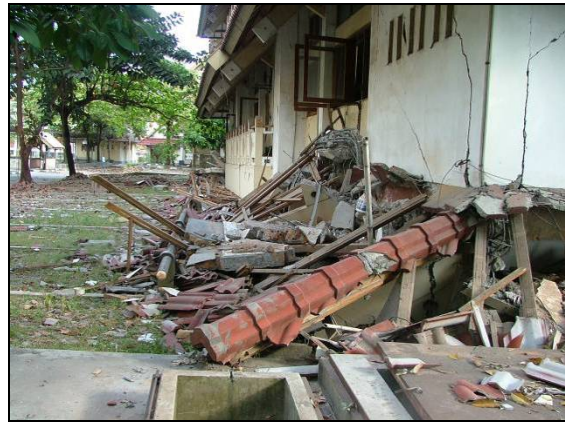
Figure 5.13 Soft first storey of the left building in STIE

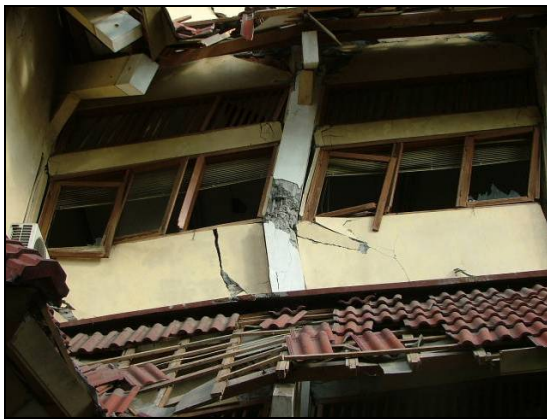
(a) Damage due to short column effect

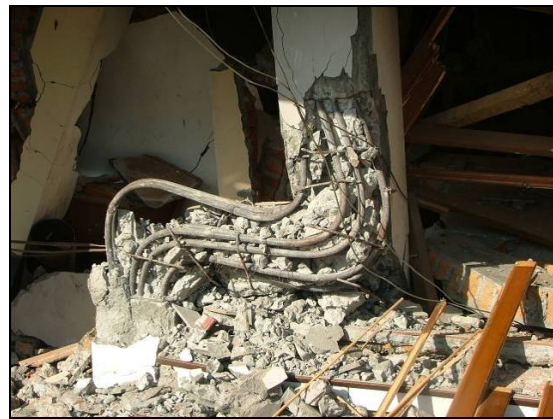
(b) Smooth bars in column

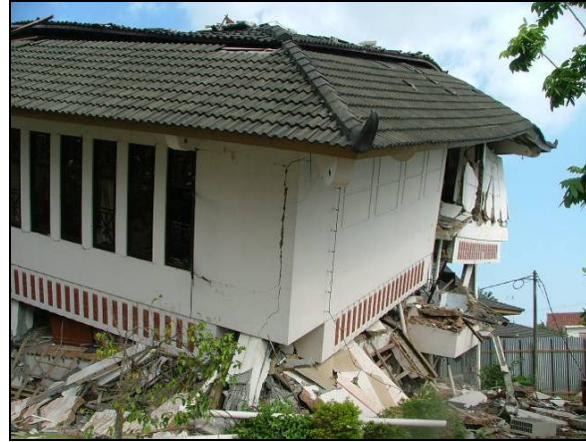
(b) Collapsed right side of building

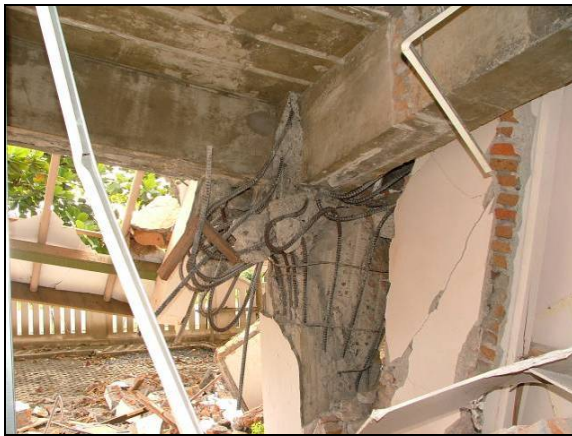
(a) Failure at beam column joint

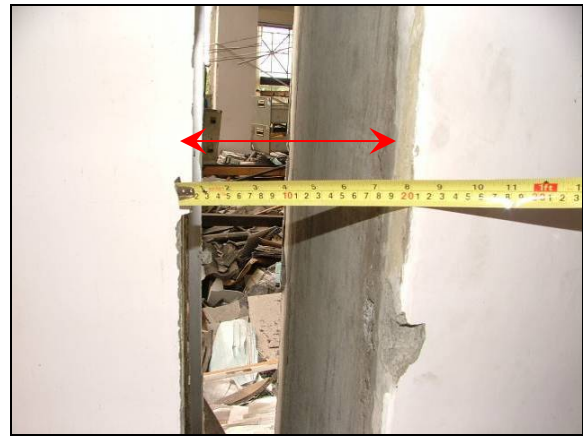
(b) 8" gap between left and right parts of building

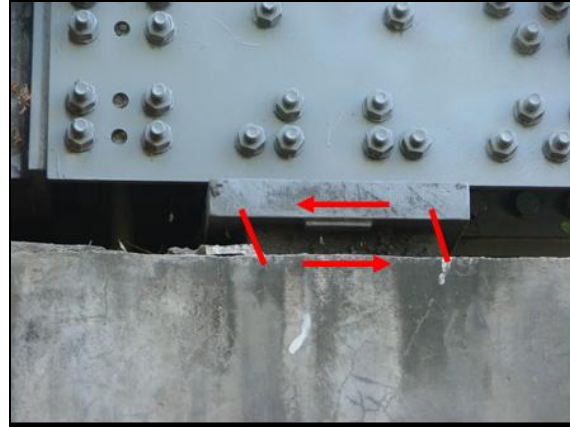
Figure 5.17 shows the damage of the Winongo Bridge in Yogyakarta City. It is a warren truss bridge with a deck. The bridge experienced slight damage at the expansion joint that did not cause closure. There was conspicuous movement of the deck in the longitudinal direction, confirmed from the deformation of the rubber bearing as shown in Figure 5.17(b). Sliding of an embankment and heavily damaged residential housings was observed in the vicinity of the structure.

(b) Evidence of deck movement

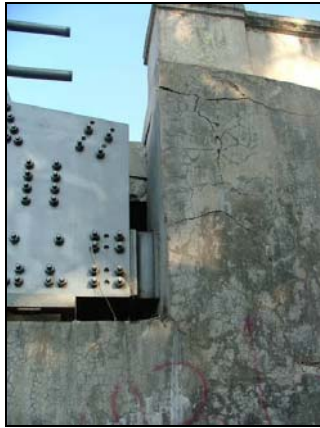
(c) Cracking of abutment

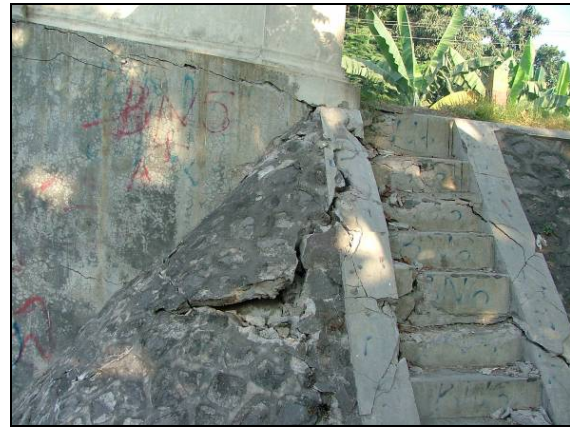
(d) Settlement of approach embankment

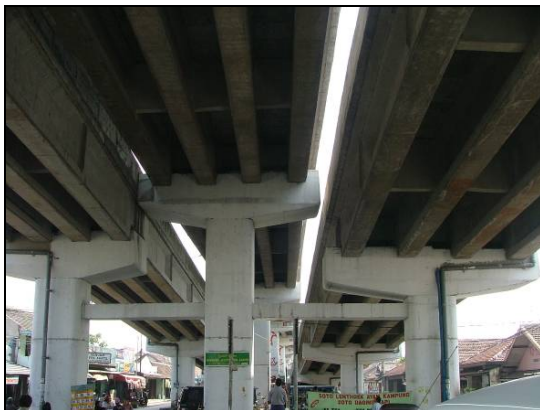
The MAE Center Team also inspected an overpass structure (Figure 5.18). Visual inspection of the bridge confirmed that there was serious damage from the earthquake. The cause of the damage was thought to be due to pounding between the bridges as Figure 5.18 shows no gap between the adjacent structures. However, inspection of the design drawings obtained from the designers (Figure 5.19) showed that the different gap sizes were in the original design.

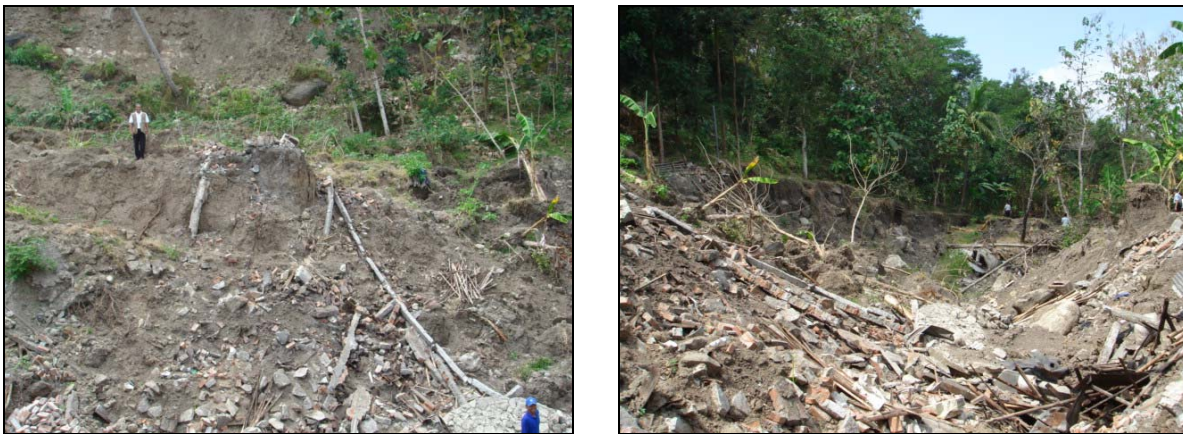
The landslide shown in Figure 6.1 occurred at Nglepen - Sengir (Sumberharjo village, Prambanan). Based upon visual inspection and discussions with local residents the affected area was approximated to be 500 meters long, 30 meters wide, and 30 meters deep. However, it is not clear whether the landslide was triggered solely by the earthquake. Researchers from Gajah Mada University reported the existence of karstic cavities within the area. Moreover, a water-way had been observed near the area following the earthquake (Ehime University, 2006). These findings thus support speculation that the earthquake caused the collapse of an underground cavity near the area that in turn triggered the landslide.

Figure 6.1 Landslide at Nglepen - Sengir (S7°49.02' - E110°30.371' - 422m altitude)

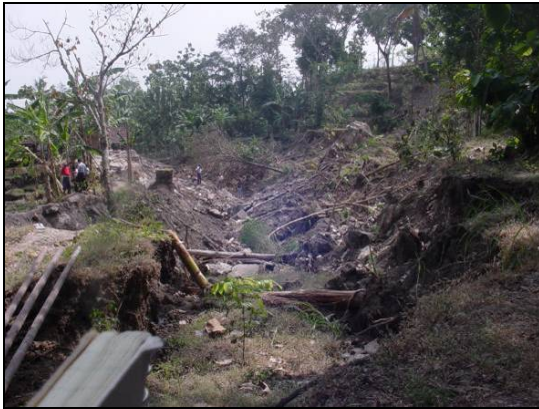
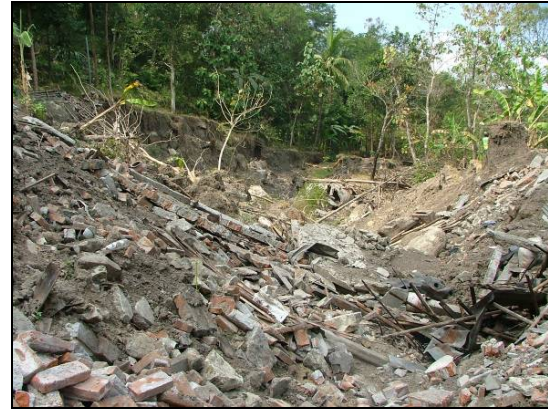
In several areas building foundations were severely affected by ground deformation caused by the landslide. Figure 6.2 shows a combination of ground slumping and landslide on the hillside at north of the OPAK fault. Housing units built on the hillside were heavily damaged or totally collapsed due to ground failure. Figure 6.3 (a) shows large ground cracks running through the village whilst Figure 6.3 (b) shows complete collapse of housing units.

(a) View from starting point of ground slumping
Figure 6.2 Ground slumping at Nglepen - Sengir (Sumberharjo village), north of OPAK fault ($S7^{\circ} 49.02'$ - $E110^{\circ} 30.371'$ and altitude of 422 m)

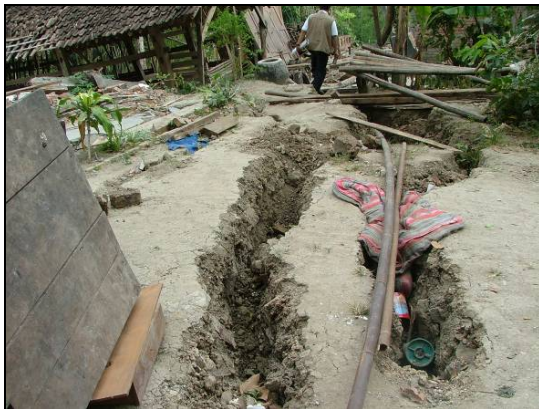
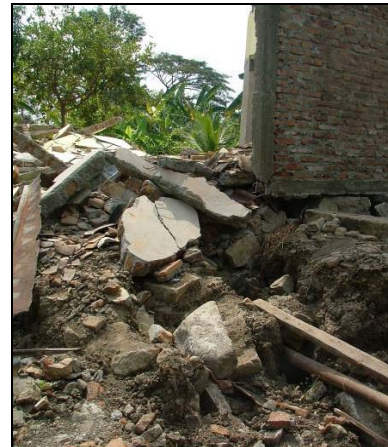
(a) Ground cracks near residential area
(b) Collapsed house
Figure 6.3 Housing collapsed by ground failures

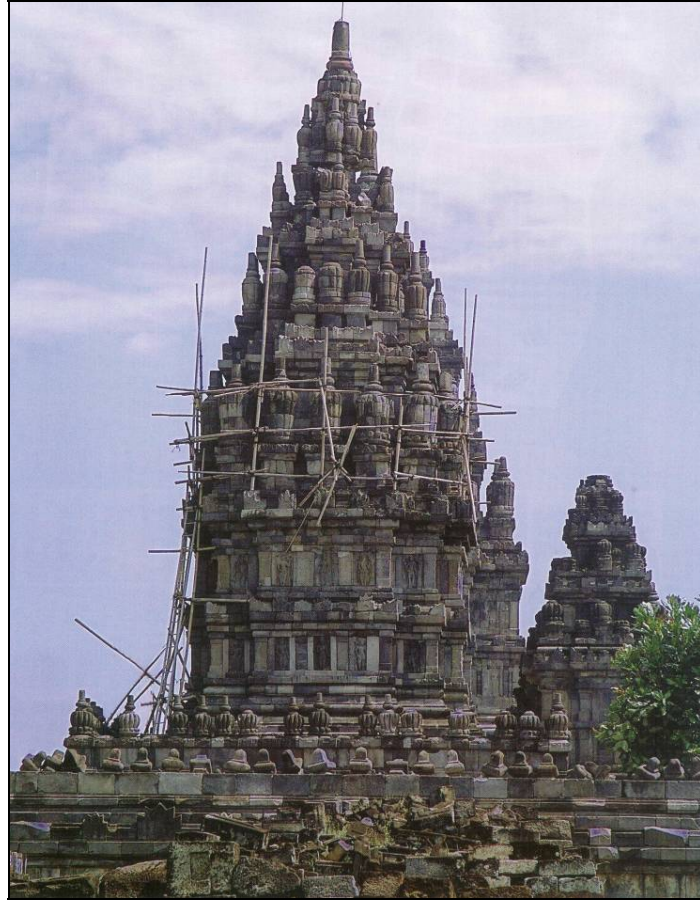
Figure 8.3 Observed state of damage of Prambanan Temples

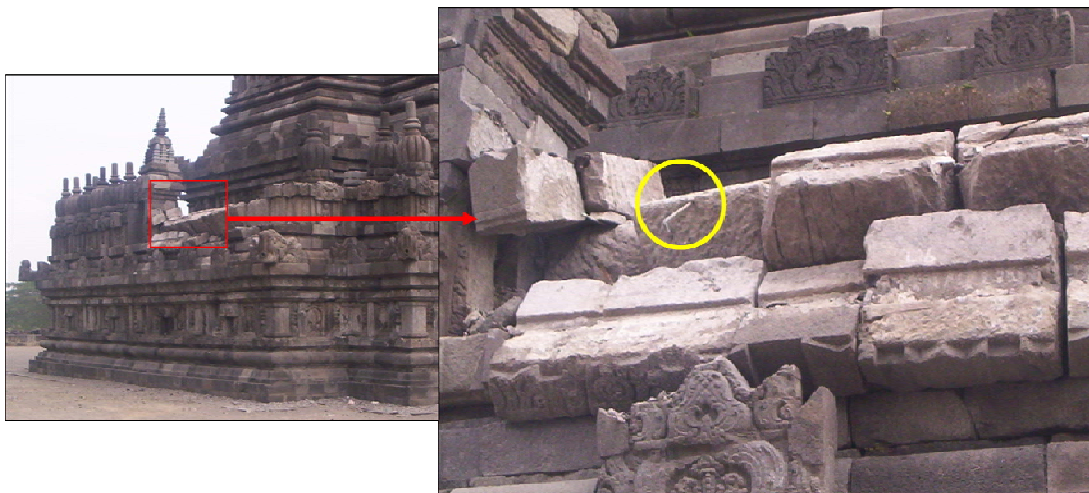
Figure 8.4 Damage to Prambanan and previous retrofitting with steel dowels

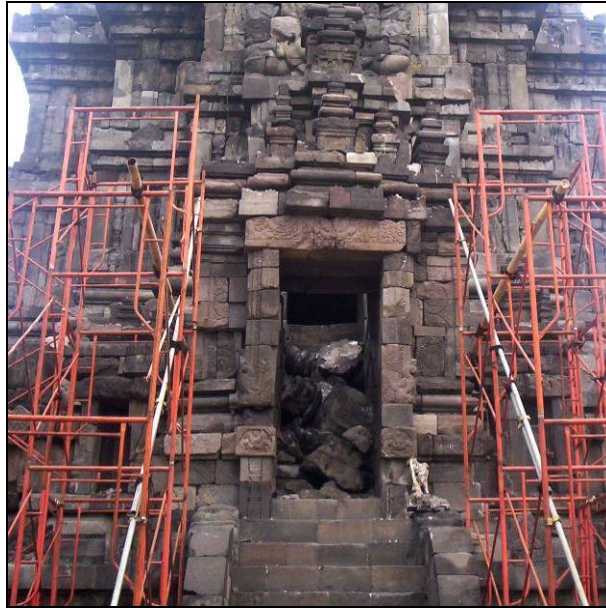
Figure 8.5 Evidence of internal heavy damage; stones shown on the staircase
