The Pisco-Chincha Earthquake of August 15, 2007

Seismological, Geotechnical and Structural Assessments

Mid-America Earthquake Center

MAE Center Report No. 08-01

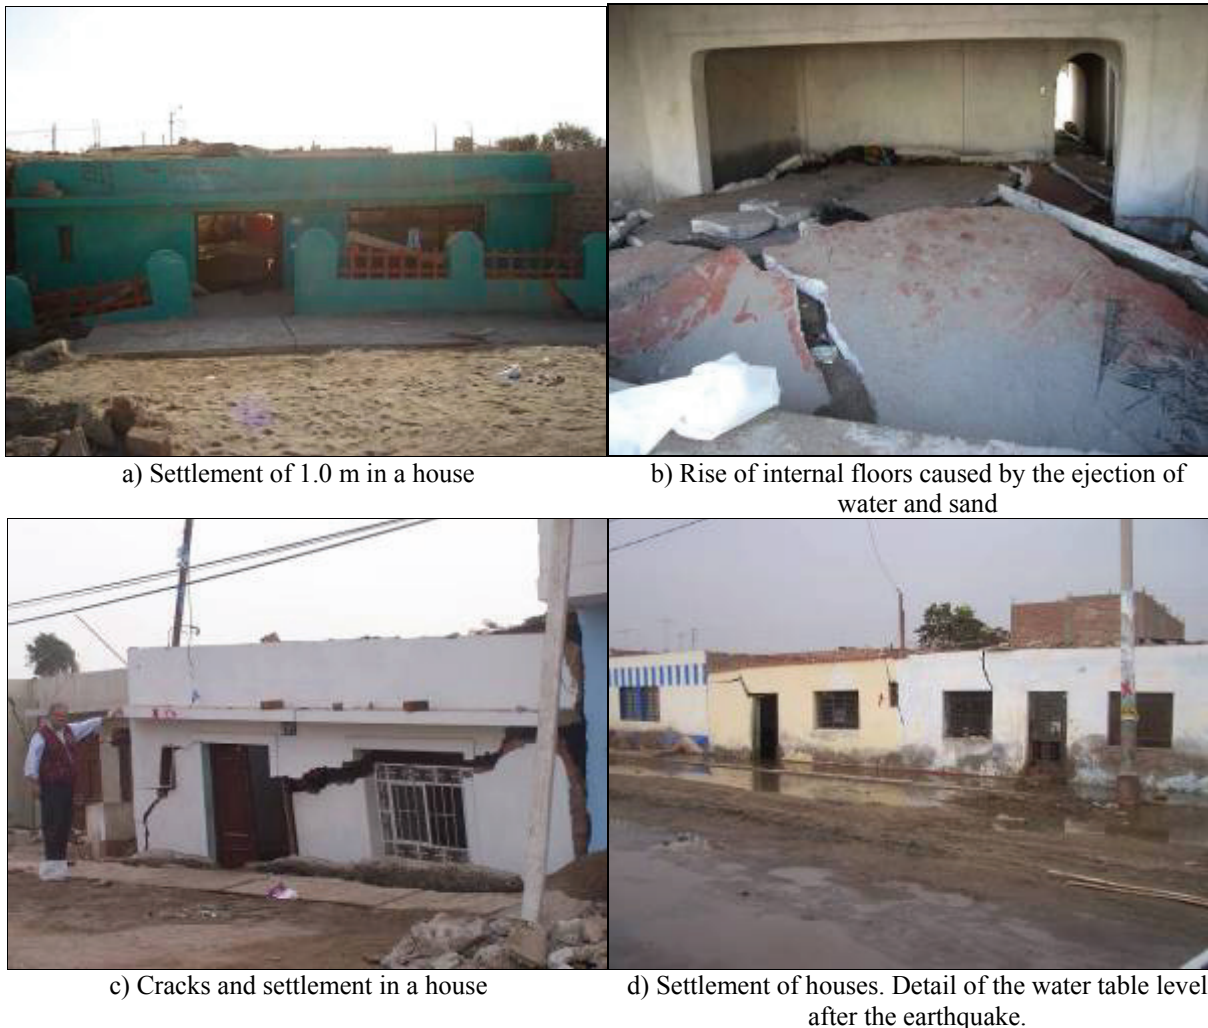
It was observed that in some zones foundations and structures were severely affected due to ground settlement and liquefaction, which caused the reduction of soil bearing capacity and lateral displacement. The greatest foundation damage was observed in the Tambo de Mora District, where some houses collapsed due to soil liquefaction. This District is located in the Province of Chincha on alluvial and sea deposits. The water table in the zone is high (0.5 to 1.0 m), reaching in some places the ground level, as it is observed in Figure 5.3. A large amount of damage was observed on Alfonso Ugarte Street. There, the houses suffered settlements up to 0.90 m and the rise of the internal floors due to the ejection of water and sand originated by soil liquefaction. In this zone, large cracks were observed, and were extended on houses and roads. Local residents declared that in some cases the water ejection reached more than 1.0 m above ground level.

Figure 5.3 House damage caused by the settlement of foundations. Alfonso Ugarte Street in Tambo de Mora District

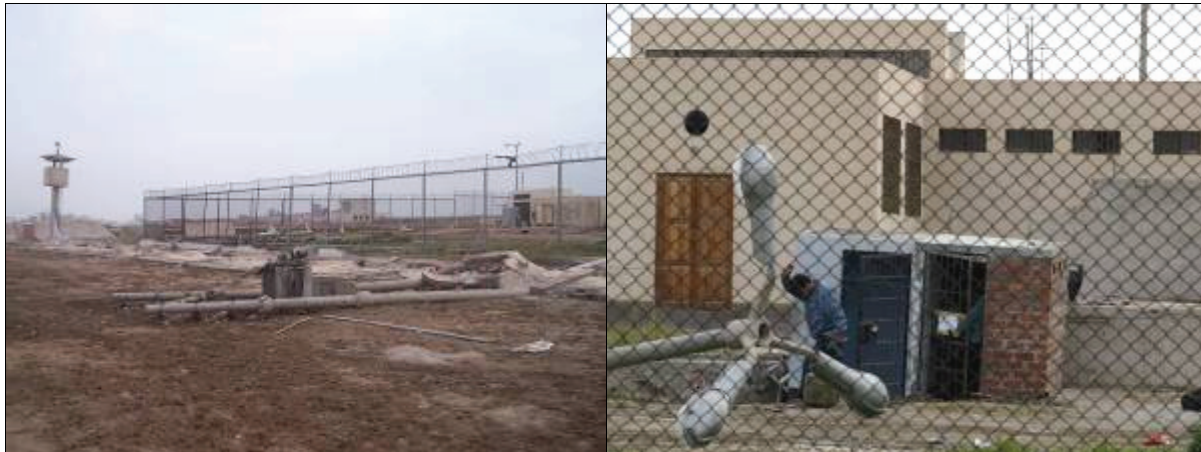
The building foundations of the National Penitentiary Institute of Chincha in Tambo de Mora were also affected during the earthquake due to settlements and lateral displacement that caused structural collapse, Figure 5.4. House foundations in the zone of Independencia, Canchamana and Pisco Playa in the Province of Pisco also suffered settlement due to the liquefaction phenomenon; in some zones, the collapse of potable water and drainage pipelines was observed, Figure 5.5. The foundations of some electric power line poles, located along the South Pan-American (SPA) highway, were affected by cracks in the road, producing many fallen poles, Figure 5.6. In an area close to Lima City, in the 70.5 km of the Pan-American South highway, in the residential zone called Las Lagunas, structural damage in some houses made of bricks and concrete columns and beams was observed. This damage was caused by soil settlement and displacement originated by soil liquefaction. These houses were built surrounding a small artificial lake formed by dragging the sand of the place. The lake water level is the same water table level of the zone, Figure 5.7.

a) Collapse of walls and high-voltage poles

Figure 5.4 Damage in the National Penitentiary Institute of Chincha originated by lateral displacements and foundation settlements

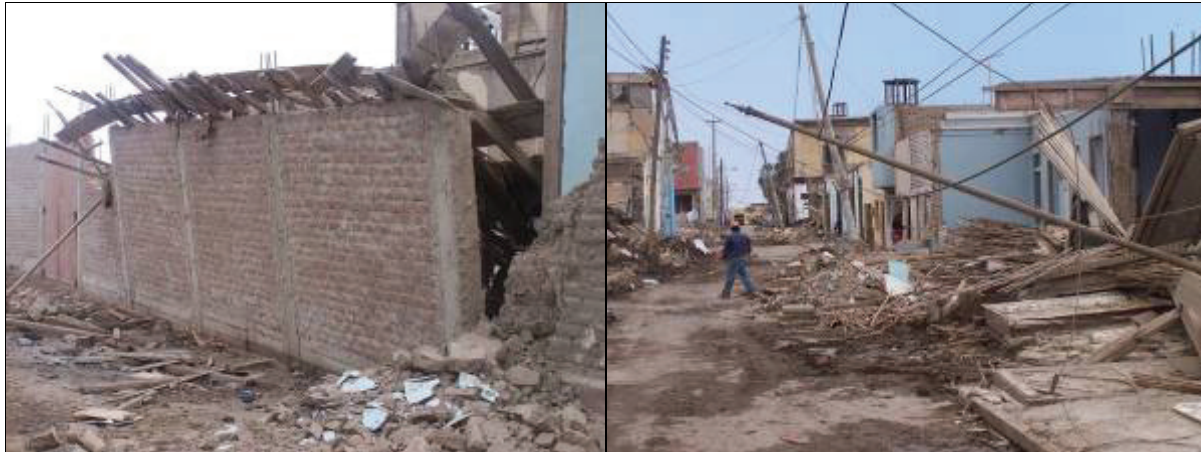
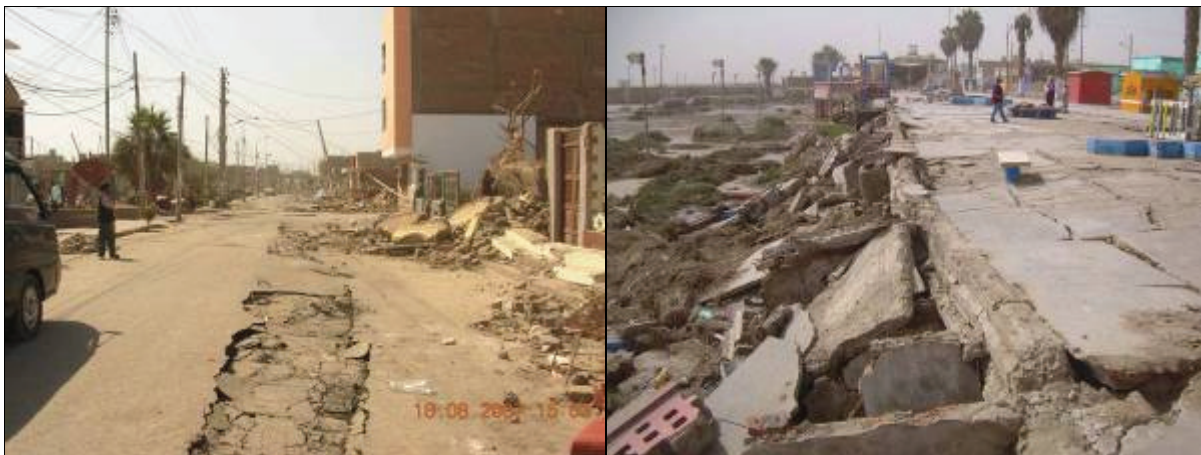
a) Structural settlement in Pisco Playa

b) Leaning electricity poles in Pisco Playa

c) Damage in Malecón Miranda

Figure 5.5 Damage in structure foundations in Pisco

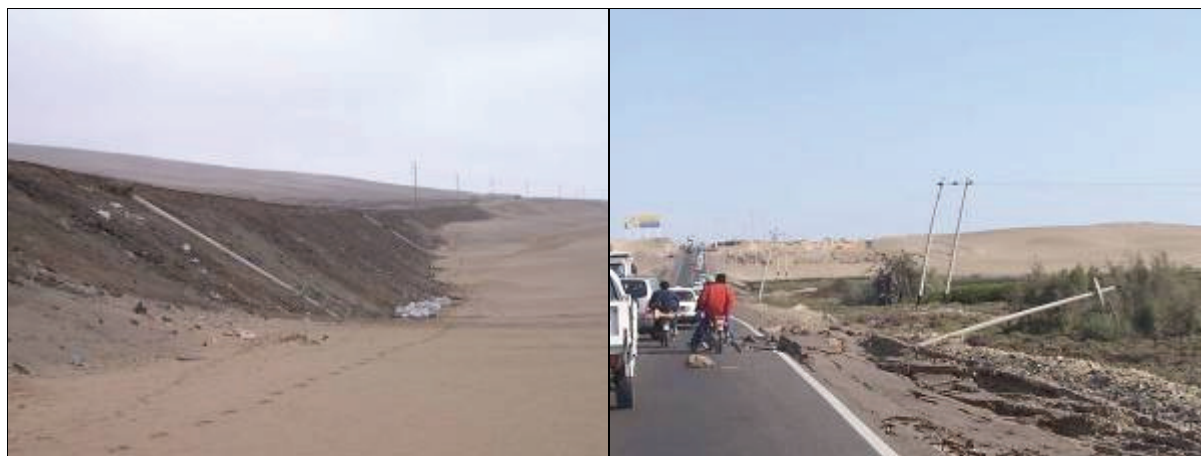
a) Fall of poles in the 78 km of the South Pan-American Highway

Figure 5.6 Toppling of poles along the Pan-American Highway caused by ground failures

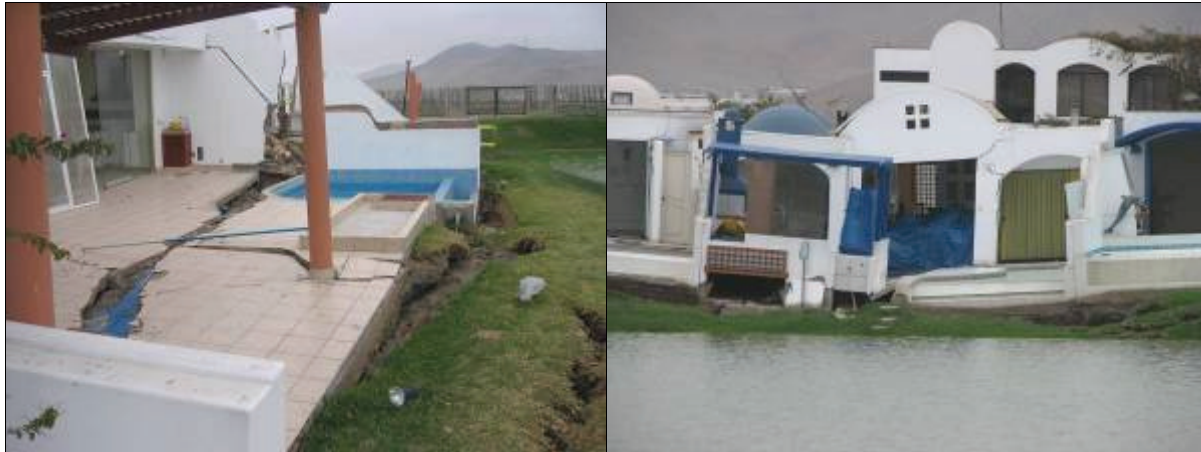
a) Settlement of houses next to the lakeshore b) Cracks in houses due to soil displacement
 Figure 5.7 Damage in Las Lagunas at 70.5 km along the Pan-American South highway

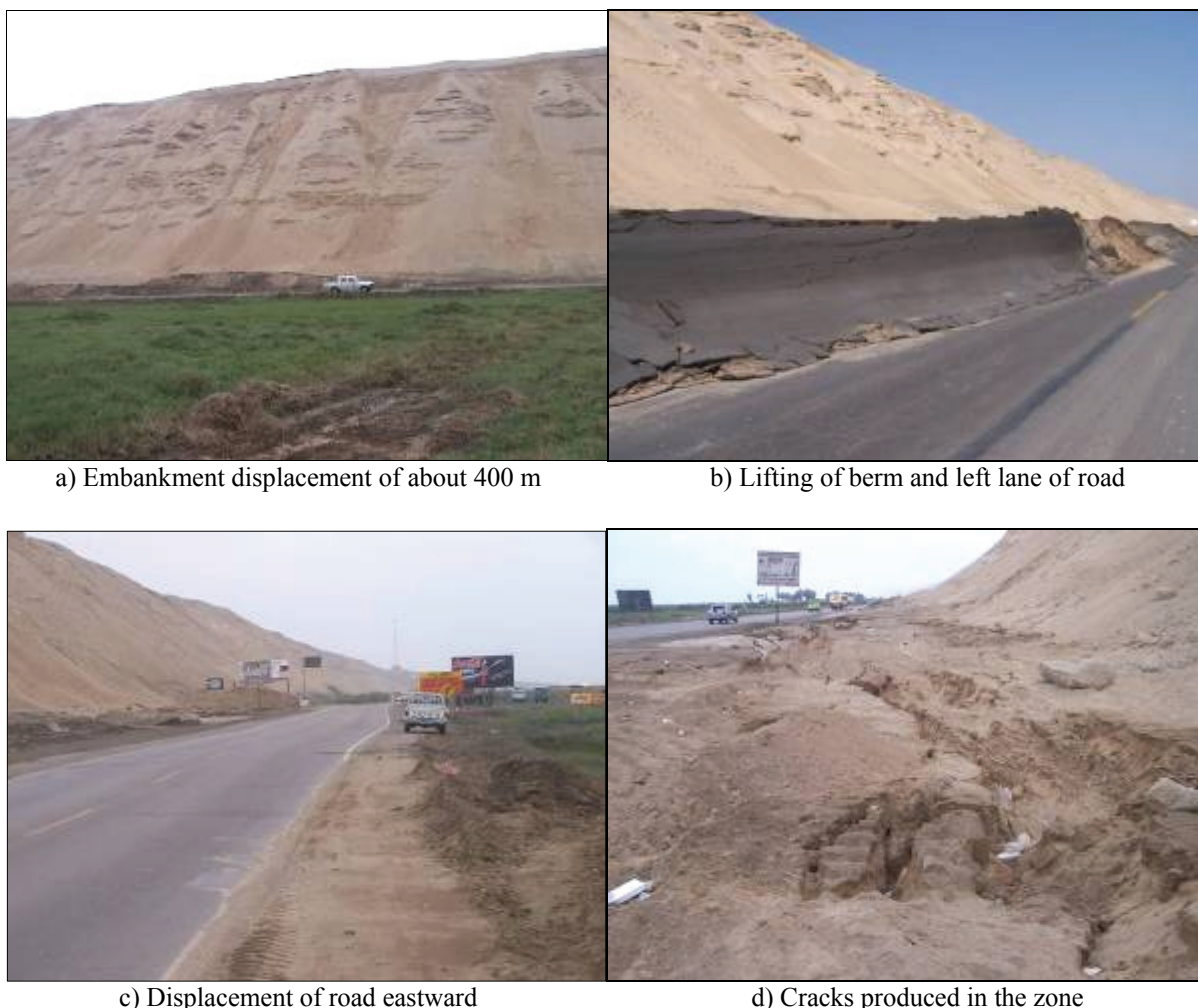
In the zone of Jahuay in the Province of Chincha, at the 188 km mark of the SPA Highway, the failure of a slope was observed, which had a length of approximately 400 m, Figure 5.8. This failure was induced by the liquefaction of a slope foot with height of about 50 m, which has been formed by typical wind deposits of The Cañete Formation. The lateral berm and the pavement of the left road lane were lifted about 3 m due to the displacement of the hill, which caused the rise of the road embankment and, as a consequence, the observed displacement eastwards. On both sides of the road large cracks and craters were observed. A local resident related that a particular crater ejected water up to 1 m above the ground level.

a) Embankment displacement of about 400 m

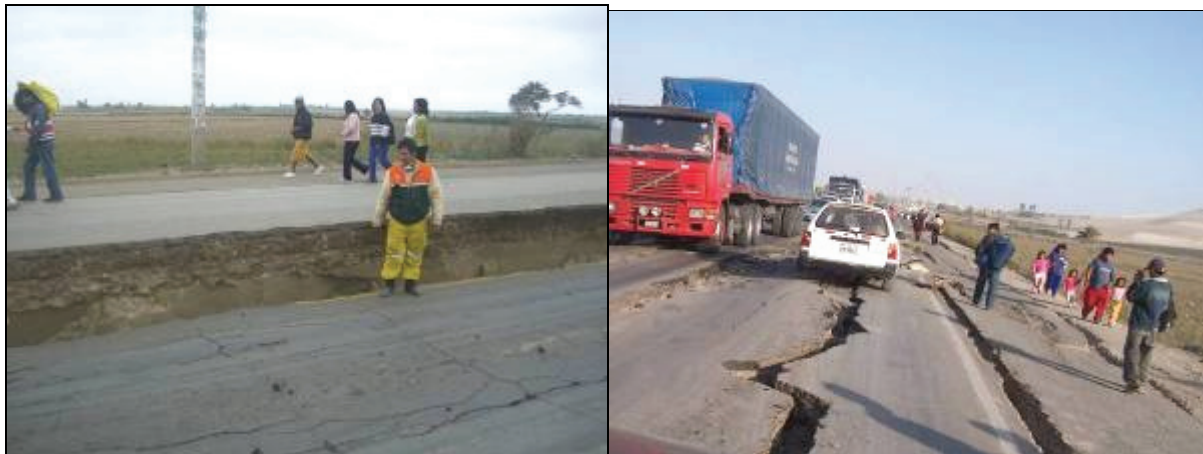
The lateral displacements caused by ground liquefaction originated multiple damages in the SPA Highway. In the Jahuay and San Clemente areas cracks in the pavement and surrounding places were observed, which caused a difference in height of 50 cm between the road borders, causing a traffic jam, Figure 5.12. In the area of the Huamaní Bridge, on the Pisco River, some ground displacements that caused fractures in berms and pavement were observed. Likewise, the liquefaction occurrence in the area where the bridge is located was confirmed by the presence of sand ejections in the ground surface cracks, Figure 5.13.

a) Large drop in a road lane

Figure 5.12 Cracks in the SPA Highway Caused by ground liquefaction in San Clemente

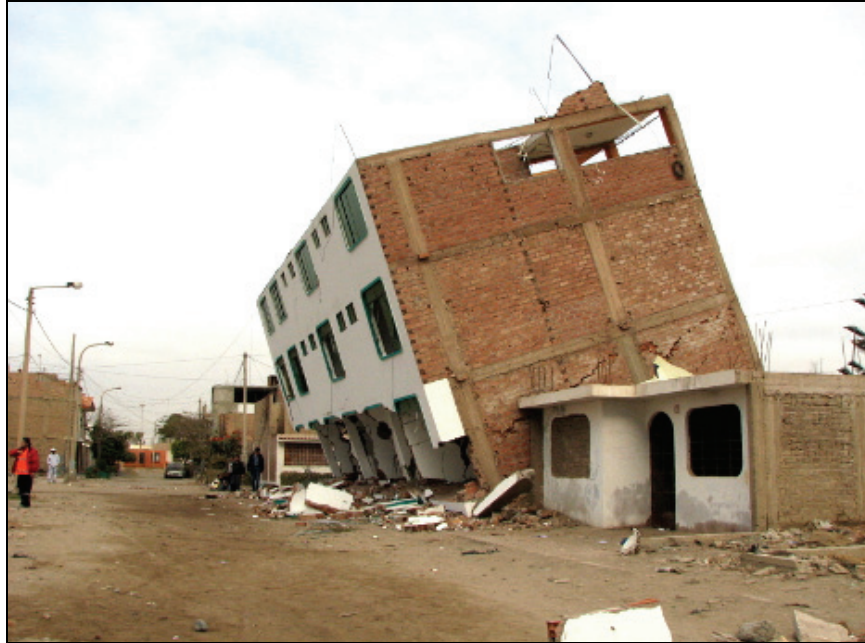
In Figure 6.13, the first story was used as a parking lot. In comparison with the massive second and third stories, first story was very weak. This picture shows the typical failure mode of a building with soft story. Figure 6.14 shows columns and cars crushed by the weight of the building.

Figure 6.13 Soft story collapse of RC structure-1

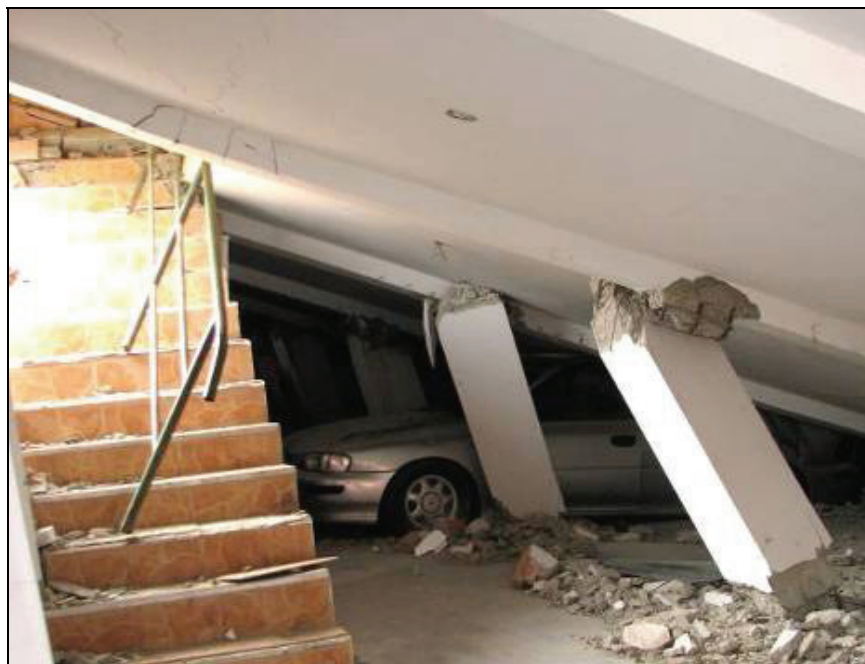
Figure 6.14 Soft story collapse of RC structure-2

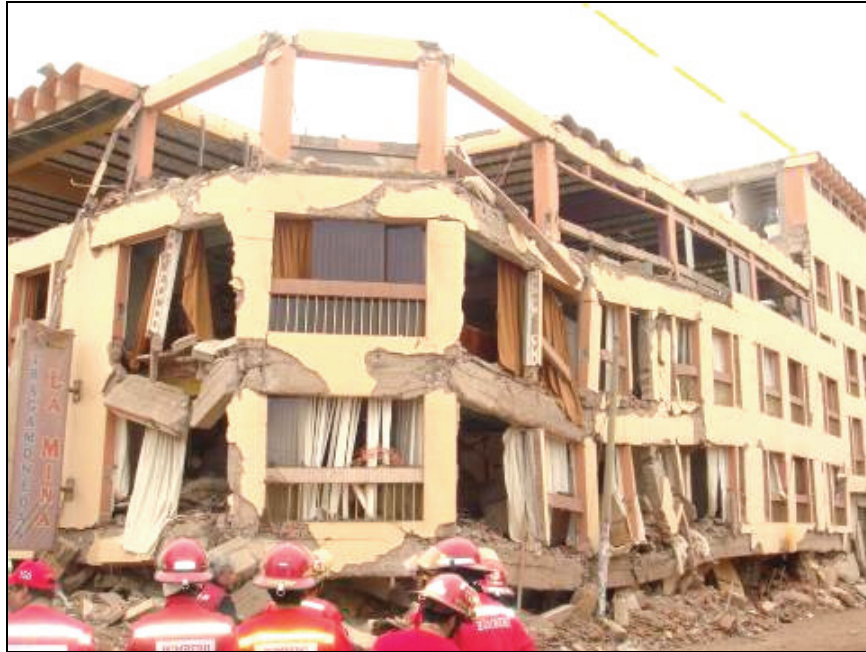
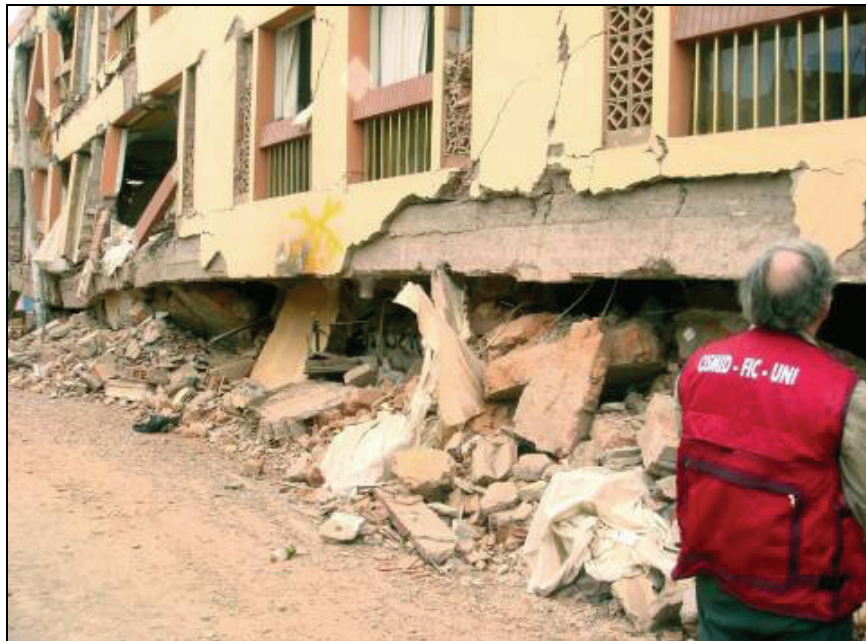
Figure 6.15 and Figure 6.17 show a reinforced concrete building used as a hotel. It can be observed that the first story of the building was completely collapsed. Many of beams and columns on 2nd and 3rd stories were damaged. In general, integrity of structural elements was not good.

Figure 6.15 Soft story collapse of RC structure-3

Figure 6.16 Soft story collapse of RC structure-3

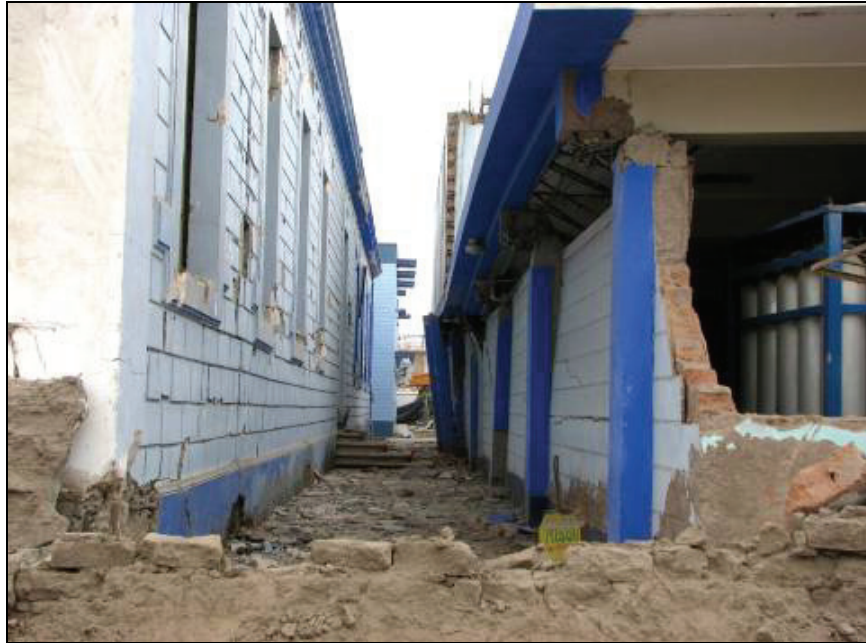
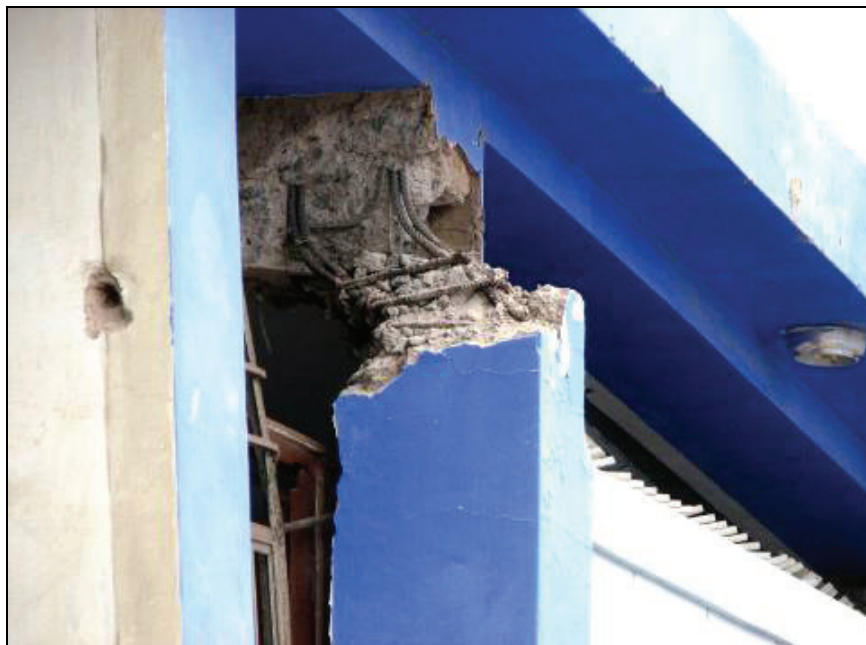
Figure 6.17 and Figure 6.18 show a building used as a part of hospital facility. The frame of the building was made with reinforced concrete. Note that the beam-column connections show shear failure mode.

Figure 6.17 Shear failure of beam-column connection

Figure 6.18 Shear failure of beam-column connection close-up

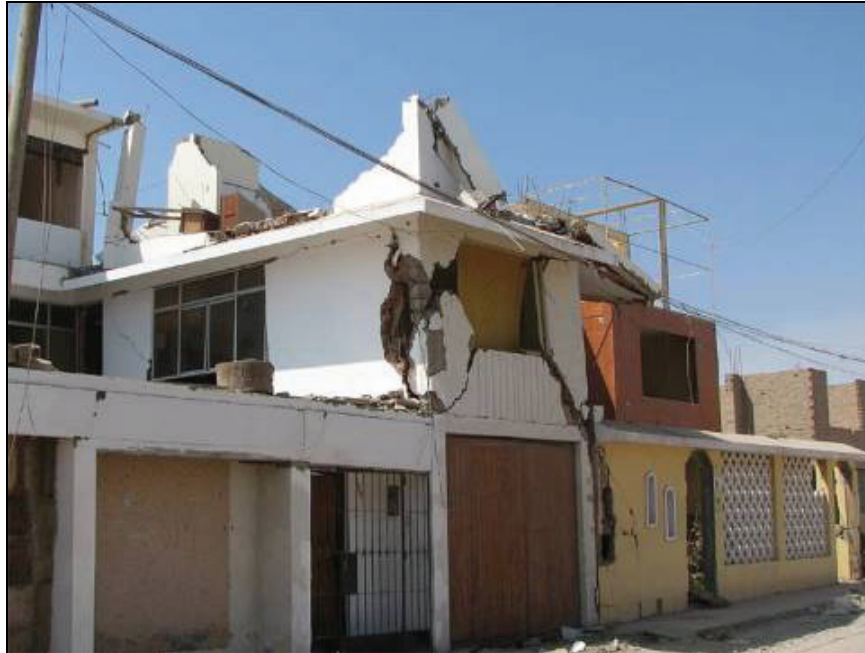
Figure 6.19 shows a reinforced column failed by shear. The column is constrained by masonry infill walls in perpendicular direction. Shear cracks were developed from masonry wall which led to shear failure of columns.

Figure 6.19 Shear failure of column

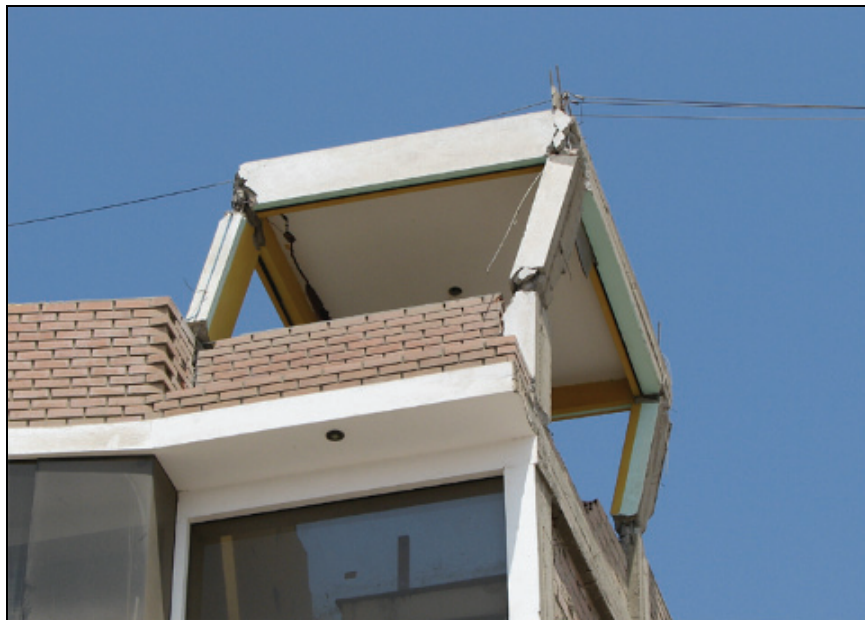
Figure 6.20 Failure due to short column effect from masonry infill wall

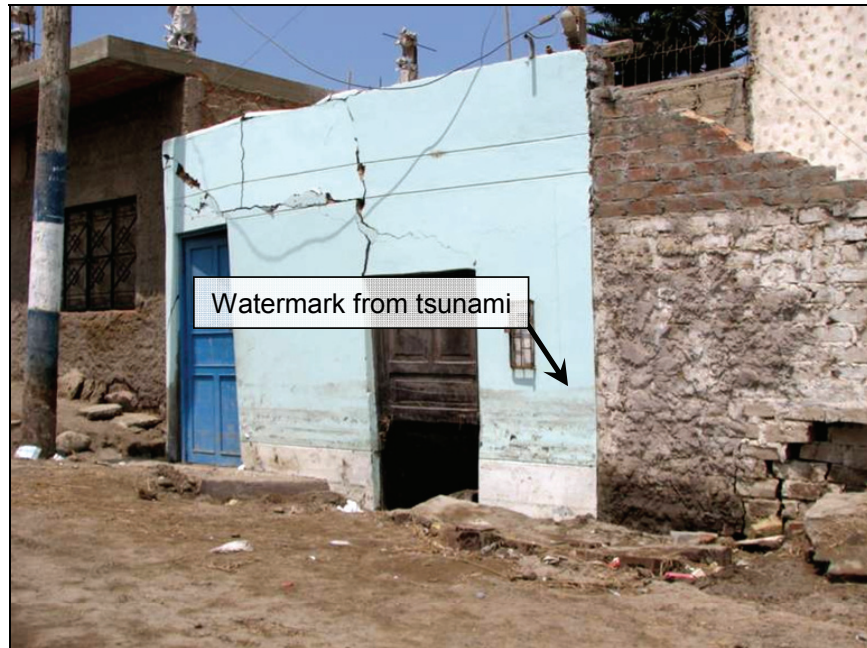
Remnants of tsunami from the earthquake were found at several buildings. Based on the watermark left on structures, the tsunami was not large enough to directly damage structures. Figure 6.25 and Figure 6.26 show evidence of tsunami.

Figure 6.25 Buildings with watermarks from tsunami-1

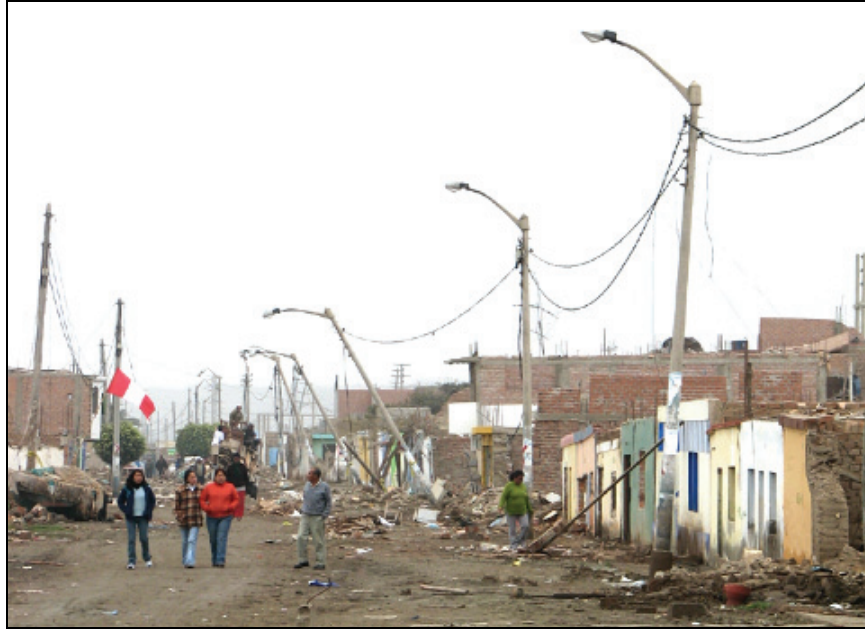
Figure 6.28 An area where most buildings were damaged due to liquefaction

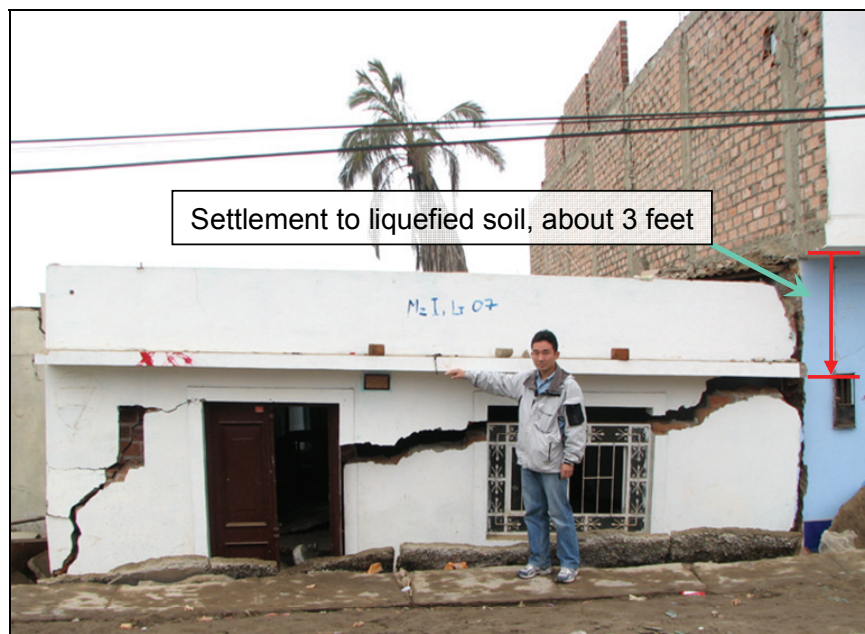
Figure 6.29 Masonry building that sunk 3 feet due to liquefaction

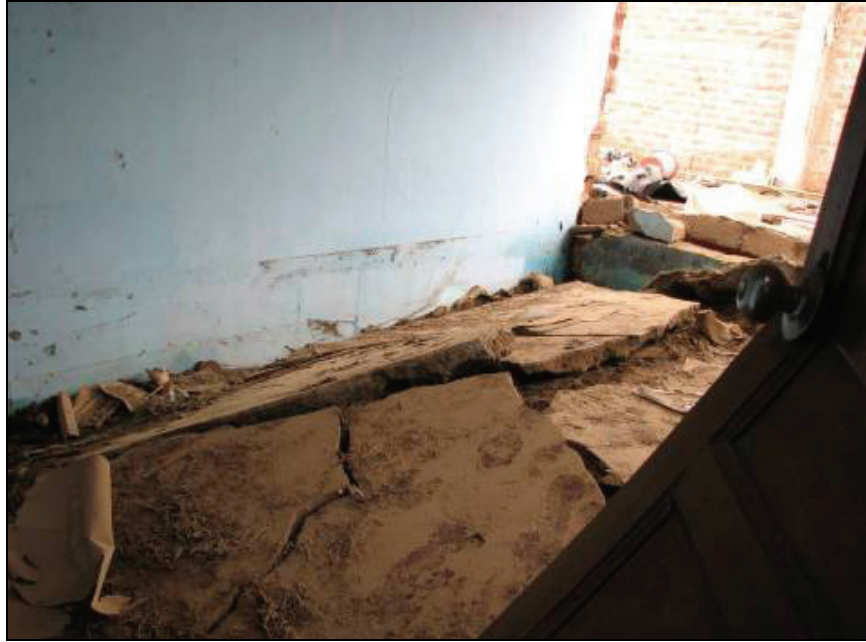
Heavily cracked floor slabs were observed in many buildings. Building walls sunk into liquefied soil. The slabs were not strong enough to resist the differential pressure. Liquefied soil left water marks on the wall, Figure 6.30. Even chairs sunk into the ground when the soil was liquefied, Figure 6.31.

Figure 6.30 Upheaval of floor slabs

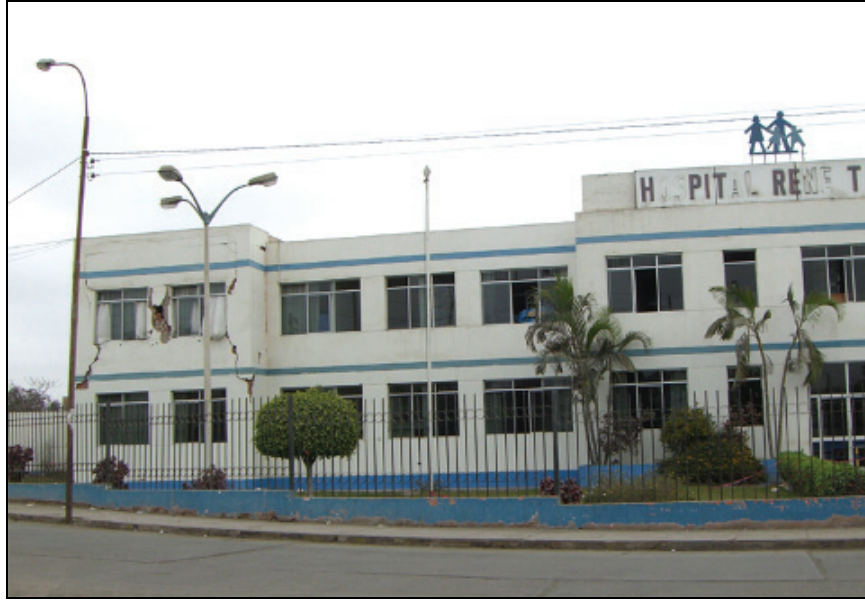
Figure 6.32 Damaged hospital building in Chincha-Alta

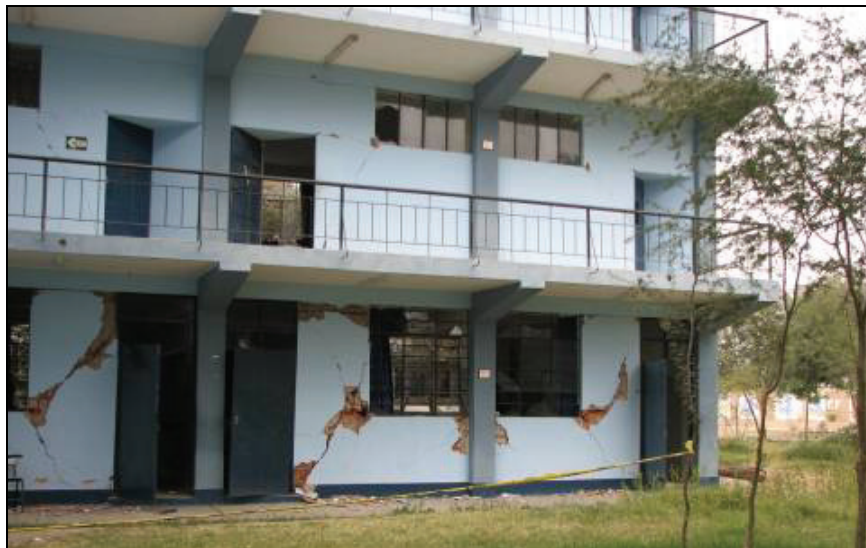
In Figure 6.33, the masonry infill walls were heavily cracked after the earthquake. In other buildings, the infill walls were almost intact while columns were damaged or totally crushed. Figure 6.34 shows interior view of the damaged building in Figure 6.33 where a column is damaged by shear. In Figure 6.35 columns of the building completely lost their load carrying capacity. This building is analyzed in Chapter 7.

Figure 6.33 Damaged infill walls of a building at the National University of Ica

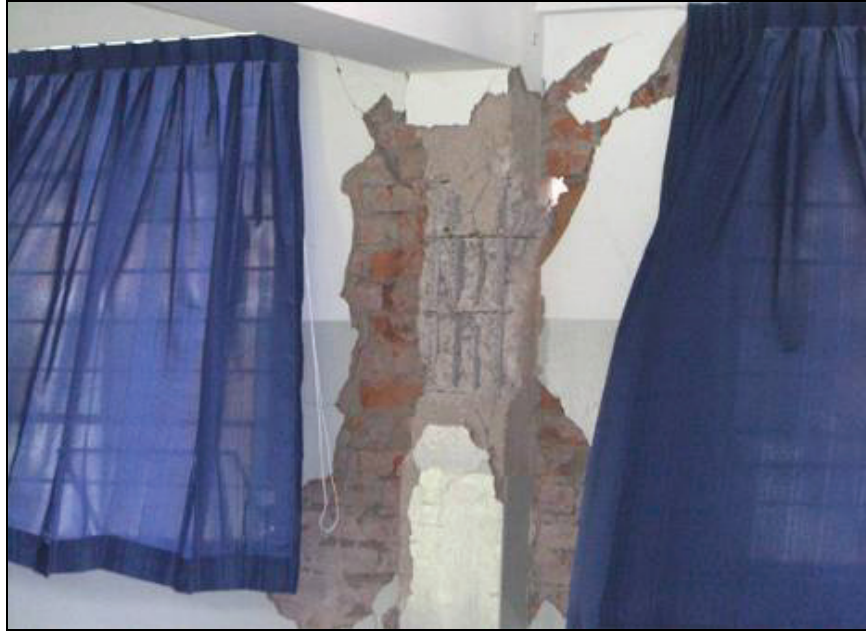
Figure 6.34 Shear failure of a column at the National University of Ica

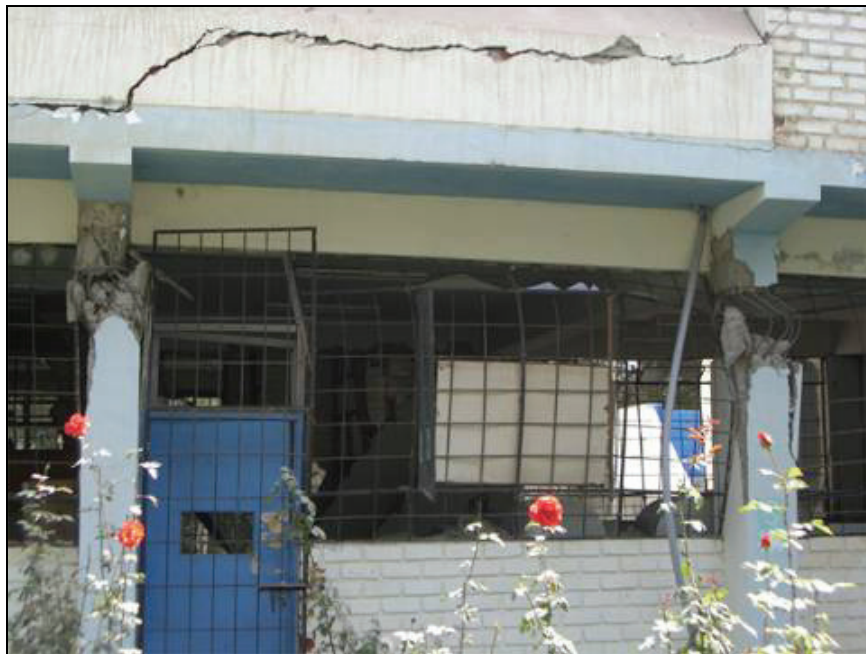
Figure 6.35 Failure of columns of a building at the National University of Ica

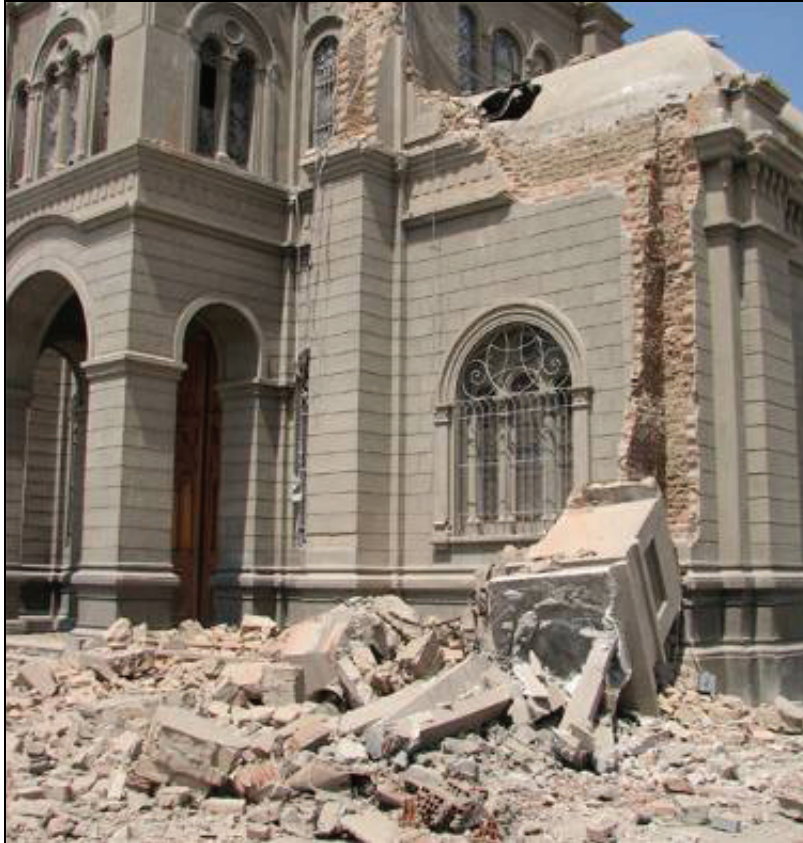
Figure 6.36 Collapse of massive masonry church building

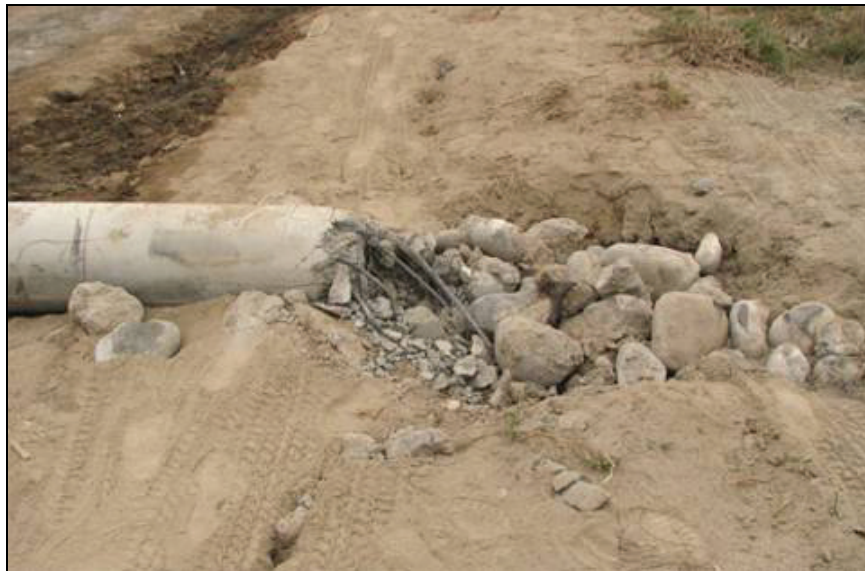
Figure 6.38 shows a failure of an electricity transmission pole. The structure, made of reinforced concrete, could not resist large moments from earthquake excitation. Figure 6.39 shows collapsed power transmission structure. The structures were supported on relatively shallow foundations on slope side which could not provide enough support. Many power transmission structures were tilted from strong earthquake excitation as depicted in Figure 6.40. The power transmission structures in Figure 6.41 and 6.42 were located at liquefied area which caused foundation failure.

Figure 6.38 Collapse of power transmission structure - structural failure

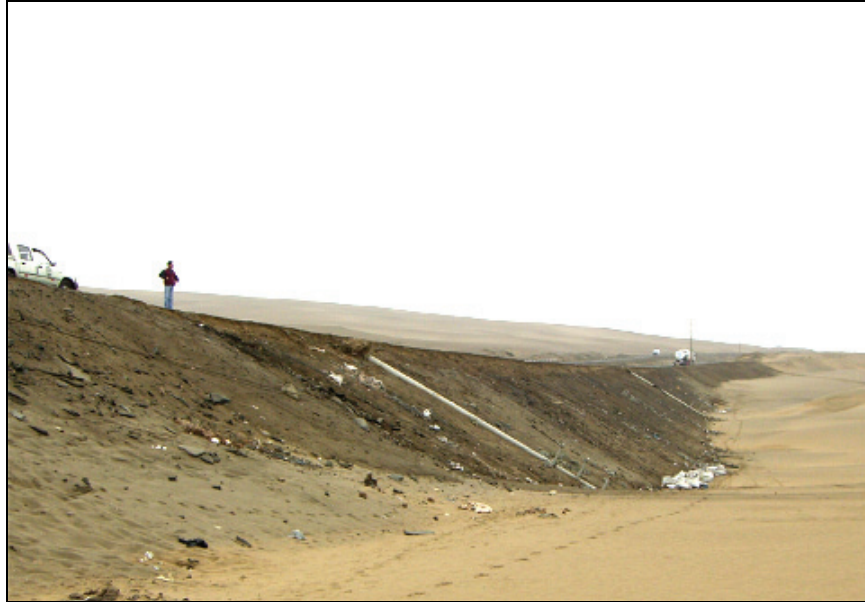
Figure 6.39 Collapse of power transmission structure - foundation failure

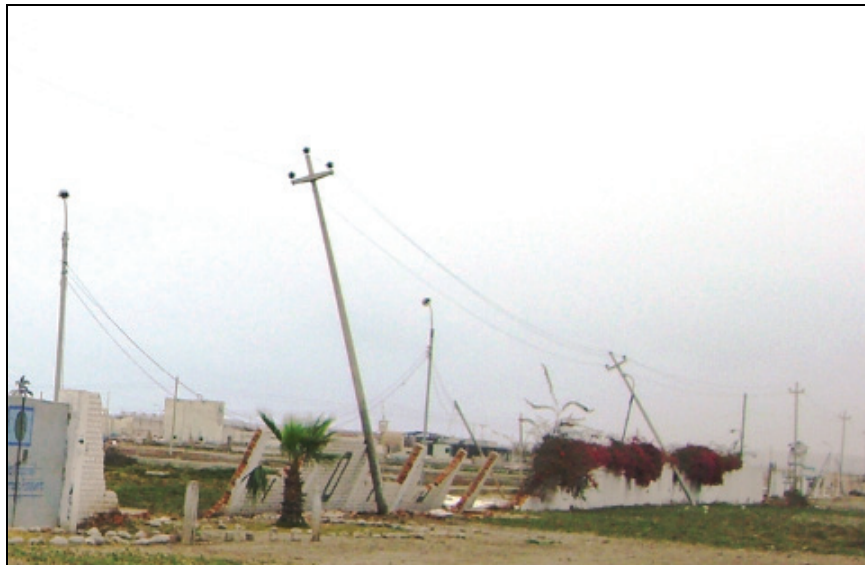
Figure 6.40 Tilting power transmission lines - foundation failure

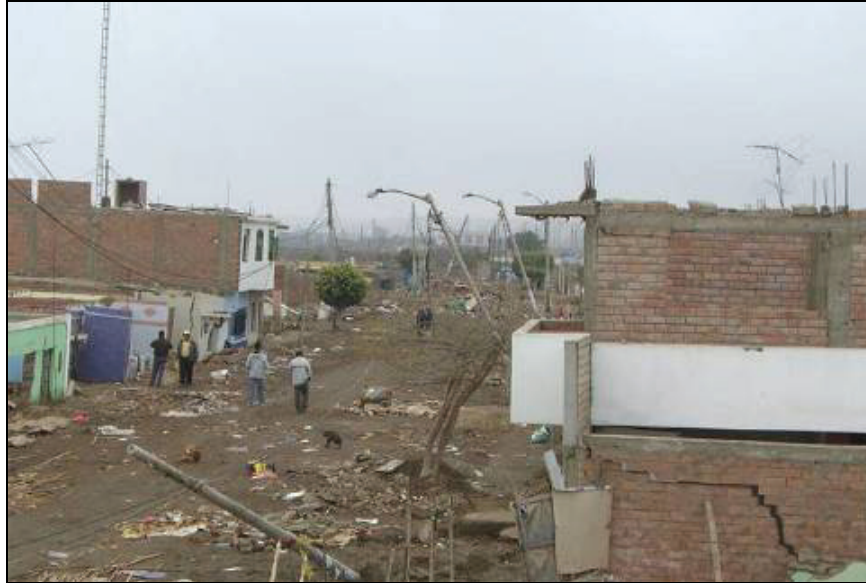
Figure 6.41 Collapse of power transmission lines

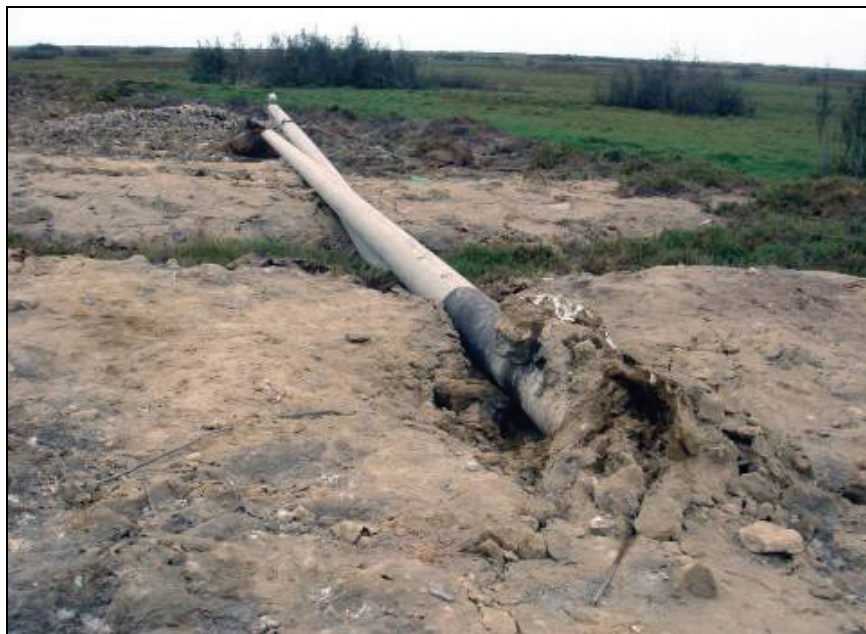
Figure 6.42 Collapse of power transmission lines

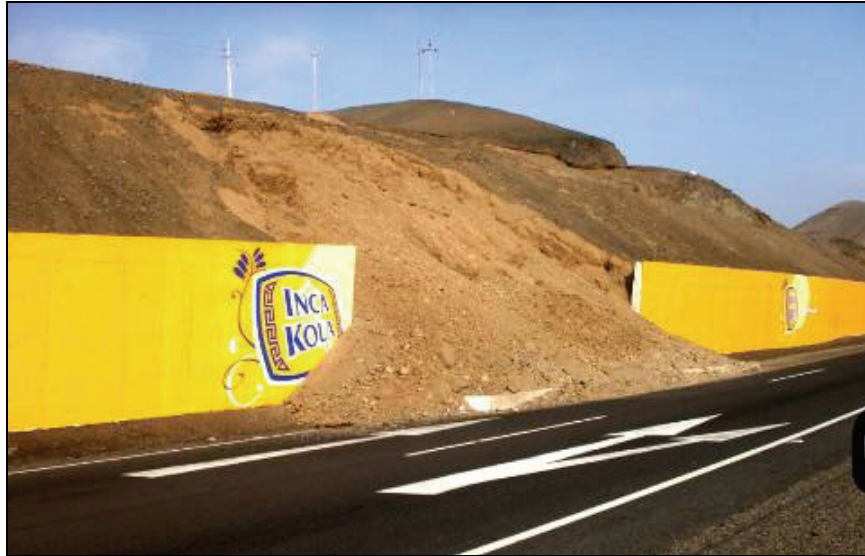
Figure 6.43 Slope failure and damage to highway

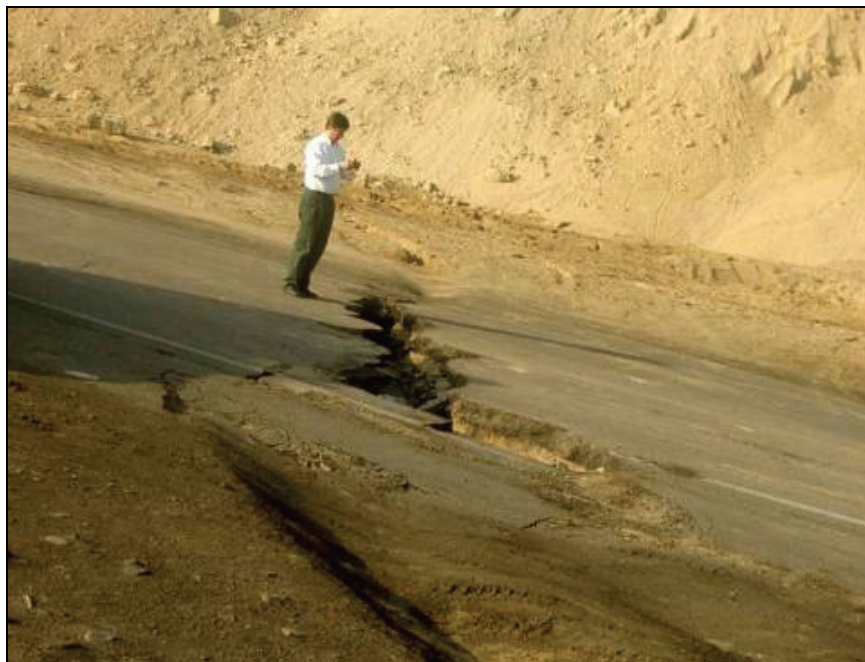
Figure 6.44 Road failure from lateral spreading perpendicular to the road

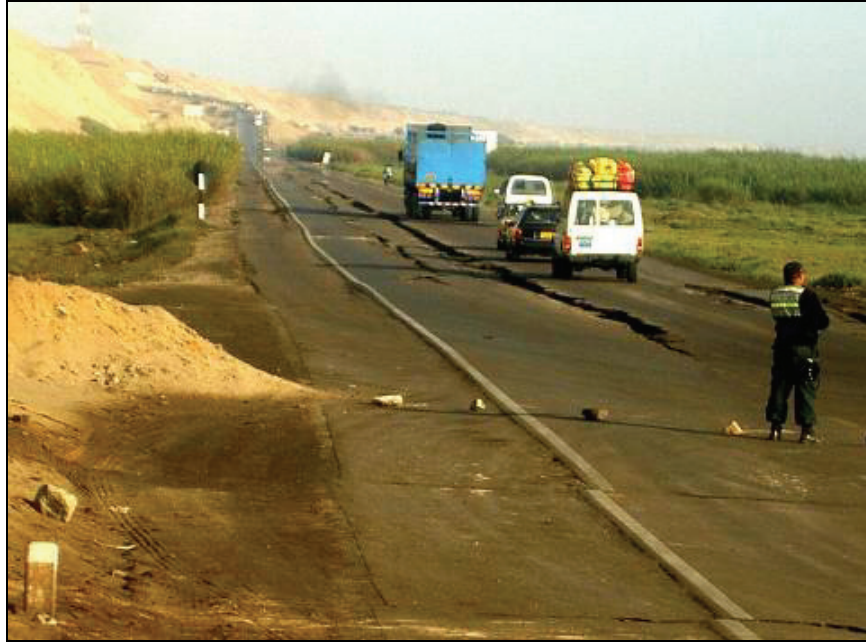
Figure 6.45 Road failure from lateral spreading parallel to the road

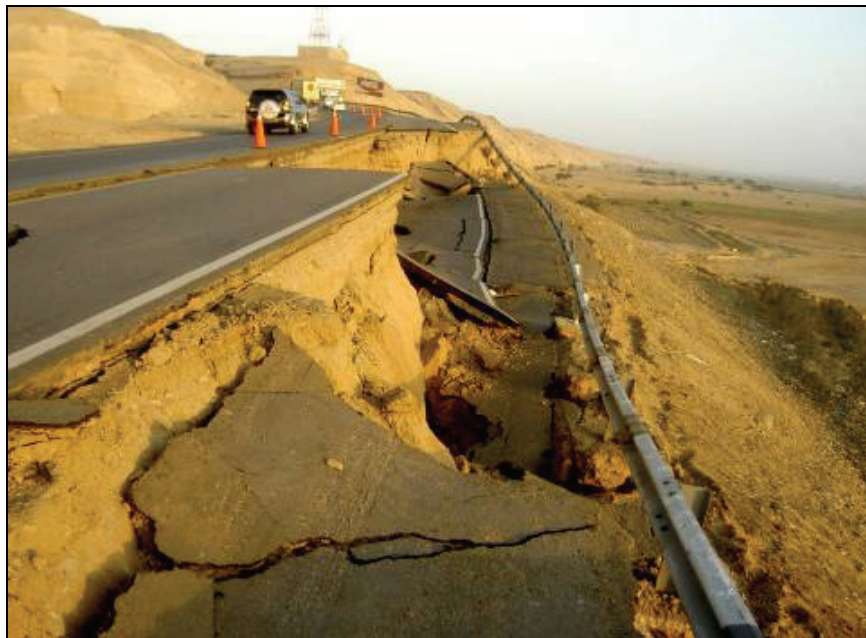
Figure 6.46 Road failure from slope failure

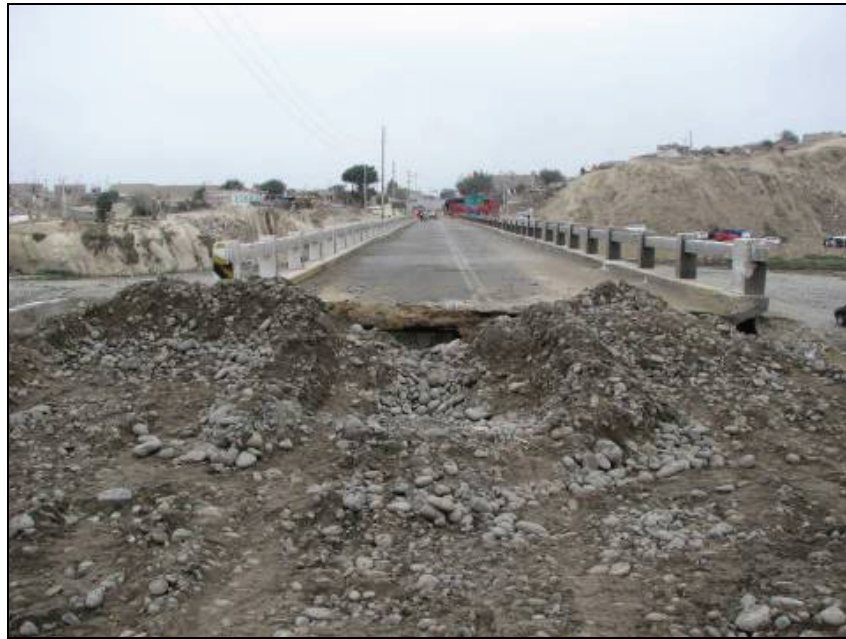
Figure 6.47 Abutment and embankment failure
