The Pisco-Chincha Earthquake of August 15, 2007

Seismological, Geotechnical and Structural Assessments

Mid-America Earthquake Center

MAE Center Report No. 08-01

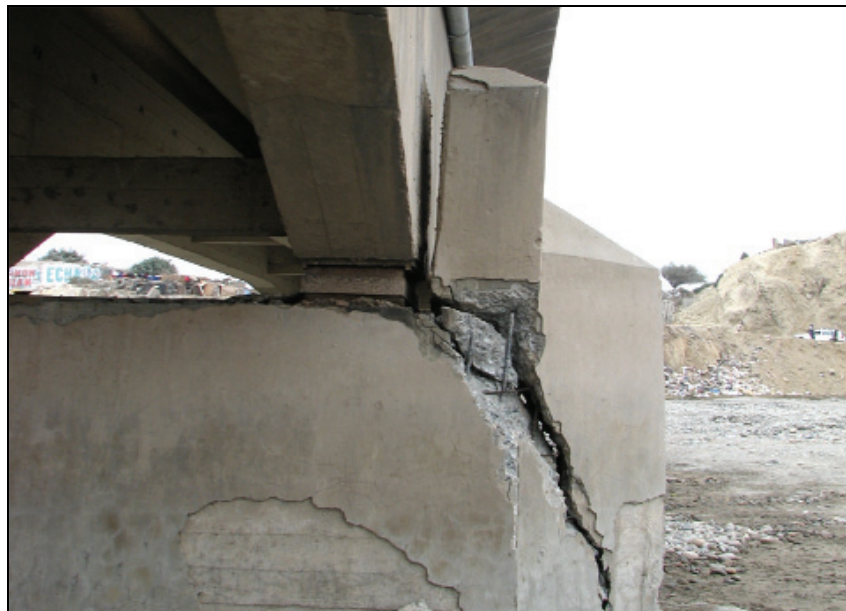
Figure 6.48 Damage to shear key of a bridge

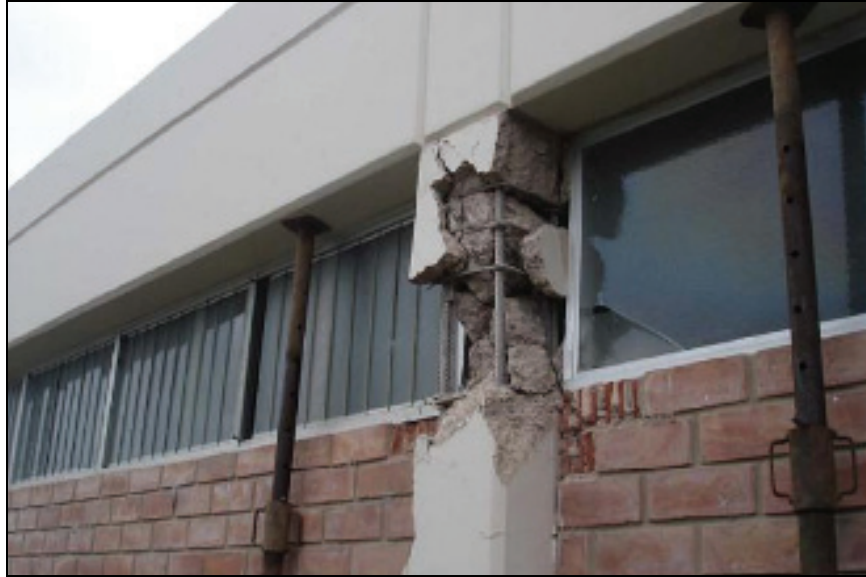
Figure 6.49 Short column failure at office building in Pisco

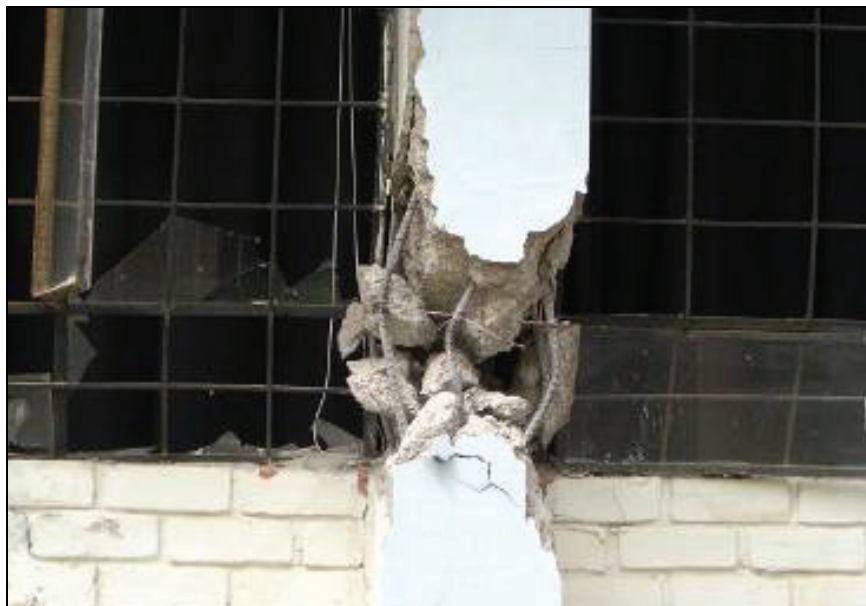
Figure 6.50 Detail of a failure in a column of a building at the National University of Ica

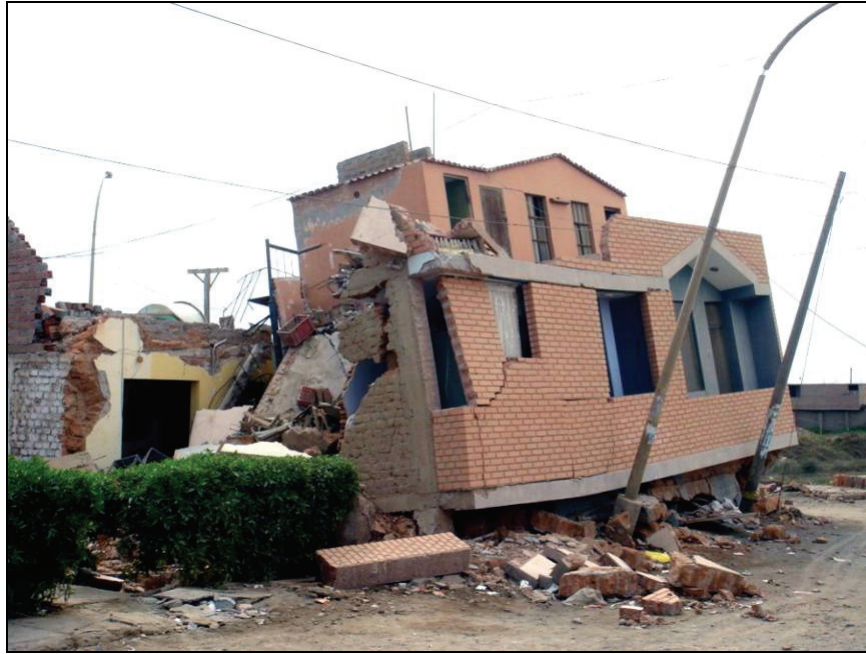
Figure 6.51 Collapse of housing unit in Pisco due to soft story problems

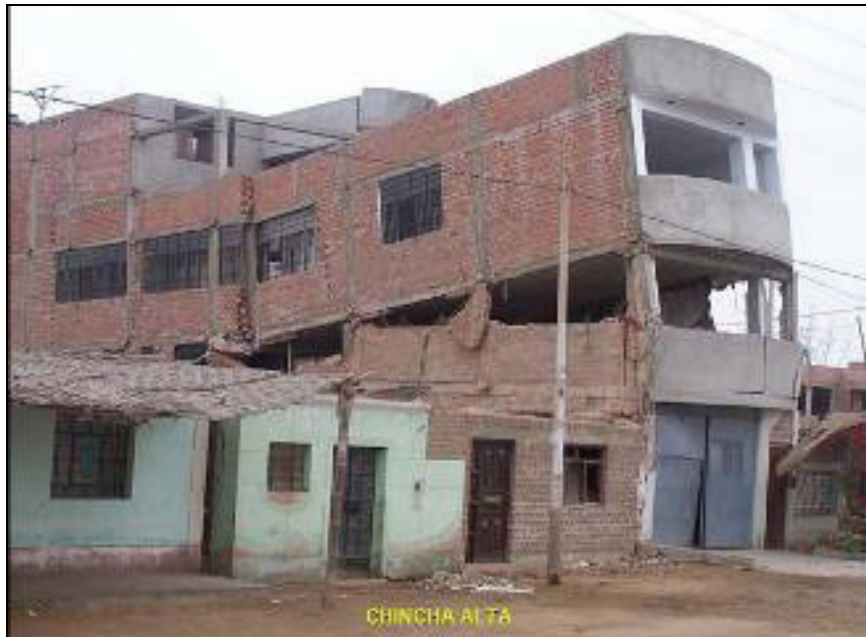
Figure 6.52 Failure of a three-floor building in Chincha Alta due to intermediate soft story

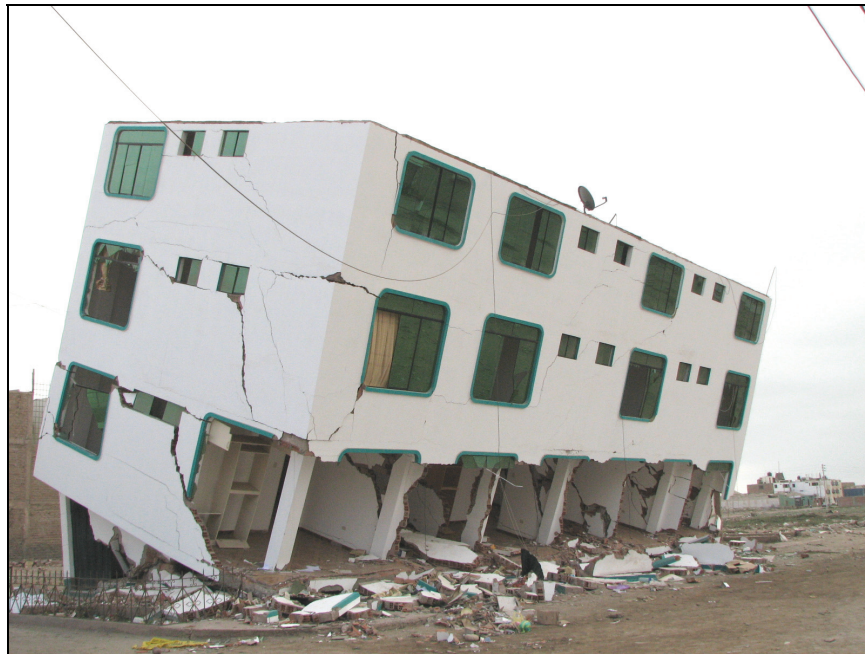
Figure 6.53 Collapse of building at Pisco Playa

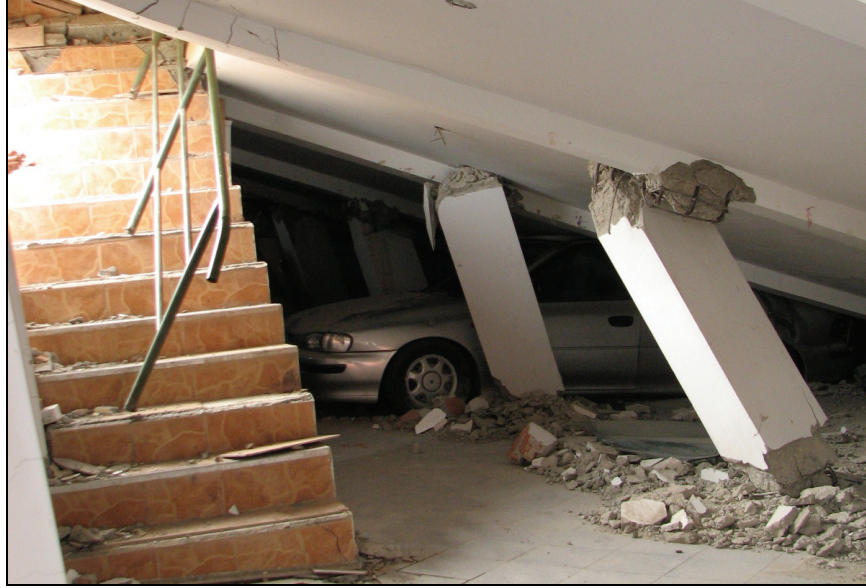
Figure 6.54 View of inner columns of collapsed building at Pisco Playa

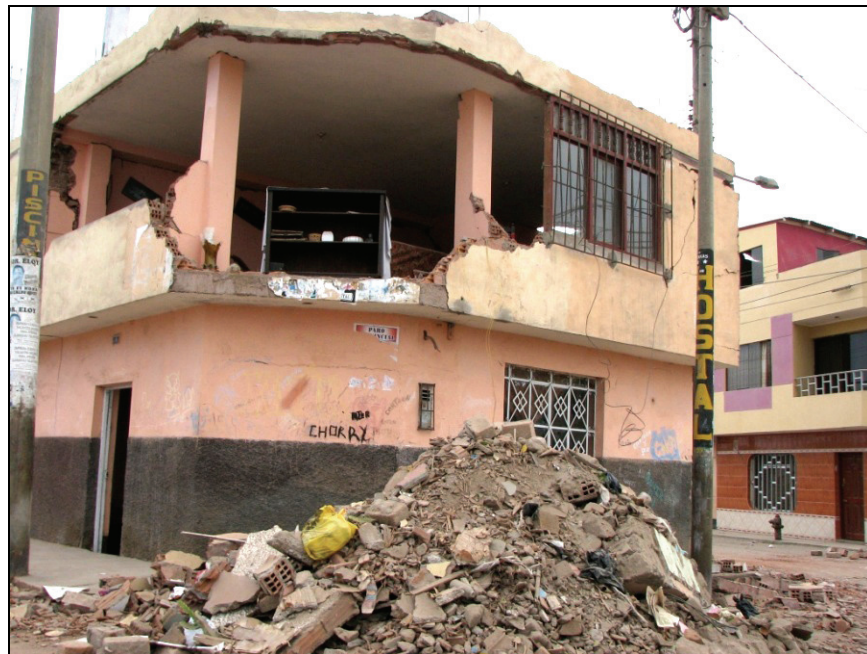
Figure 6.55 Out-of-plane failure of infill walls in Ica

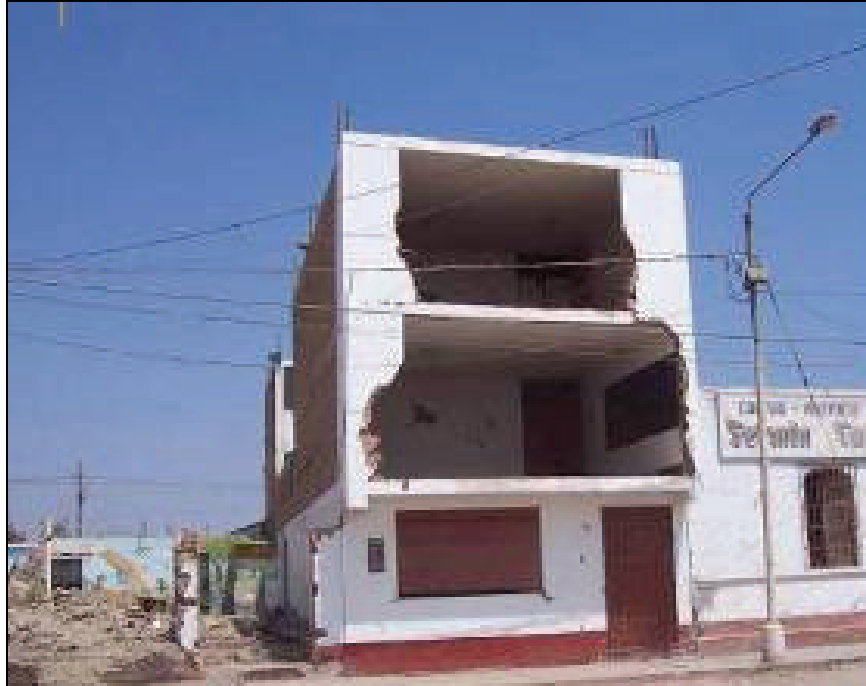
Figure 6.56 Falling of infill walls of housing unit in Pisco.

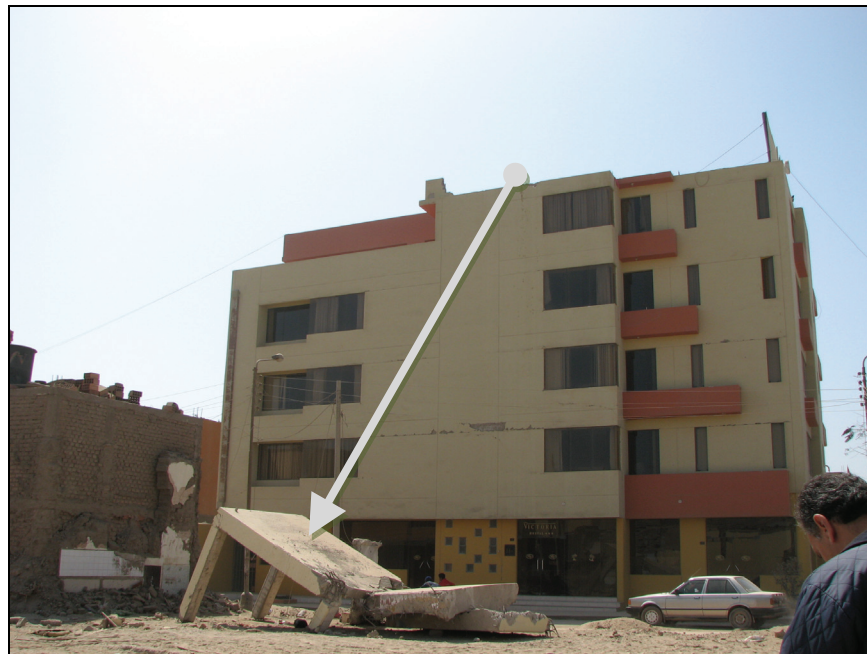
Figure 6.58 Collapse of an extension from the top floor of a building in Pisco

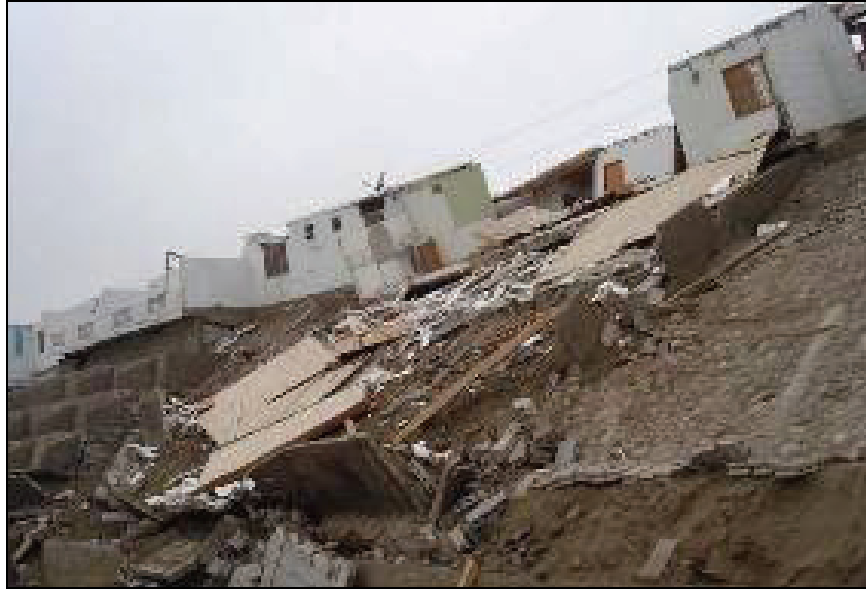
Figure 6.60 Collapsed buildings due to slope instability

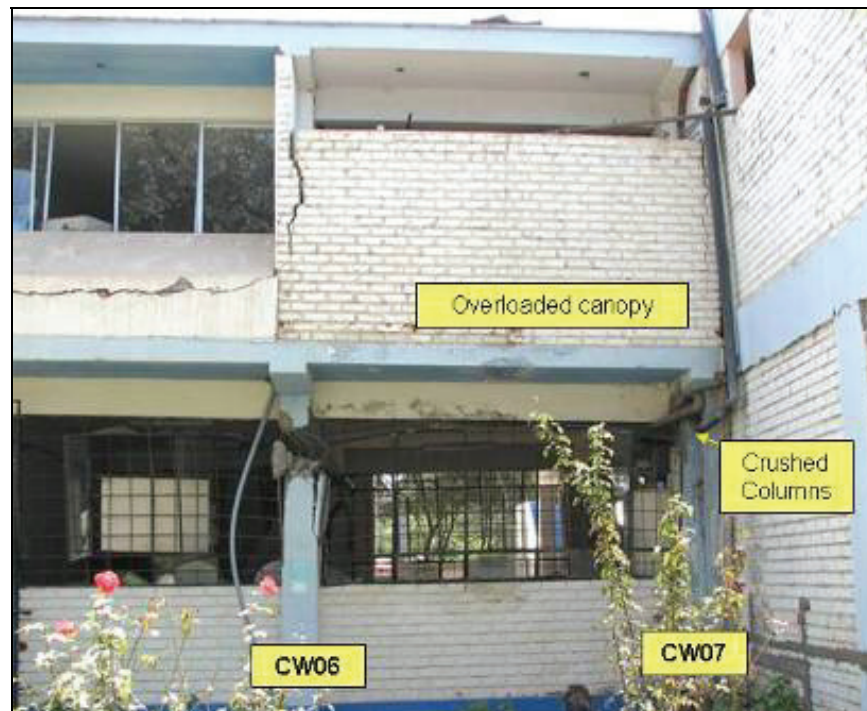
Figure 7.8 Overloaded span of the building
