Performance of Rehabilitated URM Shear Walls: Flexural Behavior of Piers

**Shaun Franklin
Jaret Lynch
Daniel Abrams**

**Department of Civil Engineering
University of Illinois at Urbana-Champaign
Urbana, Illinois**

December 2001

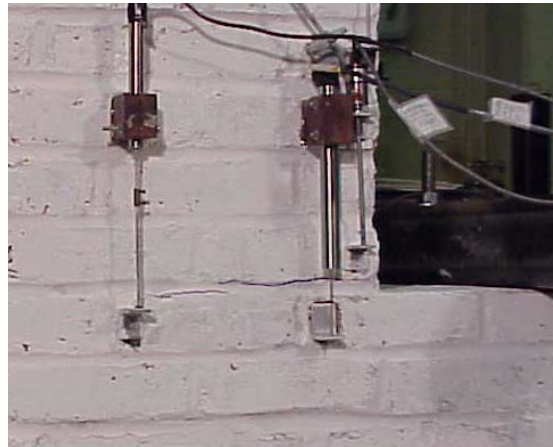
Specimen 1F was tested with a constant axial stress of 42 psi applied to the wall. Initial cracking was observed in the bed joint at the base of the pier at 0.10% drift (Figure 3-1a). The wall rocked in-plane (Figure 3-1b) with the cracks opening and then closing without any sliding or twisting until 2% drift. At 2% drift the wall began to twist about its vertical axis (Figure 3-1c) and cracking of brick in the toe section was observed in the first quarter cycle. The test was stopped at 2% drift to limit the damage to repairable levels so that the specimen could be retested as Specimen 2F.

a) Initial Cracking at 0.1% drift

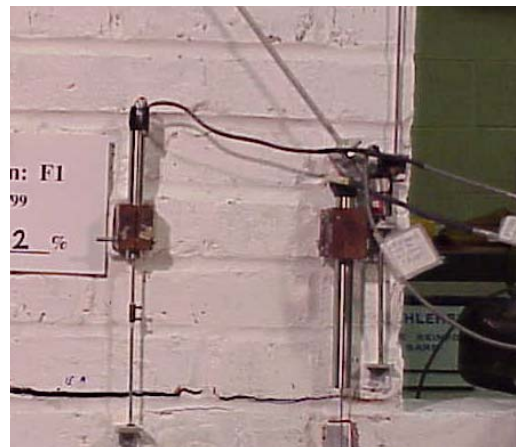
b) Rotation About Toe at 2.0 % Drift

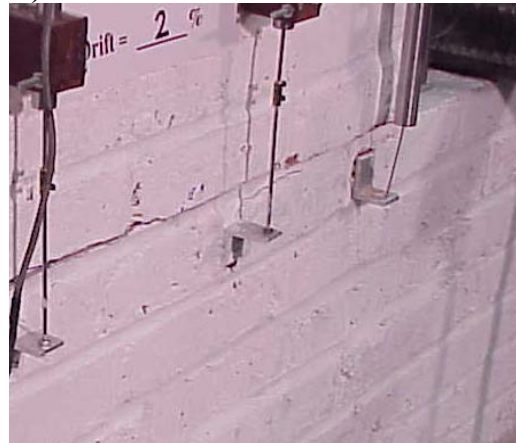
c) Rotation About Vertical Axis of at 2.0 % Drift

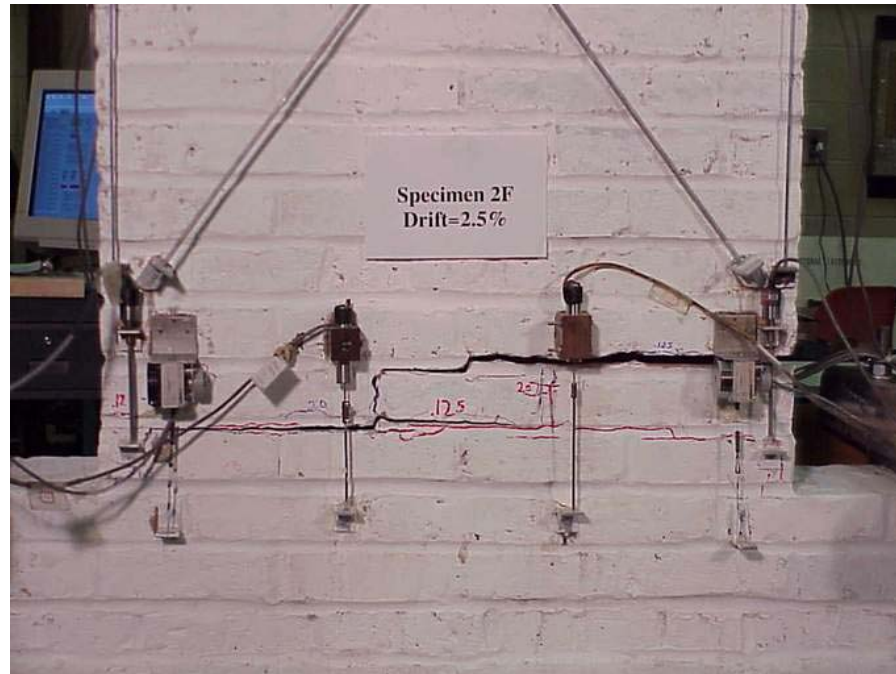
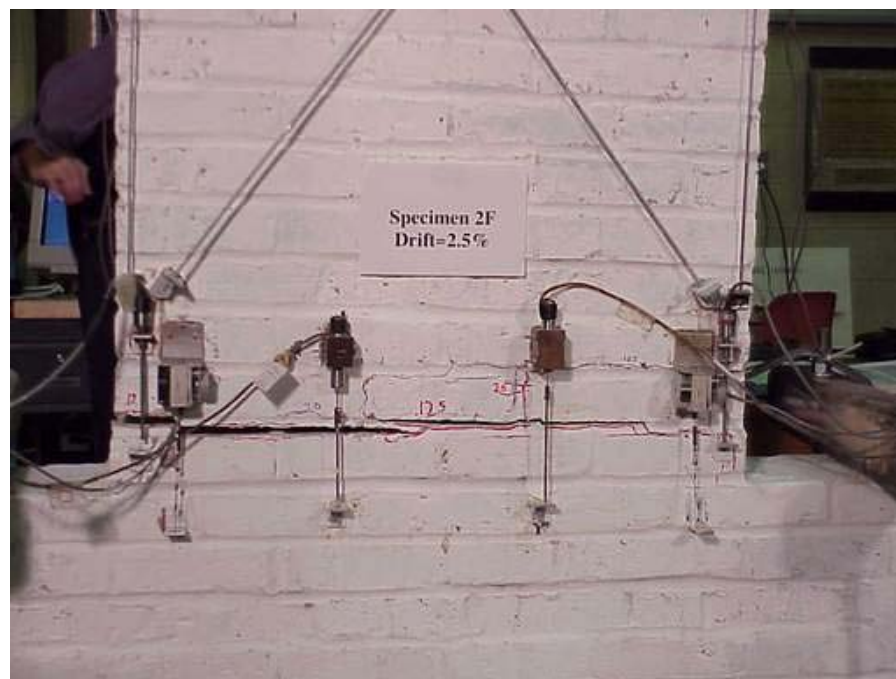
Figure 3-2 Damage Photos of Non-rehabilitated pier with light (25psi) vertical stress (2F)

Specimen 2F was tested with a constant axial stress of 25 psi. Initial cracks in the second and third bed joints of the pier were observed at 0.05% drift. These cracks propagated through the bed joint and connected with increasing amplitudes; thus forming a continuous crack about which the wall rocked up to 2.5% drift as shown in Figure 3-2.

a) Positive Rotation

b) Negative Rotation

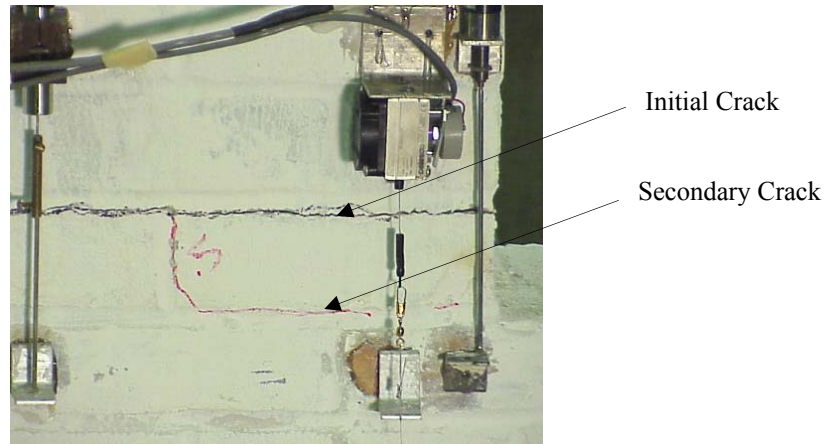
a) Crack Formation in First Bed Joint at 0.50% Drift

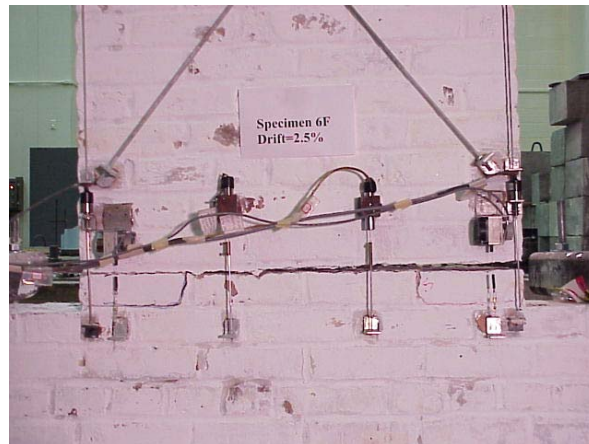
b) Rocking at 2.5% Drift

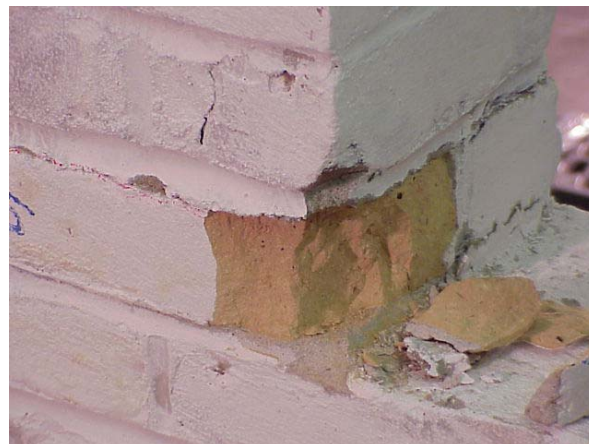
Specimen 6F was a new URM pier with no rehabilitation that was tested under an 85psi axial stress. Unfortunately a crack formed through the second bed joint while attaching the lateral actuators, so the drift level at which cracking would begin is unknown. As expected, the wall rocked about the initial crack when loaded laterally. At 0.5% drift the head and bed joints for the bricks immediately beneath the toe cracked as shown in Figure 3-3a. The pier continued to rock in a stable manner as shown in Figure 3-3b. No further damage was observed until 2.5% drift when the toe brick in the northeast corner cracked as shown in Figure 3-3c.

c) NE Brick Cracking at 2.5% Drift

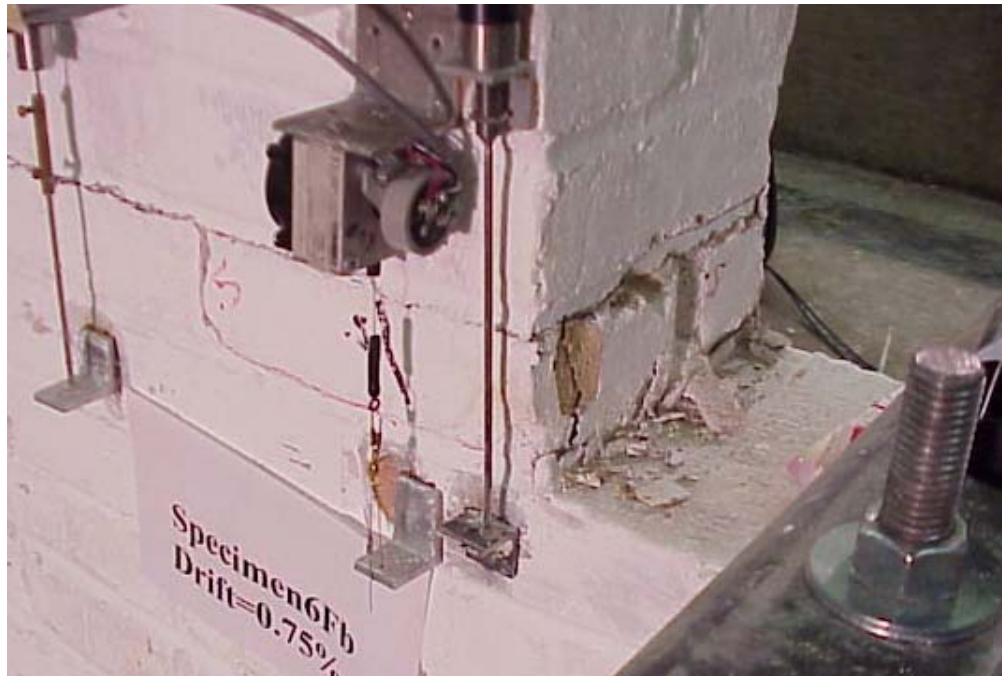
To determine whether toe-crushing could be induced, Specimen 6F was tested again with 120 psi axial stress. The designation for this test was 6Fb. Since the main crack for rocking had already formed the testing began with 0.5% drift and increased to 1.5% drift. At 0.75% drift the southwest toe brick split vertically in compression as shown in Figure 3-4a.

a) SW Toe Compression Splitting

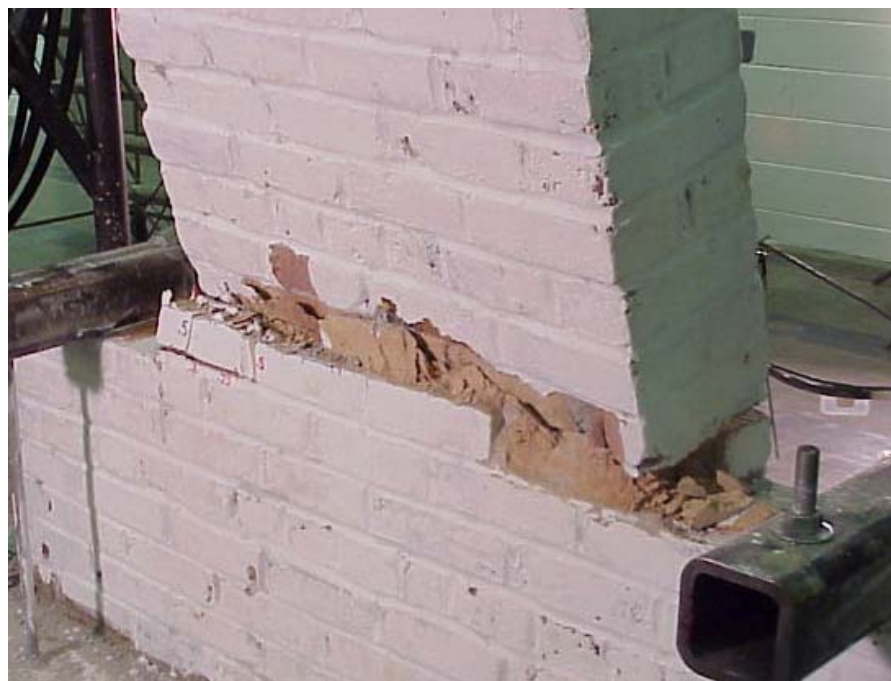
No other damage was observed until 1.5% drift when the toe brick in the northeast corner completely and abruptly crushed causing the wall to fall out of plane as shown in Figure 3-4c.

b) Toe Crushing at 1.5% Drift

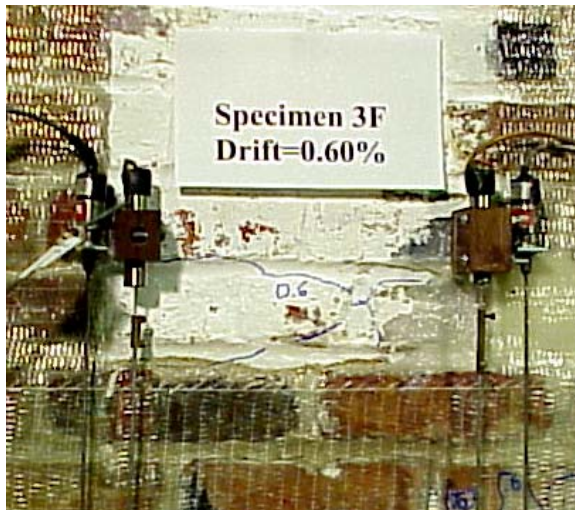
Specimen 3F was rehabilitated with strips of FRP. All rehabilitated specimens were tested with a medium level of axial force (producing 42 psi on the cross-section of the pier). The limiting behavior mode of the specimen was delamination of the FRP. The first signs of delamination were audible “popping” sounds at 0.08% drift. Visible delamination of the four vertical strips began at 0.4% drift near the base of the pier. At 0.6% drift diagonal cracks appeared in the middle of the pier as shown in Figure 3-5a. The diagonal cracking became more extensive in the exposed bricks with all increasing amplitudes, but did not appear to propagate through the FRP to the edge of the wall.

a) Onset of Diagonal Cracking

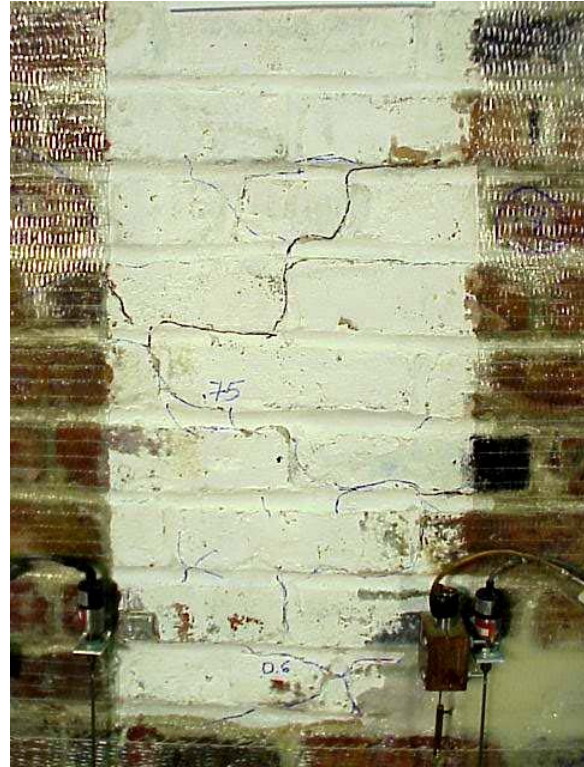
c) Diagonal Cracks at 1.25% Drift

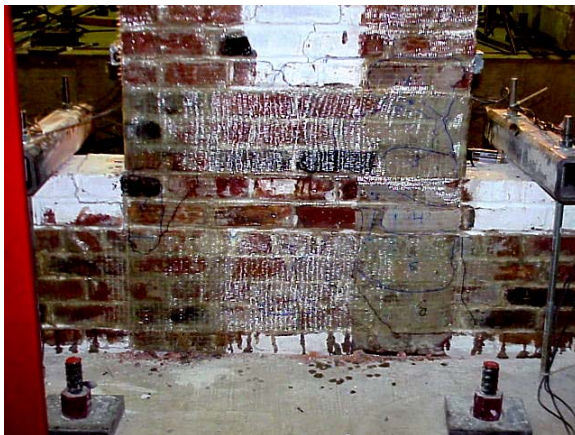
At 1.25% drift the main vertical strip of FRP on the southeast corner (the vertical strip on the right in Figure 3-5b) fully delaminated from the base, but remained attached to the horizontal strip along the base of the wall. This horizontal strip enabled force transfer to the wall base, and prevented a loss in strength. Also at 1.25% drift it was noticed that the bed joint at the base of the wall had cracked causing the steel tie-downs to engage.

b) Delamination Pattern of SE FRP Strip

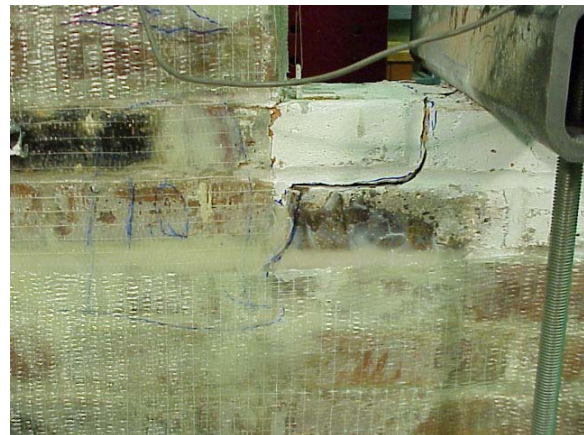
The base of the wall cracked just interior to the steel tie-downs (Figure 3-5d) and the crack propagated through the mortar toward the centerline of the wall. After successive cycles this formed a continuous u-shaped crack between the supports two courses beneath the base of the pier.

d) Cracking at Foundation Tie-down

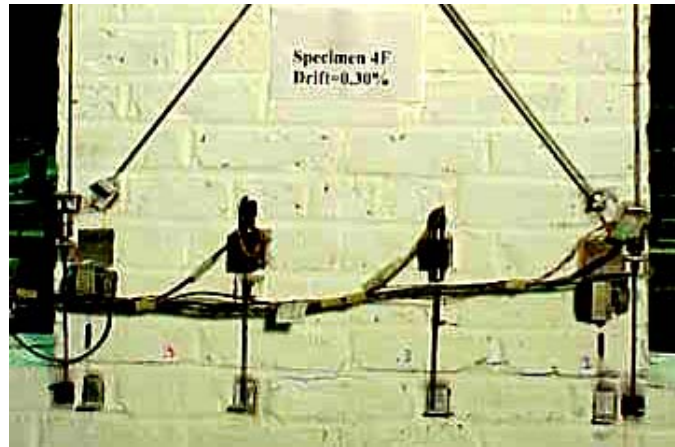
a) Cracks in Masonry at 0.3% Drift

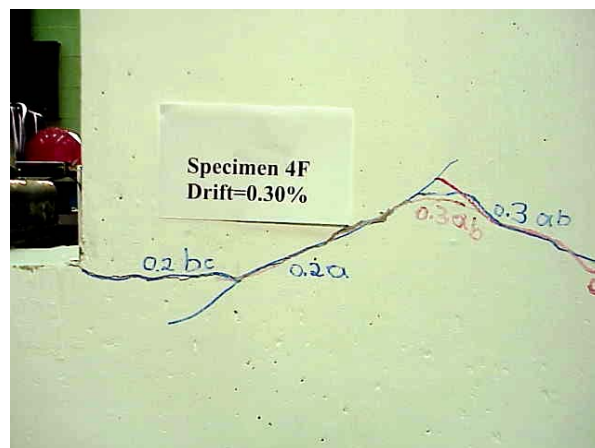
b) Cracks in Concrete at 0.3% Drift

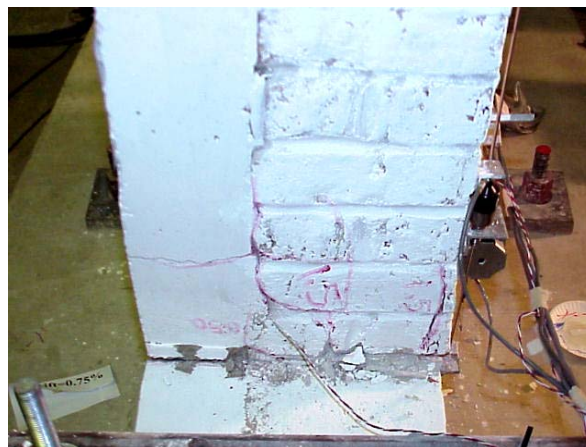
Specimen 4F was rehabilitated with 4 inches of reinforced concrete and tested with medium axial force. Cracking began in concrete at the level of the reference datum (Figure 2-5) at 0.2% drift and reached fully across the base of the pier at 0.3% drift as shown in Figure 3-6b. Cracking in the masonry began in the bed joint at the level of the reference datum at 0.3% drift as shown in Figure 3-6a. With increasing amplitudes the wall rocked about the base crack, elongating the vertical reinforcement well into the plastic range. When the cycles were reversed the vertical reinforcement did not compress to its original length, thus the wall leaned out of plane away from the shotcrete. The maximum drift was 1.5% at which point the wall was leaning three degrees out of plane and compression forces were concentrated enough on the masonry face to cause crushing as shown in Figure 3-6c.

c) Masonry Crushing

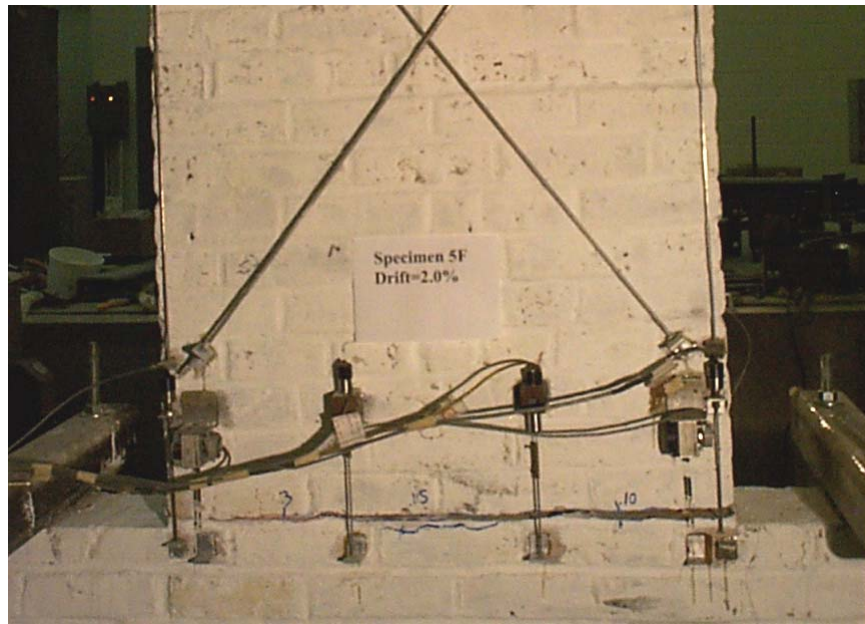
Figure 3-7 Specimen 5F, 2.0% Drift

lengthened with increasing amplitudes until it reached across the entire width of the base at 0.2% drift. The pier continued to rock as seen in Figure 3-7 up to 2.5% drift without any signs of additional damage.

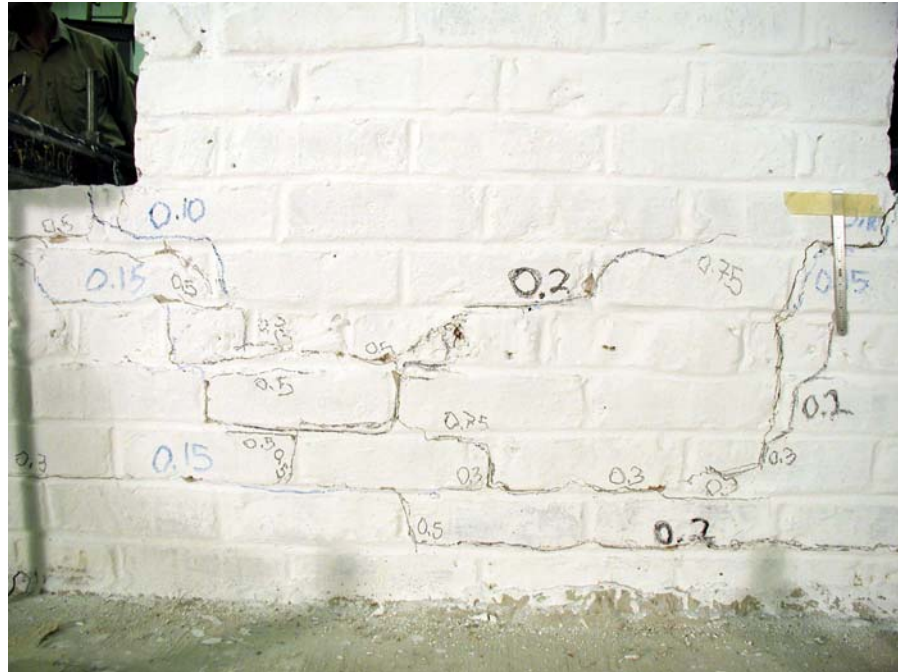
reduced-width section of the pier. The crack pattern progressed downward and toward the center of the wall with each increasing drift level, Figure 3-8a. Asymmetry was observed in the height at which the cracks crossed the center-core locations. It was discovered later that the west core did not extend down as far as was expected due to a problem during the drilling operation. The predominant behavior of the wall was rocking. The center of rotation was lower than the plain specimens and closer to the center of the pier due to the presence of the center-cores. The test was stopped at 2% drift because the top of the wall was tilting out-of-plane by approximately 1 inch, Figure 3-8b.

a) Crack Pattern

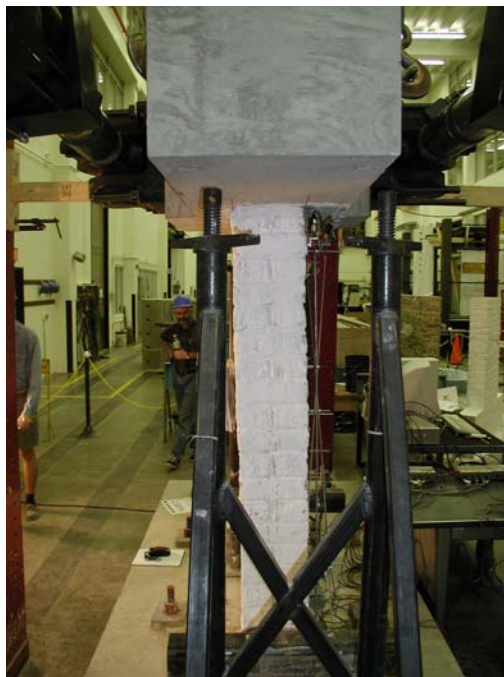
b) Out of Plane Motion

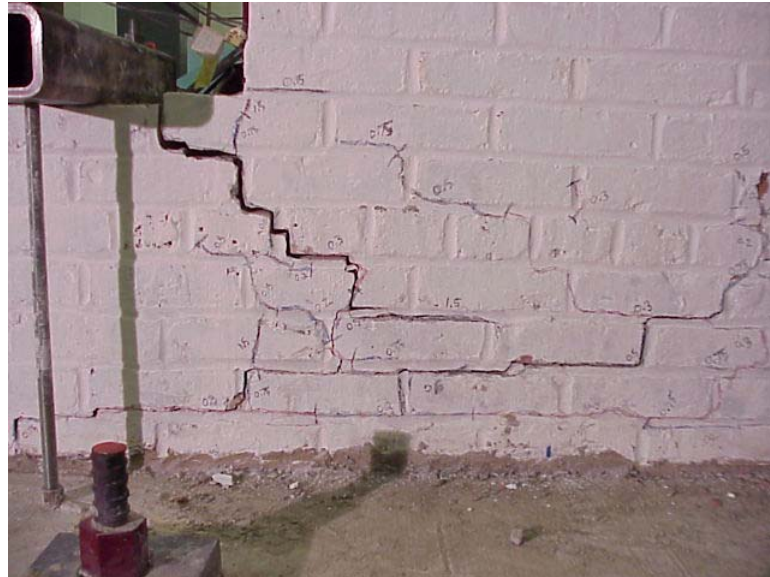
a) Rocking Behavior

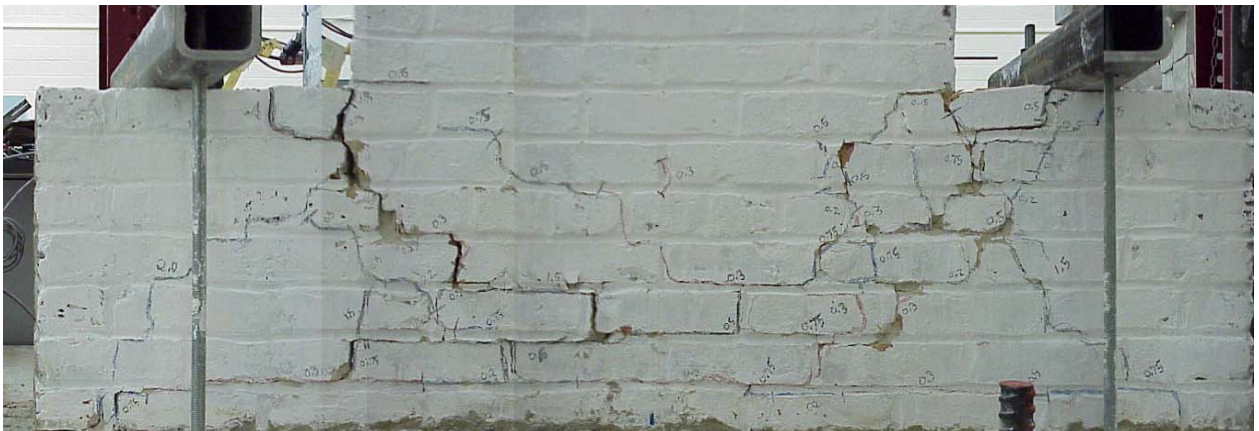
b) Crack Pattern

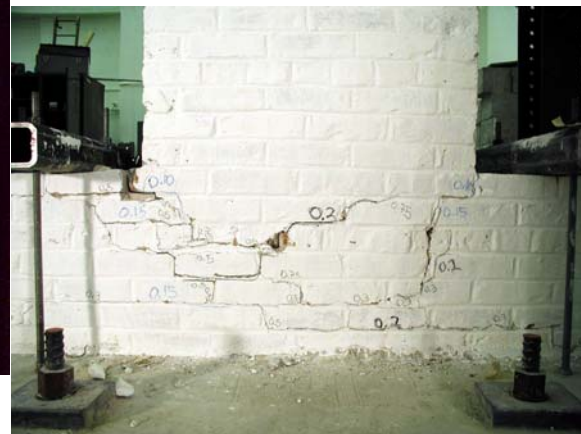
e) Center-Core Rehabilitated Pier

Figure 4-9. Damage photos at the end of testing
