The Yogyakarta Earthquake of May 27, 2006

**Amr S. Elnashai
Sung Jig Kim
Gun Jin Yun
Djoni Sidarta**

Mid-America Earthquake Center

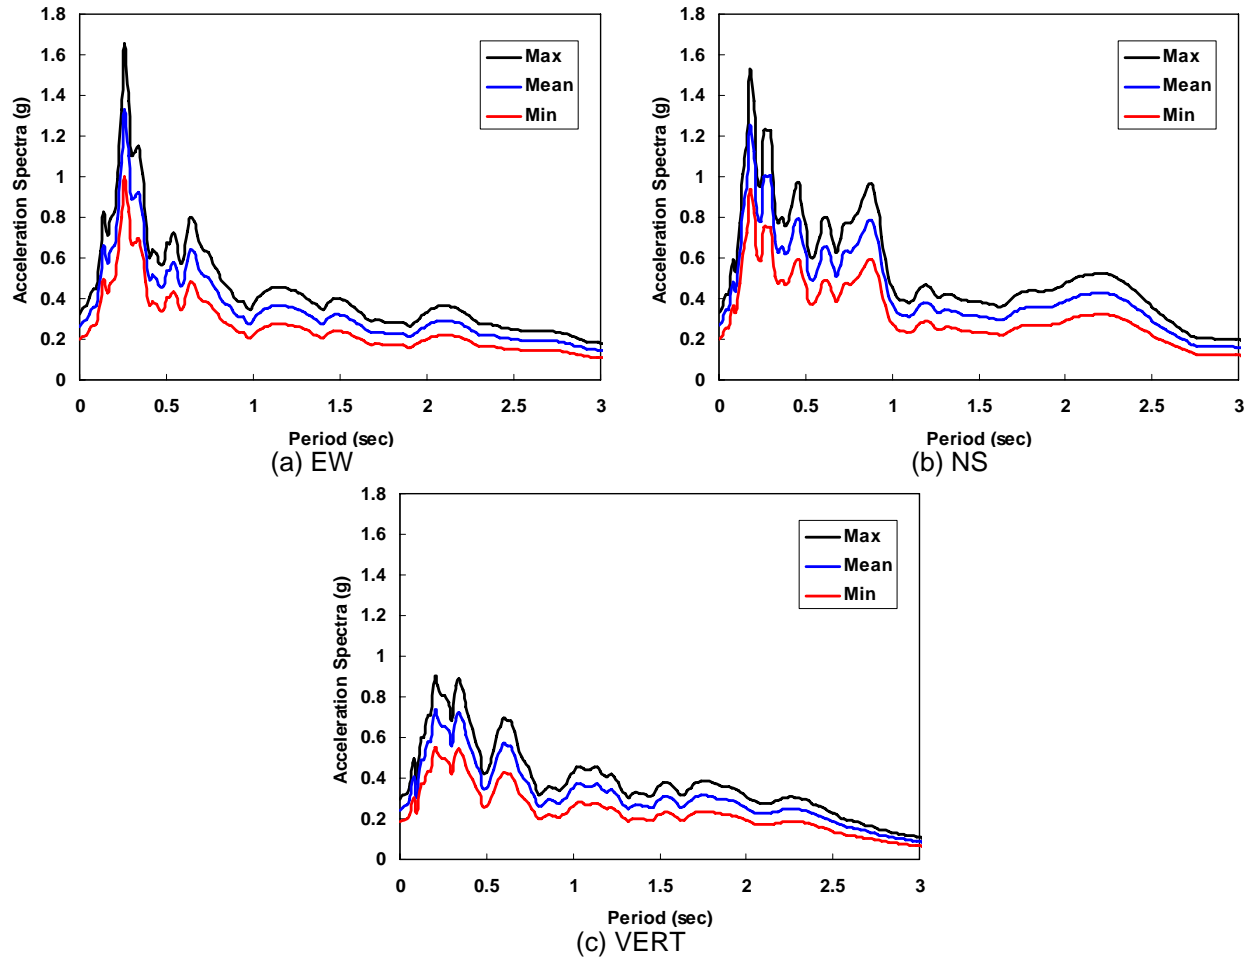
Figure 4.12 Elastic acceleration spectra (5% damping) considering uncertainty

The signal from YOGI is the most usable of the available records, since it is obtained from an area where significant damage has occurred. The signal from BJI station is very weak. Therefore, spectra for the YOGI records are evaluated with uncertainties and different ductility levels. Figure 4.12 illustrates the elastic spectra with 5% damping for three components with the bands of uncertainty described above. The highest amplification is about 5.0 for the EW component. This is compared to the value of 2.6, which is the 84 percentile amplification factor given by Newmark and Hall (1982), thus indicating the relative severity of the YOGI record. For the vertical acceleration spectra, the highest amplification factor is about 3.0, associated with a relatively broad period range of high amplification. This value is identical with the amplification factor given by Eurocode 8 (EC8) which is based on the proposed spectra by Elnashai and Papazoglou (1997). However, the range of high amplification is 0.05~0.15 sec in EC8, while high amplifications in the YOGI record go up to 0.35 seconds. Notwithstanding that the spectra are obtained from reconstructed (or salvaged) data from saturated waveforms, the high frequency contents may be credible because the correction method affects low frequency modulation more than its high frequency counterpart. Therefore, this is an unusual feature that may explain the extensive damages and failure of roofs and vertical members in Yogyakarta. Ratio quantities are not affected by the instrument conversion.

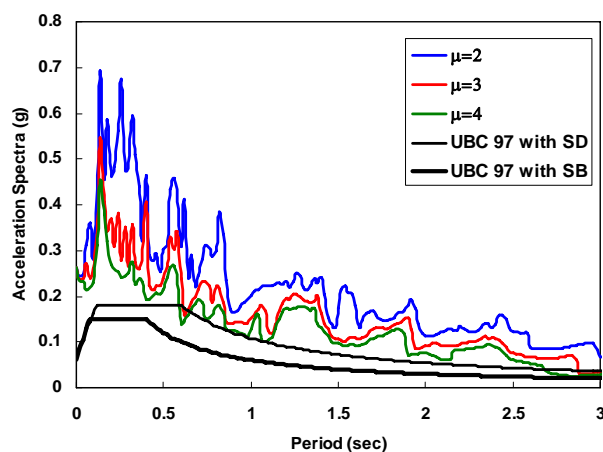
Figure 4.14 Comparison with seismic coefficient of design spectra by UBC 97

ductility structures, and an amplification factor of 2.5 is used, the seismic base shear coefficient for design would be 0.15 ~ 0.18. As shown in Figure 4.14, the spectra indicate that low ductility structures ($\mu=2$) were subjected to lateral force coefficients in the region of 0.6-0.7, about 4-5 times as much as the code coefficient. Even for long period structures, the seismic code coefficient from the calculated spectra is about 0.15 or more, much higher than the code would have indicated. Therefore, even if these structures were designed to resist seismic forces according to the code, they would have suffered unexpectedly high levels of damage.

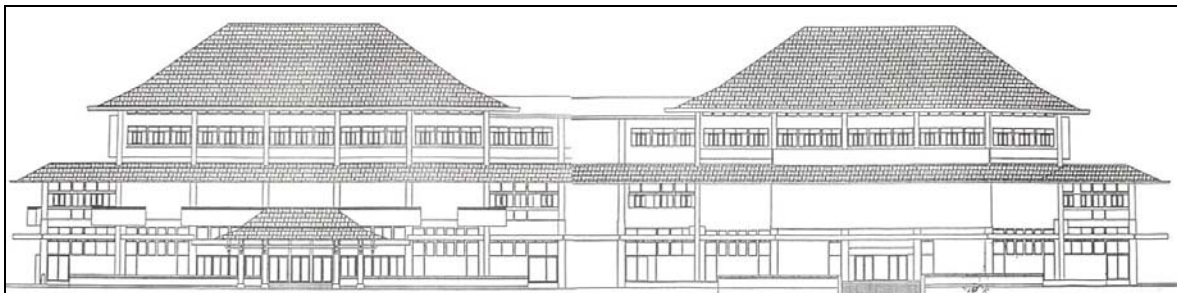
Figure 5.8 Elevation of IAI from design drawing

One of the most severely damaged buildings in Yogyakarta City is the Indonesian Art Institute (IAI - Institut Seni Indonesia) shown in Figure 5.8 to Figure 5.11. Figure 5.8 shows the original design drawing and indicates that the left and right parts of this building are almost identical. Notwithstanding, whilst the first storey of the left part totally collapsed as shown in Figure 5.9, the right part was only partially damaged. As shown in Figure 5.10 and Figure 5.11, the exterior column of the right part failed in shear, whilst the exterior and interior columns of the left part failed by shear and axial distress. Therefore, it is concluded that the left columns failed first followed by the exterior right columns. Since this building was almost symmetric based on the drawings, it is difficult to find the failure source. The shear failure of the left columns may have been caused by short column effect due to the existence of the non-structural panel.

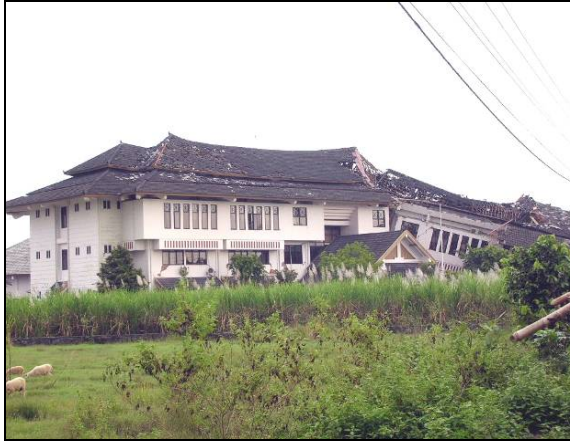
(a) Entire view

The economic losses due to damage of government structures public administration buildings in Yogyakarta and Central Java province is estimated to have reached \$15Million (BAPPENAS, 2006). The MAE Center Team investigated the Finance and Development Audit Agency (BPKP – Badan Pengawasan Keuangan dan Pembangunan) which partially collapsed. It is the most severely damaged structure among public buildings in Yogyakarta City. Figure 5.15 shows the overall layout of BPKP which is a 3-storey RC structure. Whereas half the building suffered collapse, the other has sustained only minor damage. The partial collapse may have been caused by failure of the biaxially loaded corner column. The corner column would have also been subjected to large shear forces from rotation of the building due to plan irregularities. Figure 5.16 shows the failure of beam-column joint and an 8 in gap between left and right parts of the building.

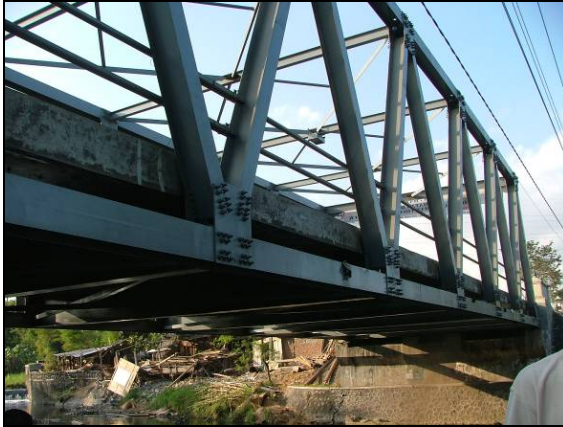
Figure 5.17 Winongo Bridge (S7°50.46'-E110°20.88' altitude 342 m)

Figure 5.17 shows the damage of the Winongo Bridge in Yogyakarta City. It is a warren truss bridge with a deck. The bridge experienced slight damage at the expansion joint that did not cause closure. There was conspicuous movement of the deck in the longitudinal direction, confirmed from the deformation of the rubber bearing as shown in Figure 5.17(b). Sliding of an embankment and heavily damaged residential housings was observed in the vicinity of the structure.

(a) Overview of Winongo Bridge

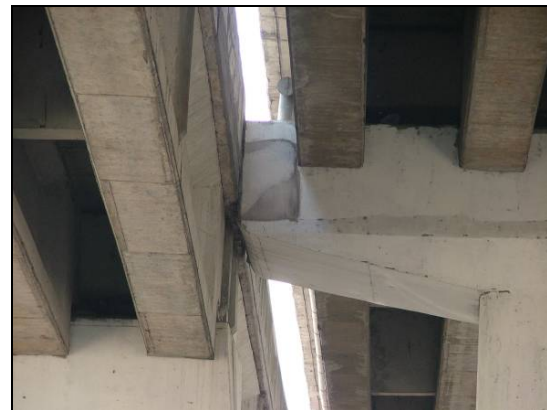
Figure 5.18 Overpass bridge in Yogyakarta City (S7°47.19'-E110°24.62' altitude 507 m)

The MAE Center Team also inspected an overpass structure (Figure 5.18). Visual inspection of the bridge confirmed that there was serious damage from the earthquake. The cause of the damage was thought to be due to pounding between the bridges as Figure 5.18 shows no gap between the adjacent structures. However, inspection of the design drawings obtained from the designers (Figure 5.19) showed that the different gap sizes were in the original design.

(b) Gap between bridge decks

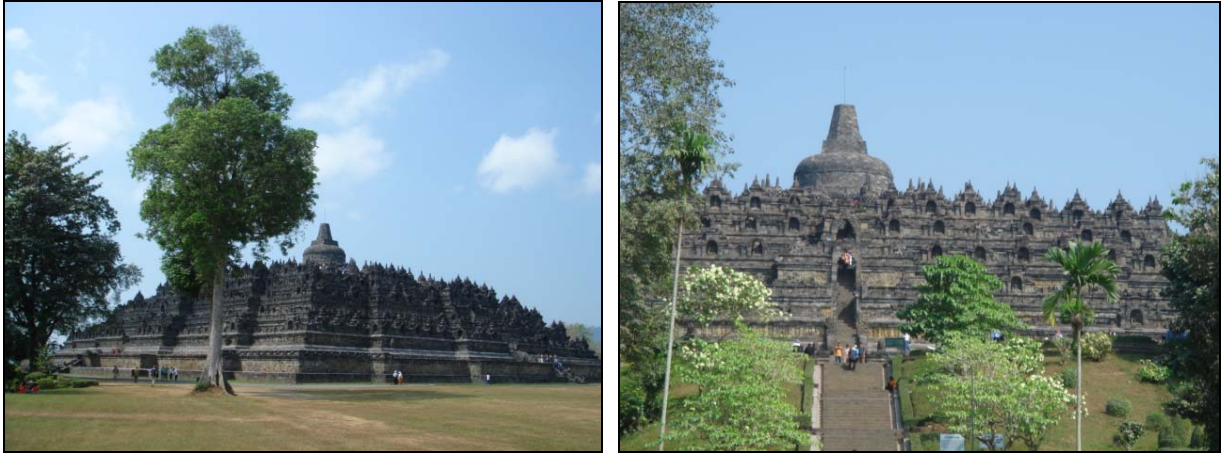
Figure 8.6 Borobudur Temple

Initial reports suggest that Borobudur remains undamaged from the earthquake and also the team did not observe any indication of damage from the earthquake during the visit.
