The Pisco-Chincha Earthquake of August 15, 2007

Seismological, Geotechnical and Structural Assessments

Mid-America Earthquake Center

MAE Center Report No. 08-01

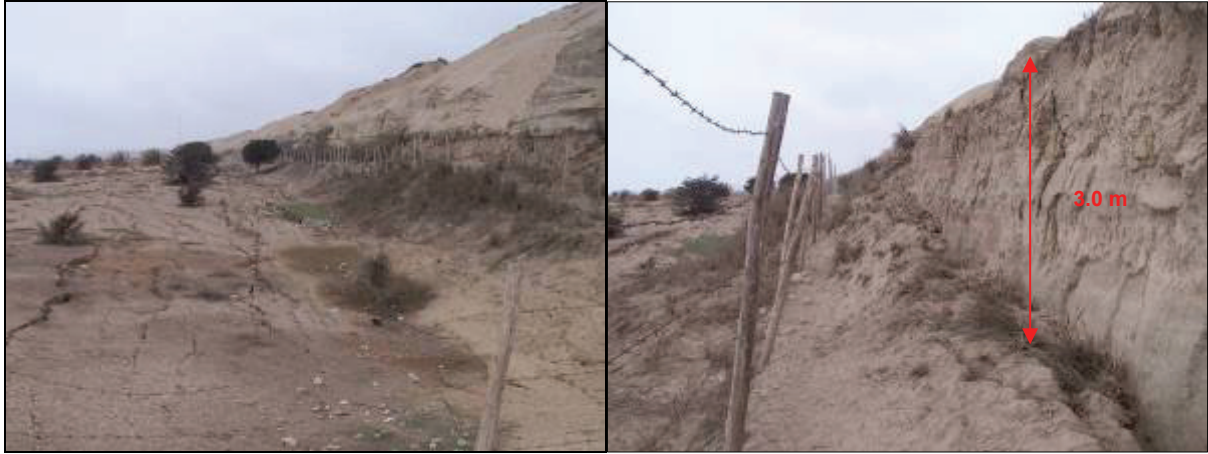
In the crowded Canchamana downtown, located 2.5 km northward from Tambo de Mora in Chincha, some cases of massive lateral ground displacement were observed, caused by the liquefaction of the seacoast terrace, Figure 5.9. The displaced area presumably has a width of 1.0 km and length of more than 3.0 km. In a local road, between Canchamana and Victoria, a maximum vertical displacement of 3.0 m was observed. In the same zone, ground cracks were observed parallel to the seacoast with widths of up to 1.0 m; in some cracks evidence of water and sand ejection was clear, Figure 5.10.

a) Soil cracks due to lateral displacement

b) Large vertical displacement in the affected zone

Figure 5.9 Lateral ground displacement due to soil liquefaction

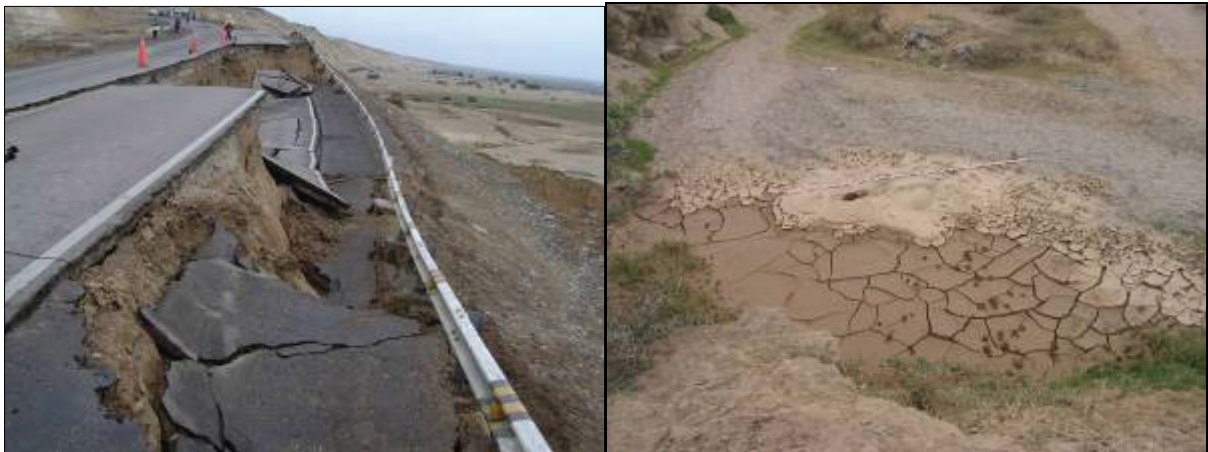
a) Settlement in the left road lane

b) Evidence of ejection of water and sand close to the embankment base

Figure 5.10 Damage at the 191 km mark of the S PA Highway due to lateral displacement

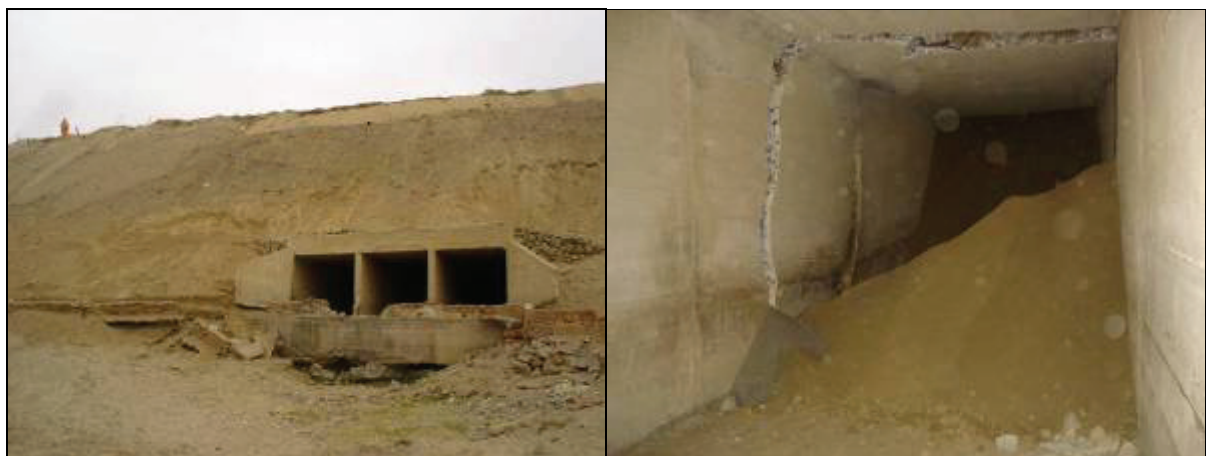
Due to the extension of the lateral displacements in the zone of Canchamana, caused by soil liquefaction, the 8-meter-height embankment of the 91 km SPA Highway suffered settlements, affecting concrete sewers located in the zone, Figure 5.11. Evidence of water and sand ejections as well as cracks close to the embankment base were found.

a) View of a concrete sewer under the embankment

b) Damage in a sewer due to lateral displacement

Figure 5.11 Damage in sewer due to lateral displacement

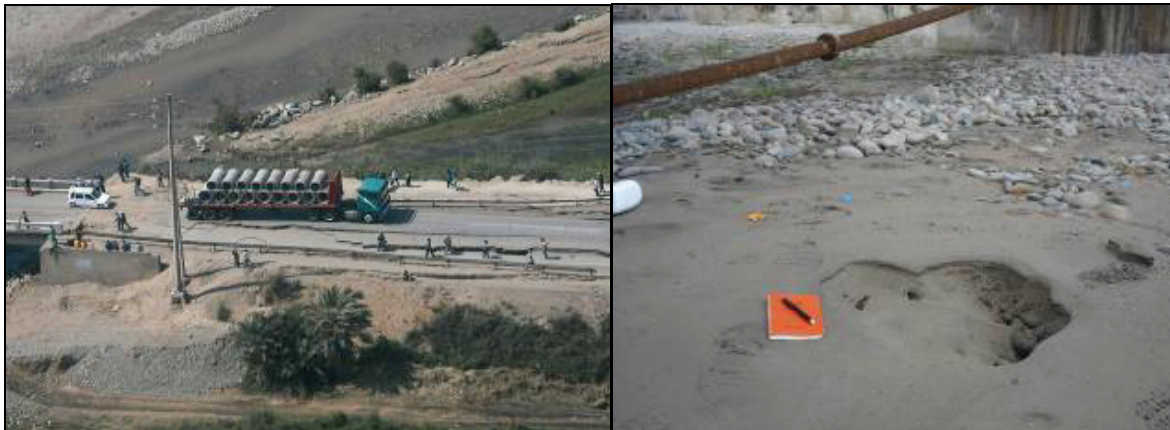
The lateral displacements caused by ground liquefaction originated multiple damages in the SPA Highway. In the Jahuay and San Clemente areas cracks in the pavement and surrounding places were observed, which caused a difference in height of 50 cm between the road borders, causing a traffic jam, Figure 5.12. In the area of the Huamaní Bridge, on the Pisco River, some ground displacements that caused fractures in berms and pavement were observed. Likewise, the liquefaction occurrence in the area where the bridge is located was confirmed by the presence of sand ejections in the ground surface cracks, Figure 5.13.

a) Aerial view of the Huamaní Bridge embankment

b) Ejection of sand and water found close to a bridge

Figure 5.13 Soil liquefaction observed in the Huamaní Bridge Area in the 229 km of the SPA Highway

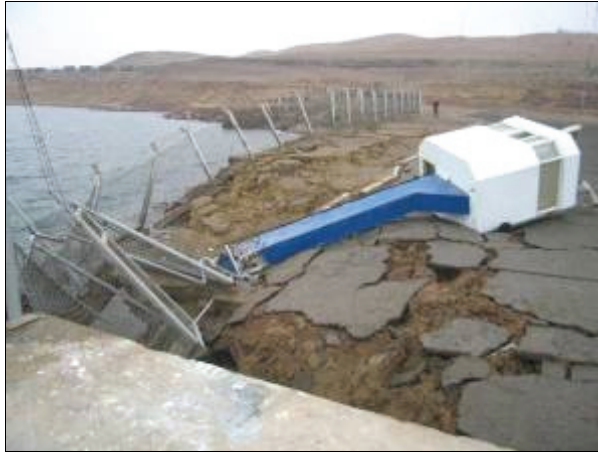
San Martín Port, which is located in Punta Pejerrey, Paracas, was affected by ground liquefaction. This was evidenced with lateral displacements that caused cracks with widths of about 25 cm, the formation of sand volcanoes, and vertical displacement of about 80 cm. The most affected places were those where the port facilities are located, in areas near to the sea.

a) Structural collapse due to ground cracks in areas gained to the sea

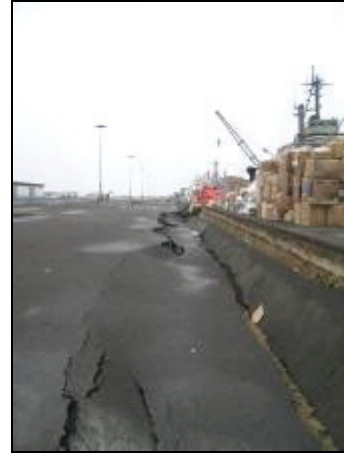
b) Vertical displacement of 80 cm

Figure 5.14 Damage in the San Martín Port caused by liquefaction

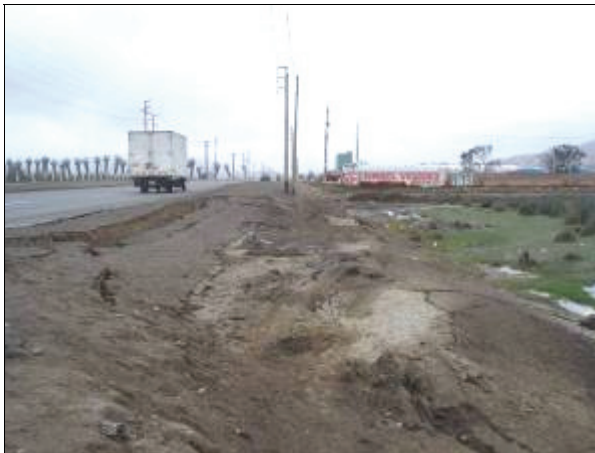
Close to Lima City, in the zone of Los Pantanos de Villa in Chorrillos District, cracks that caused leaning in poles and ground settlement were observed.

a) Ground displacement due to soil liquefaction

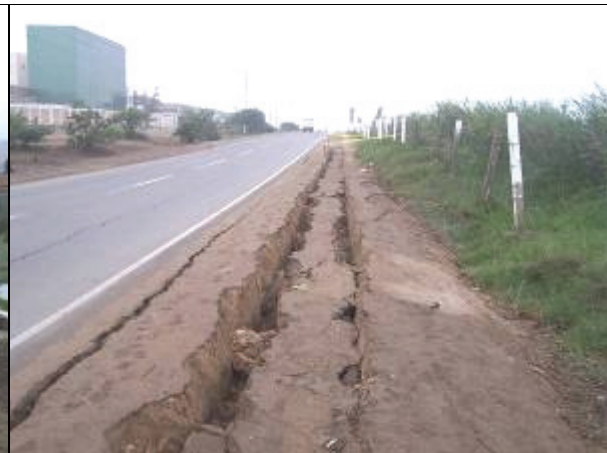
b) Cracks in the pavement and berm of the highway

Figure 5.15 Cracks in Defensores del Morro Avenue in Los Pantanos de Villa

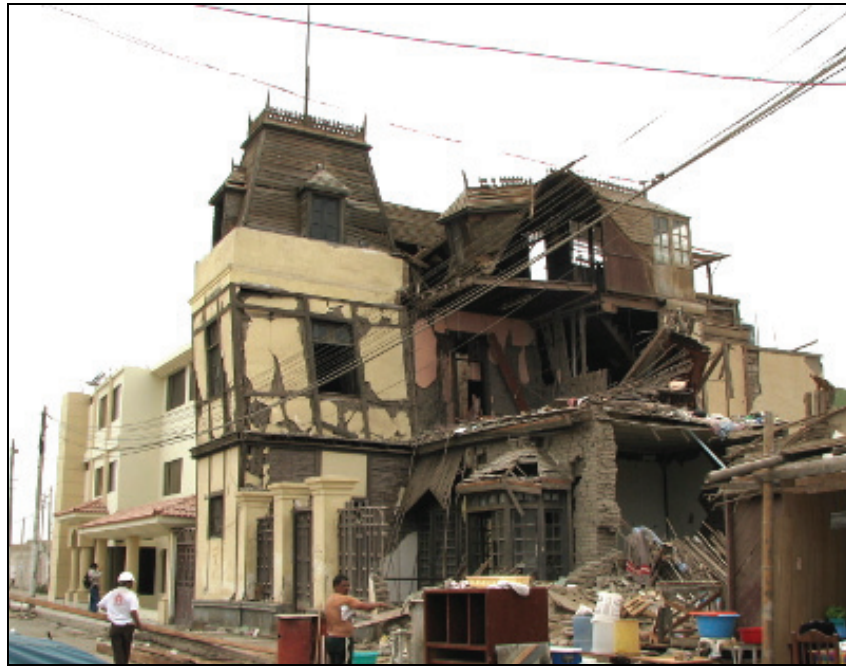
Figure 6.3 Residential building made of reinforced adobe-1

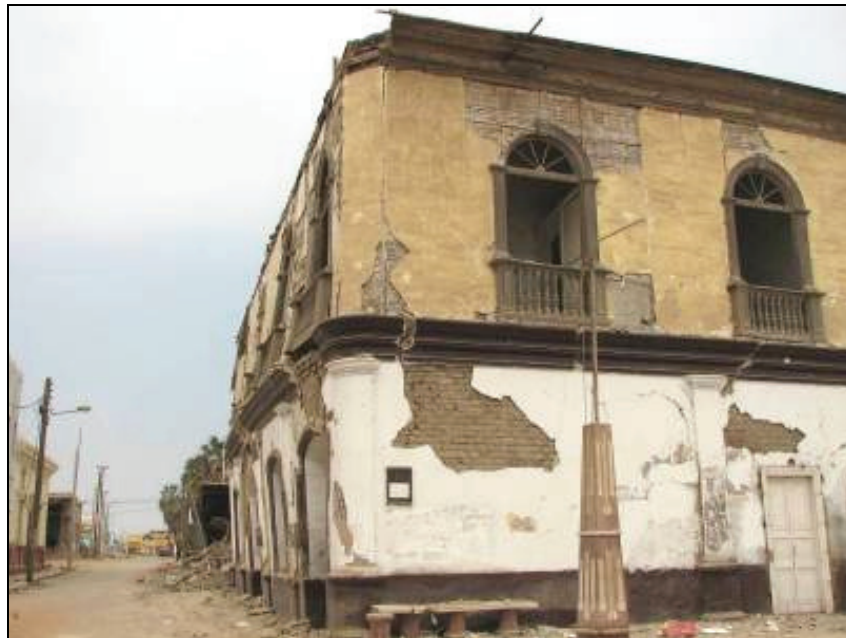
Figure 6.4 Residential building made of reinforced adobe-2

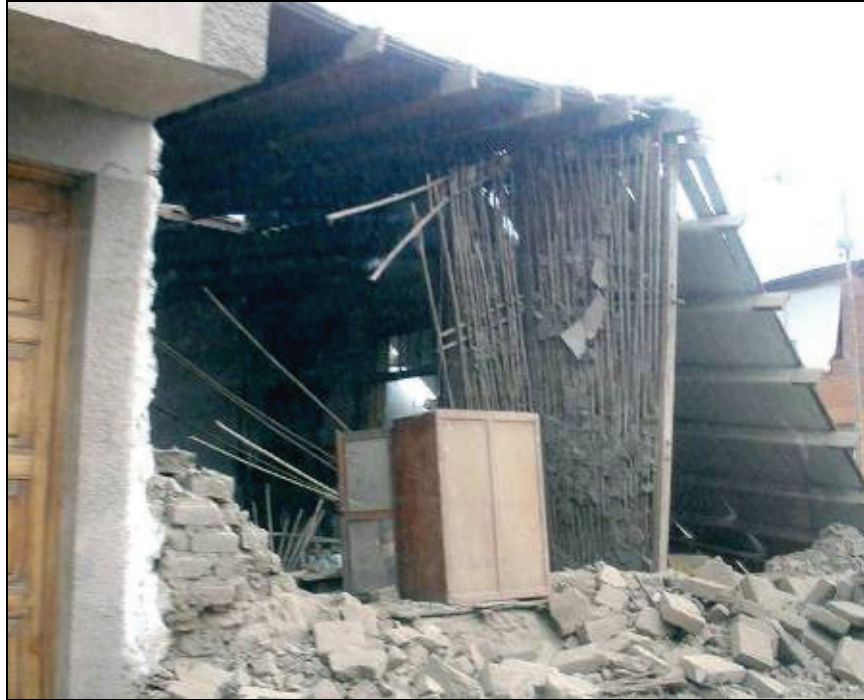
Figure 6.5 Adobe wall supporting roof

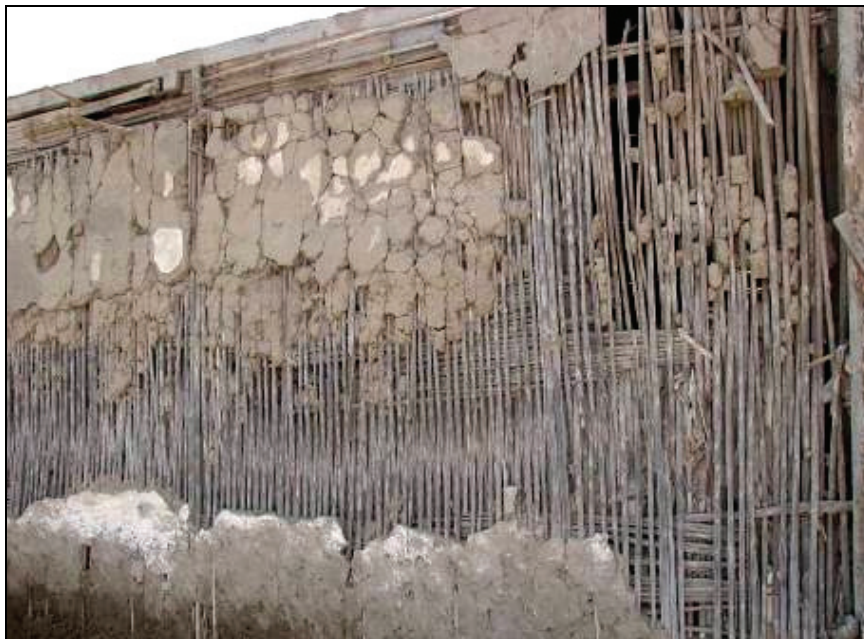
The majority of damaged and collapsed structures were made of adobe or masonry. Several residential structures were built in two stories with adobe. When adobe is used, natural fibers, such as thin wooden sticks, are used to reinforce adobe wall, Figure 6.6.

Figure 6.6 Typical layout of reinforcement and adobe of residential building

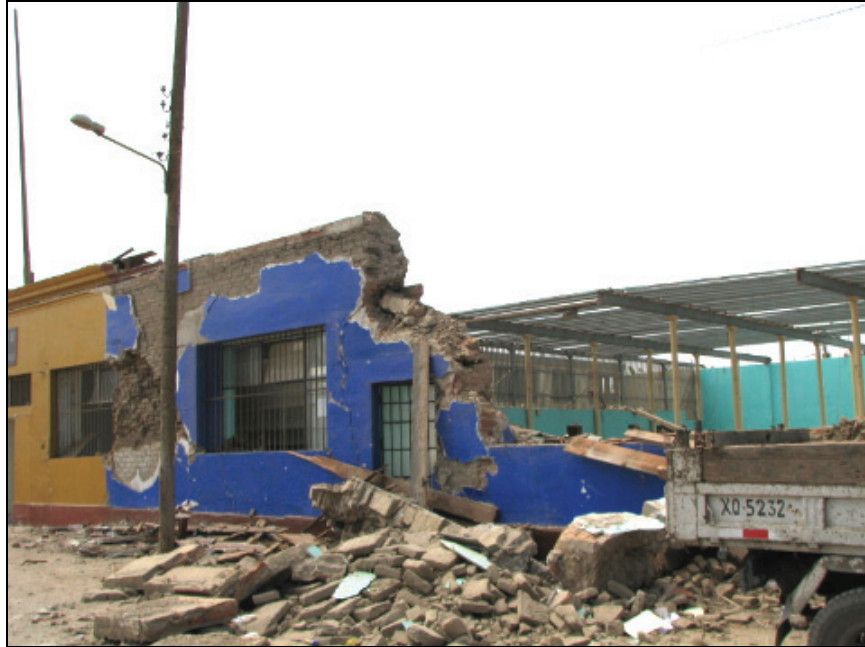
Masonry was used for both residential and many of non-residential buildings. Non-residential buildings, Figure 6.7 and Figure 6.8, were typically constructed with thick masonry walls. Even in these buildings no or very little reinforcements were used. Figure 6.12 shows a building which had soft 1st story. Both 1st and 2nd stories were built with masonry without reinforcement.

Figure 6.7 Collapsed masonry structure-1

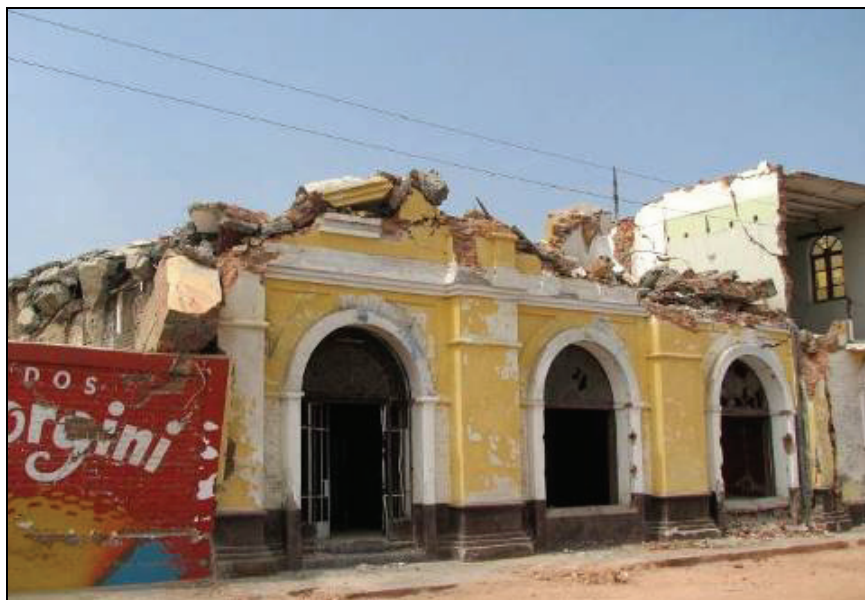
Figure 6.8 Collapsed masonry structure-2

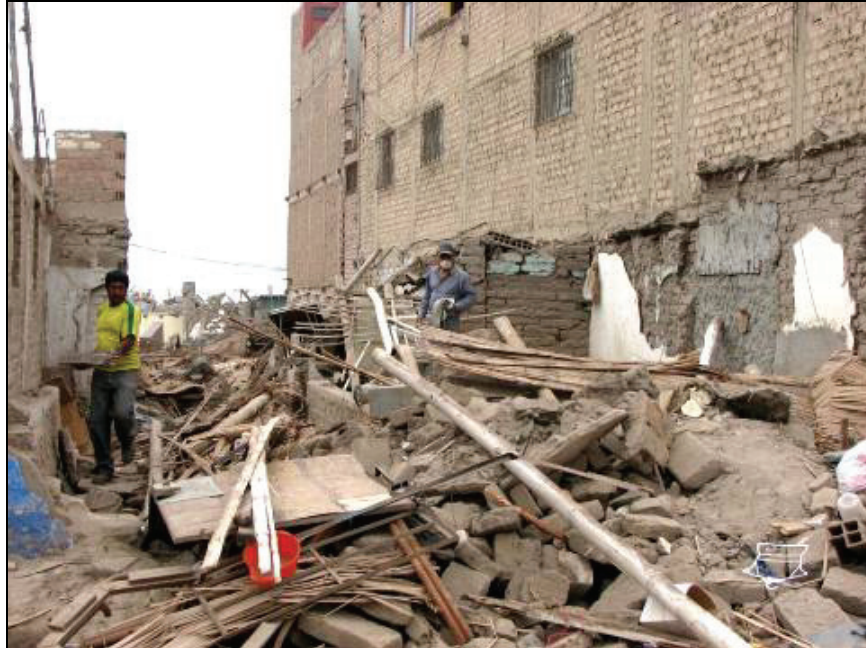
Figure 6.9 Collapsed masonry structure-3

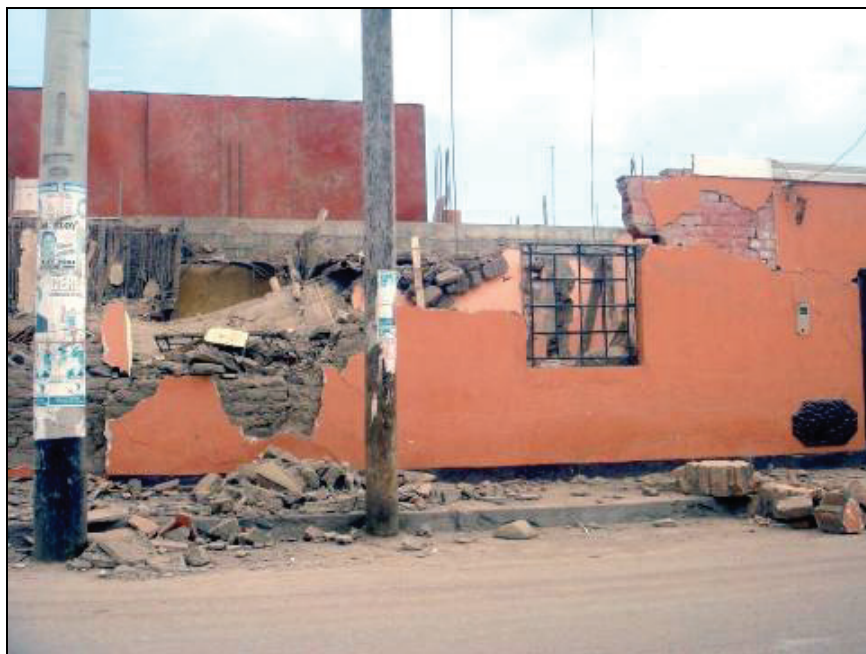
Figure 6.10 Collapsed masonry structure-4

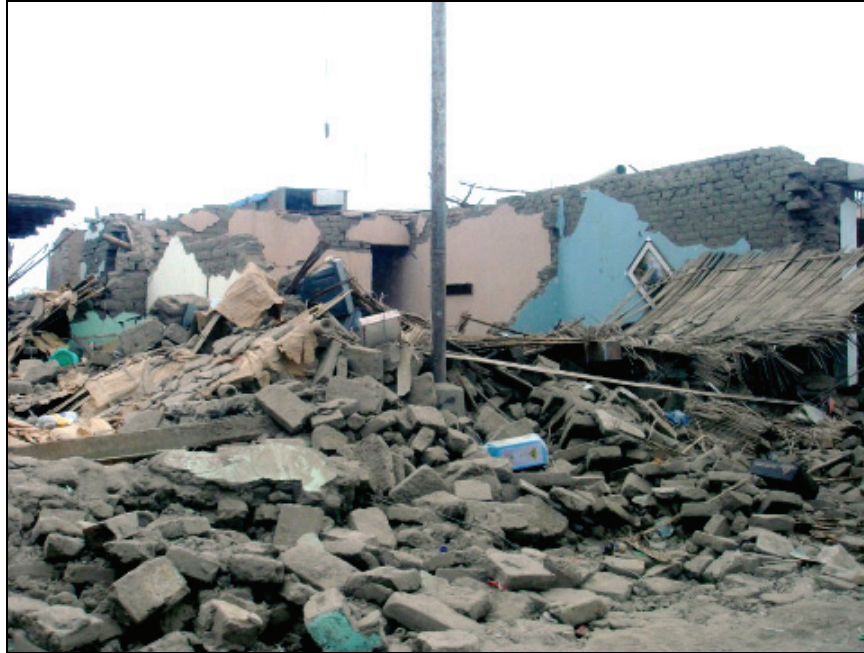
Figure 6.11 Collapsed masonry structure-5

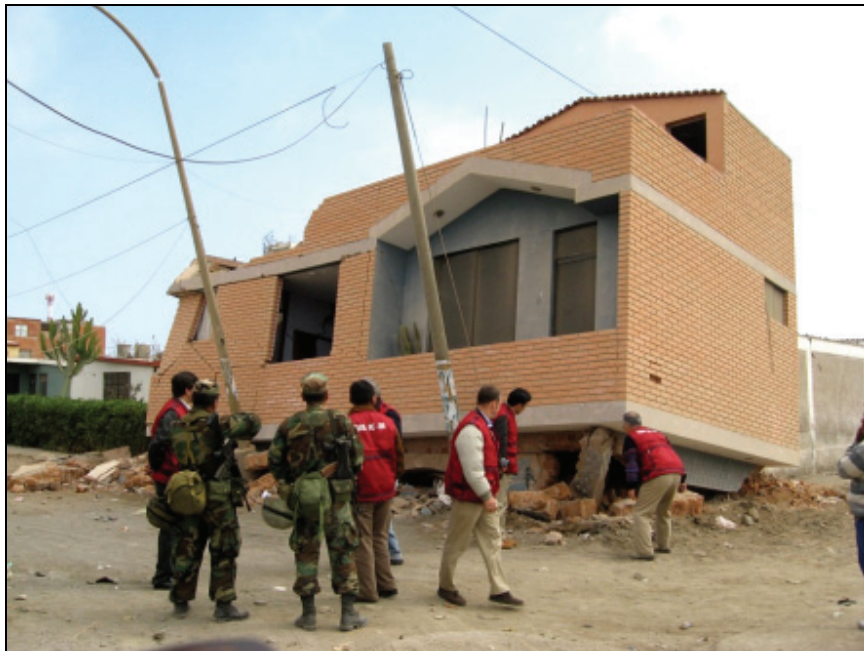
Figure 6.12 Collapsed masonry structure with RC columns-6

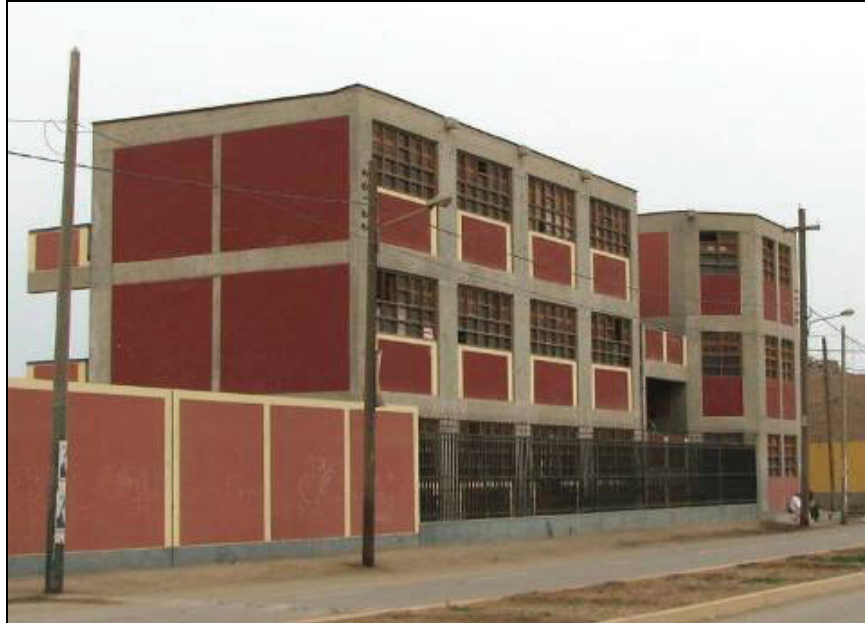
Figure 6.21 New wing of the San Juan de Dios Hospital in Chincha

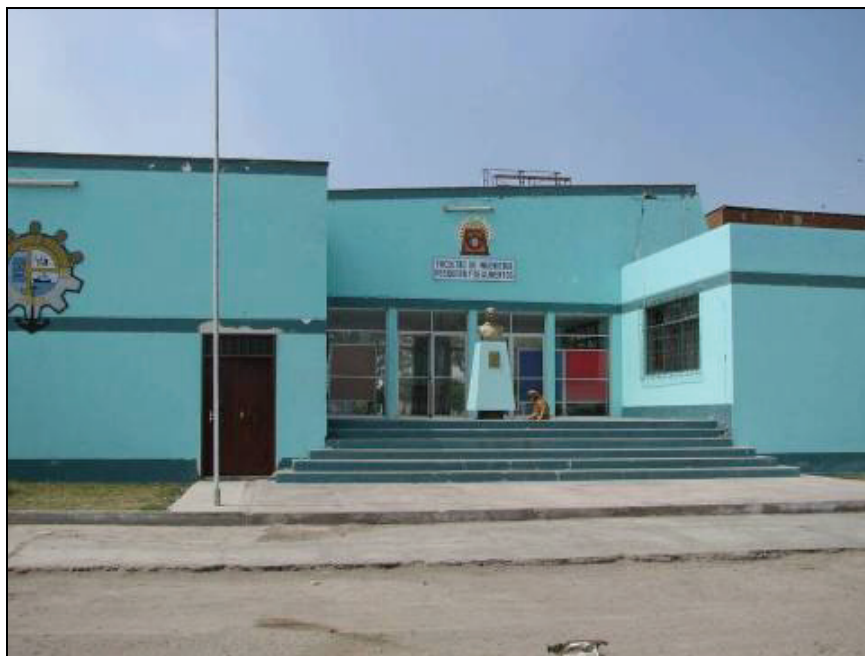
Figure 6.22 Undamaged education building

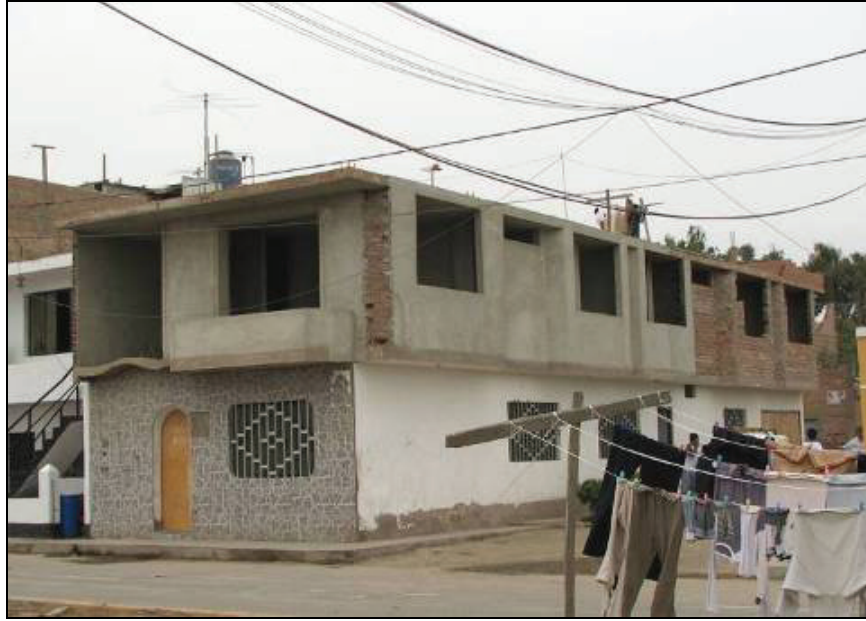
Figure 6.23 Undamaged residential building

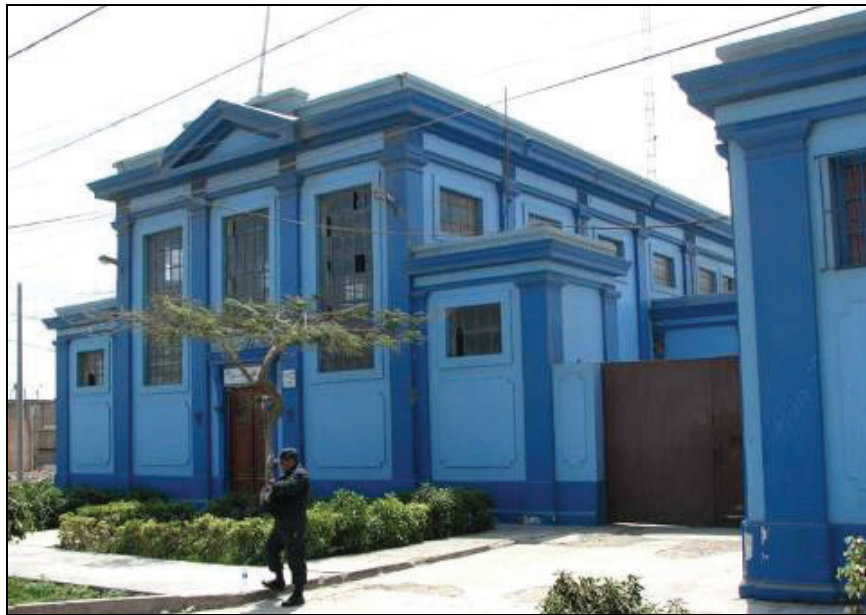
Figure 6.24 Undamaged building

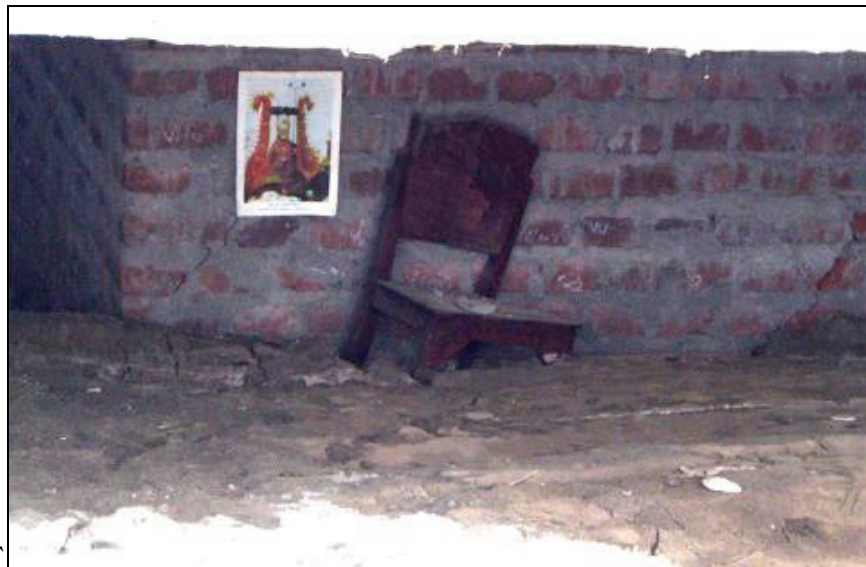
Heavily cracked floor slabs were observed in many buildings. Building walls sunk into liquefied soil. The slabs were not strong enough to resist the differential pressure. Liquefied soil left water marks on the wall, Figure 6.30. Even chairs sunk into the ground when the soil was liquefied, Figure 6.31.

Figure 6.31 A chair partially buried in liquefied soil

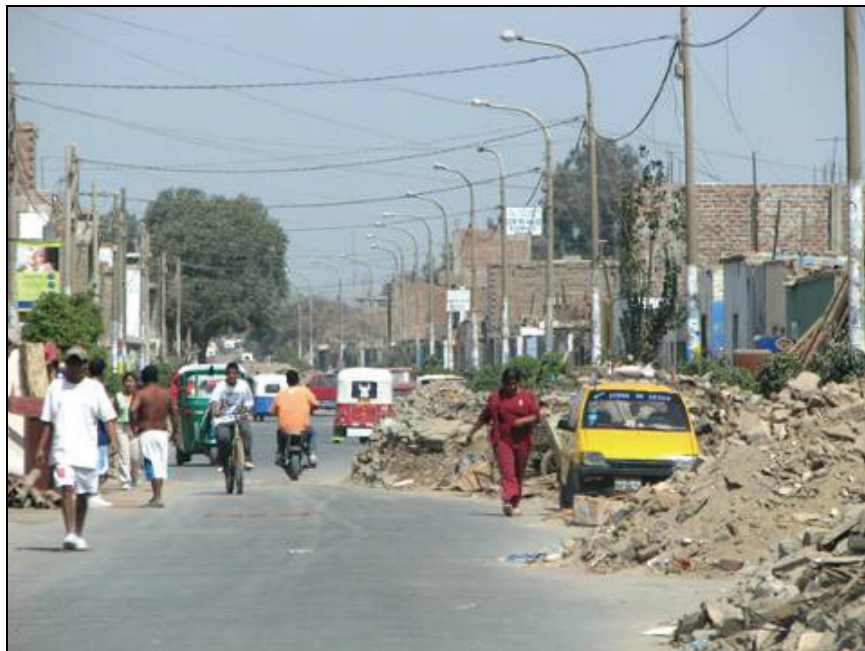
Figure 6.37 Debris from collapsed of masonry residential buildings

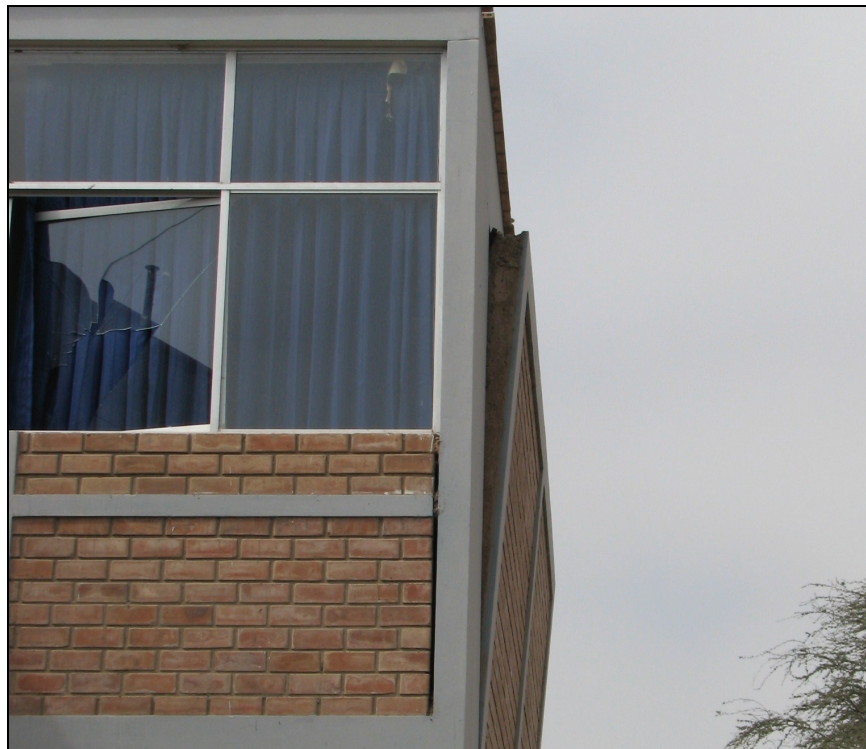
If infill walls are not properly restrained in out-of-plane direction, walls can collapse during strong ground shaking, producing damages to inhabitants and properties. If walls on the façade of a structure collapse, the consequences could be deadly to pedestrians. Figure 6.55 through Figure 6.57 shows several RC buildings with infill wall failure.

Figure 6.57 Tilted infill wall at the National University of Ica

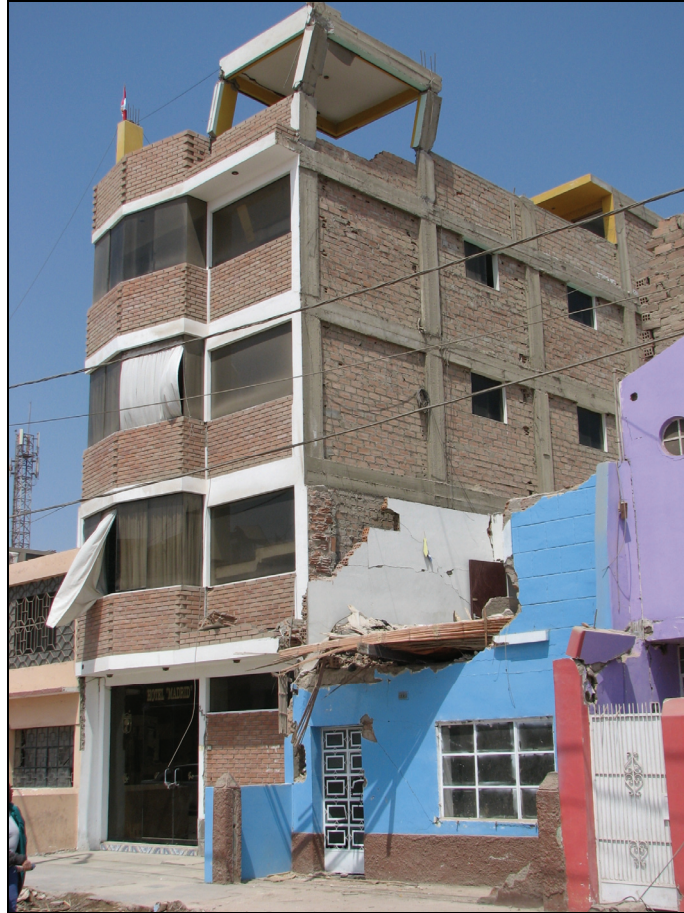
During an earthquake, upper floors experience larger displacement and acceleration than lower floors. It is common in practice to build additional floors at a later stage on top of existing buildings. When these elements are not designed and constructed properly without strengthening their supporting components, their collapse can be devastating. Figure 6.58 shows the remains of an add-on element that fell from the top floor of the building. The extensive damage that this element inflicted on people and property outside of the building is clear. Medium-height buildings tend to have additional elements in the upper part, mainly for water tanks. Figure 6.59 shows the status of an added element near collapse, as an example of a dangerous result of poor engineering and construction detail.

Figure 6.59 Added element about to fall down from the top floor of a building in Pisco.

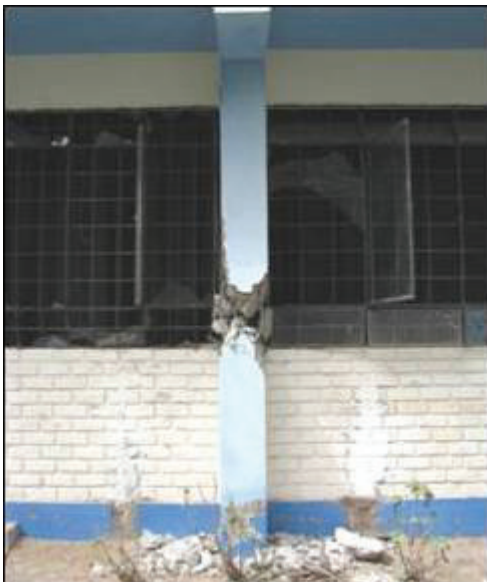
Partial infill walls were constructed between columns in EW direction. Some of the infill walls experienced minor cracks and crushing at the corners. But most infill walls remained intact. The damage pattern of columns showed that the infill walls shortened effective length of columns. The shortened columns reduce structural periods, which in general increase seismic force demand. In addition, the shortened columns are subject to non-ductile shear failure rather than ductile flexural failure. Figure 7.5 shows examples of the column failure from the earthquake. It can be noted from Figure 7.5 (a) that the cover concrete has completely fallen off, core concrete is crushed, and longitudinal rebars are buckled. The damage pattern also shows that it failed due to flexure-axial interaction. On the other hand, Figure 7.5 (b) shows a shear failure of a column. The left side of the column is in contact with a higher infill wall than the right side of the column, significantly restricting flexural deformation toward the left. The difference in the height of infill walls forces non-symmetric deformation capacity of the column. Hence, shear cracks were developed in one direction. It can be easily noted from the marked damage patterns in Figure 7.4 that columns with less restraint from infill walls, CW15 and CW17, suffered less damage than columns with larger restraint. Additional pictures of failed columns are presented in Figure 7.5 (c)-(f).

(a) Moment-axial interaction failure, CW16

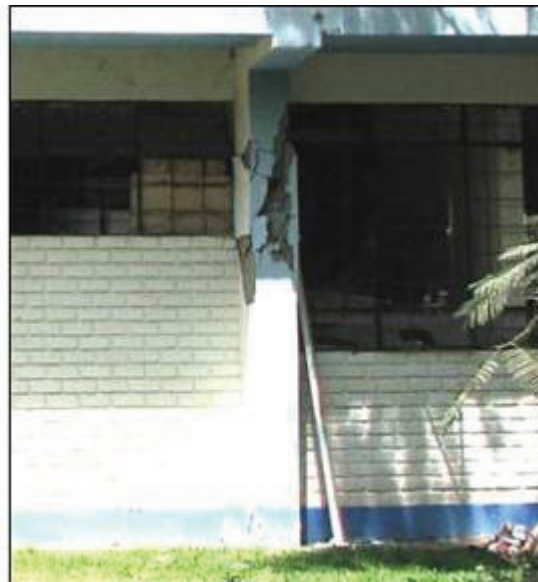
(b) Shear failure, CW18

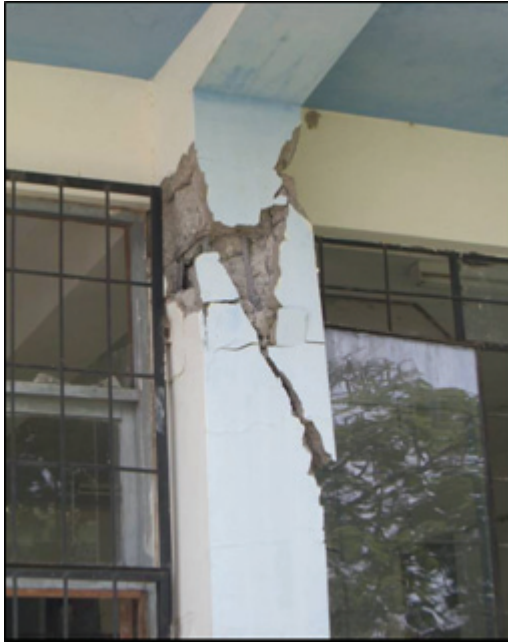
(c) Shear failure, CW03

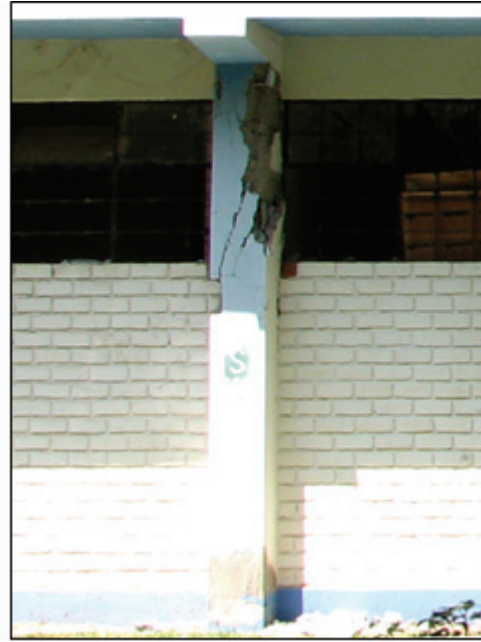
(d) Shear failure, CE19

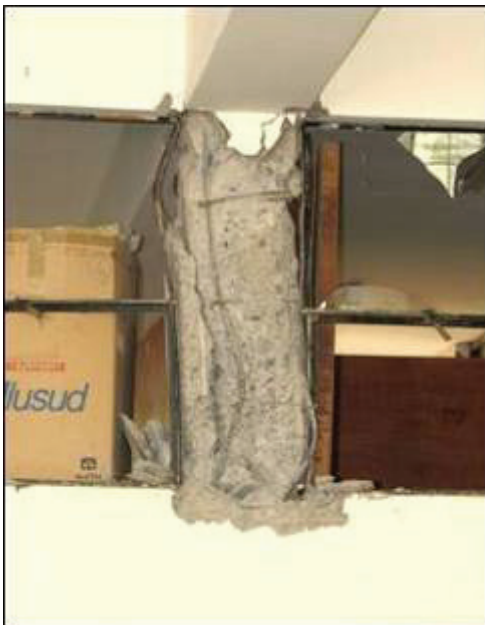
(e) Shear failure, CW11

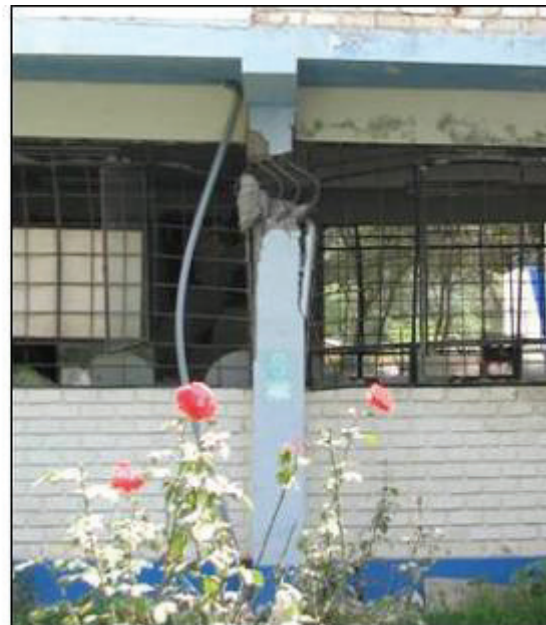
(f) Shear failure, CW06

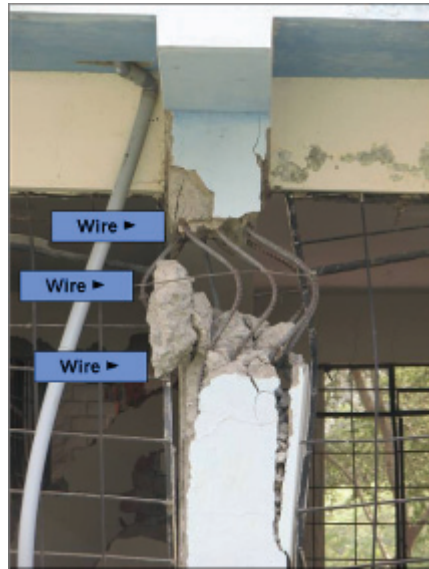
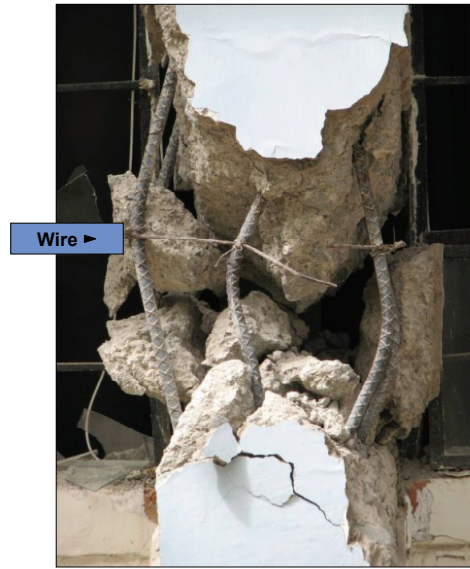
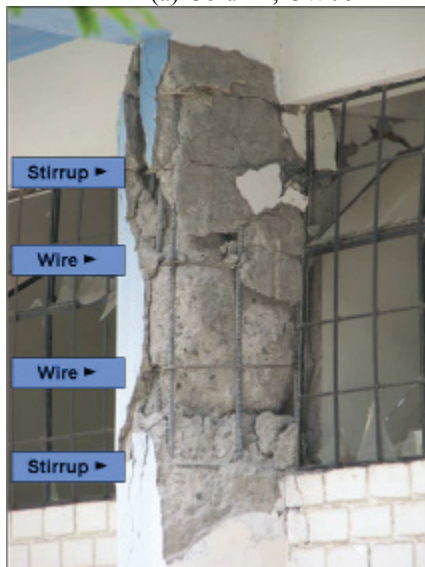
Figure 7.7 Stirrups of damaged columns

Damaged columns exposed diameters and a number of longitudinal bars as well as those of stirrups. Figure 7.7 shows a close-up view of the damaged columns, which revealed stirrups and longitudinal reinforcements. It can be clearly seen that in most columns, smooth wires with diameters of 5 mm or less were used instead of regular deformed reinforcements. The

longitudinal bars buckled as the weak stirrups couldn't provide enough confinement. In addition, the number of stirrups was not large enough to provide resistance to shear force demand. The combination of increased shear force demand from column shortening with reduced shear capacity and ductility from inappropriate stirrups are the most likely cause of the column failures.
